AEFA PROJECT NO. 86-20

**PRELIMINARY AIRWORTHINESS EVALUATION  
OF A UH-1 EQUIPPED WITH A TERRAIN MAPPING  
RECEIVER ANTENNA**

**FINAL REPORT**

**US ARMY AVIATION ENGINEERING FLIGHT ACTIVITY  
EDWARDS AIR FORCE BASE, CALIFORNIA 93523 - 5000**

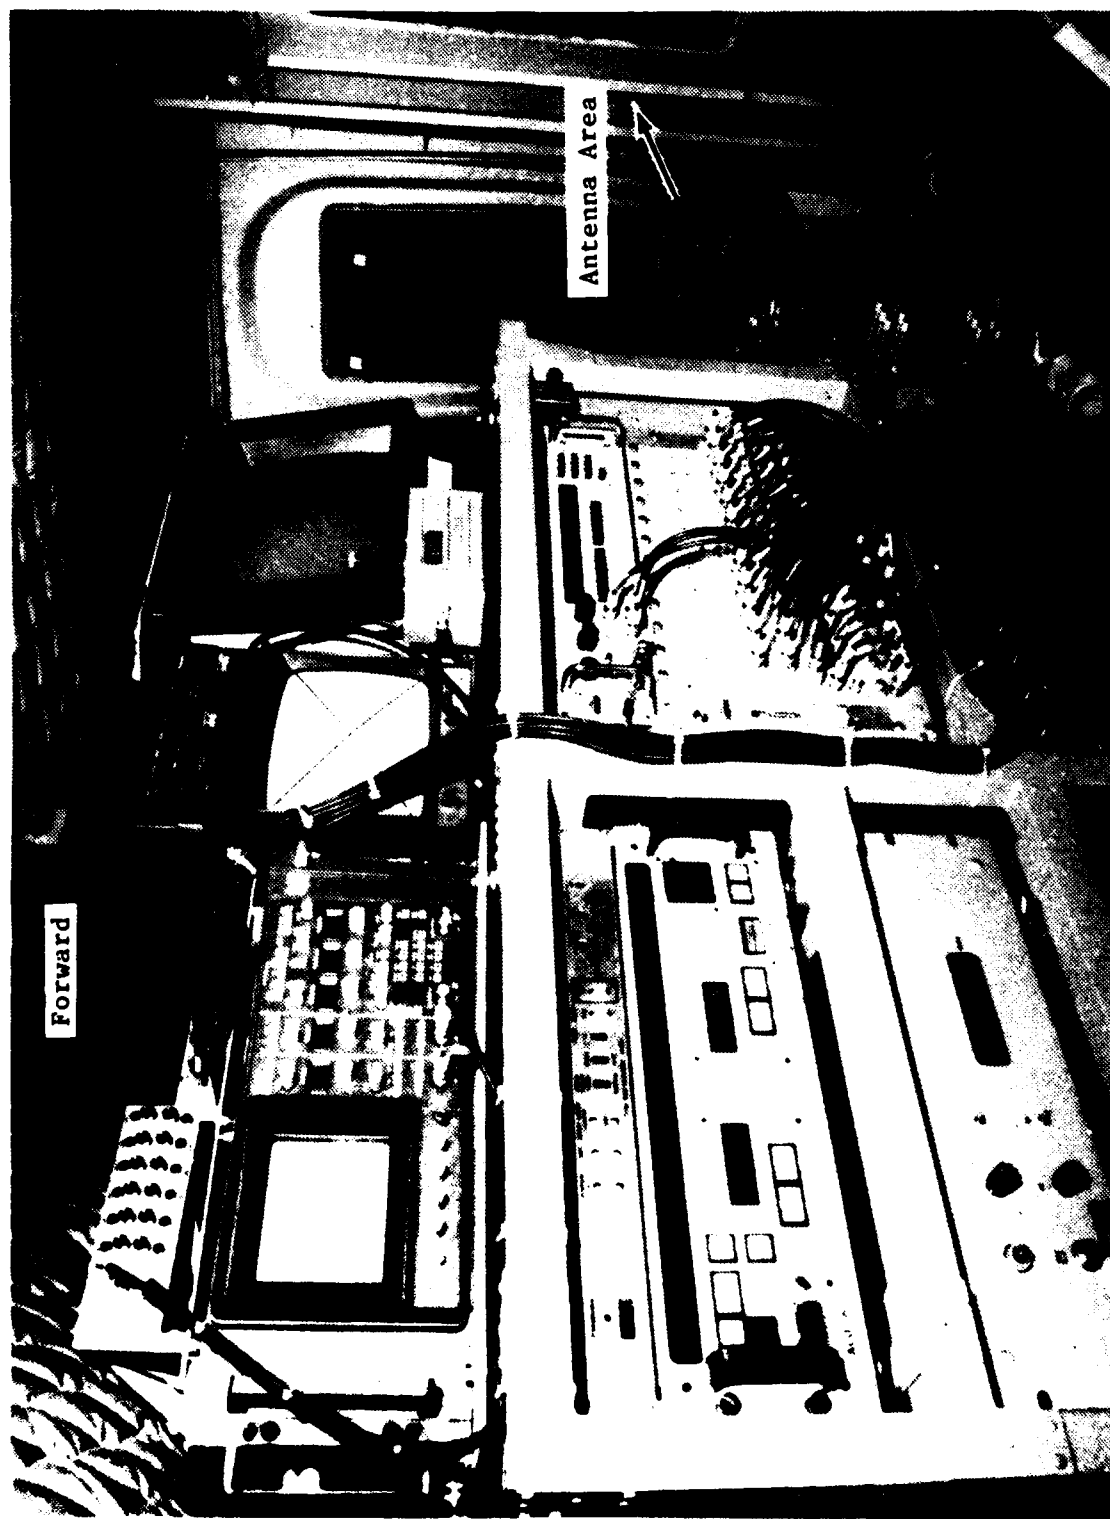
Photo 2. Electronic Equipment at the Operator's Station

19. The crew and cargo compartments were qualitatively evaluated throughout the test program. Electrical mission equipment was installed in the cabin area (photo 2). The only onboard fire extinguisher was located on the floor to the right of the pilot's seat. The mission equipment operator did not have immediate access to this fire extinguisher. Due to the great extent of electrical mission equipment located in the cabin area, a greater electrical fire hazard existed than in a standard UH-1H helicopter. A portable fire extinguisher should be installed in the cabin area and be accessible to the mission equipment operator in flight.

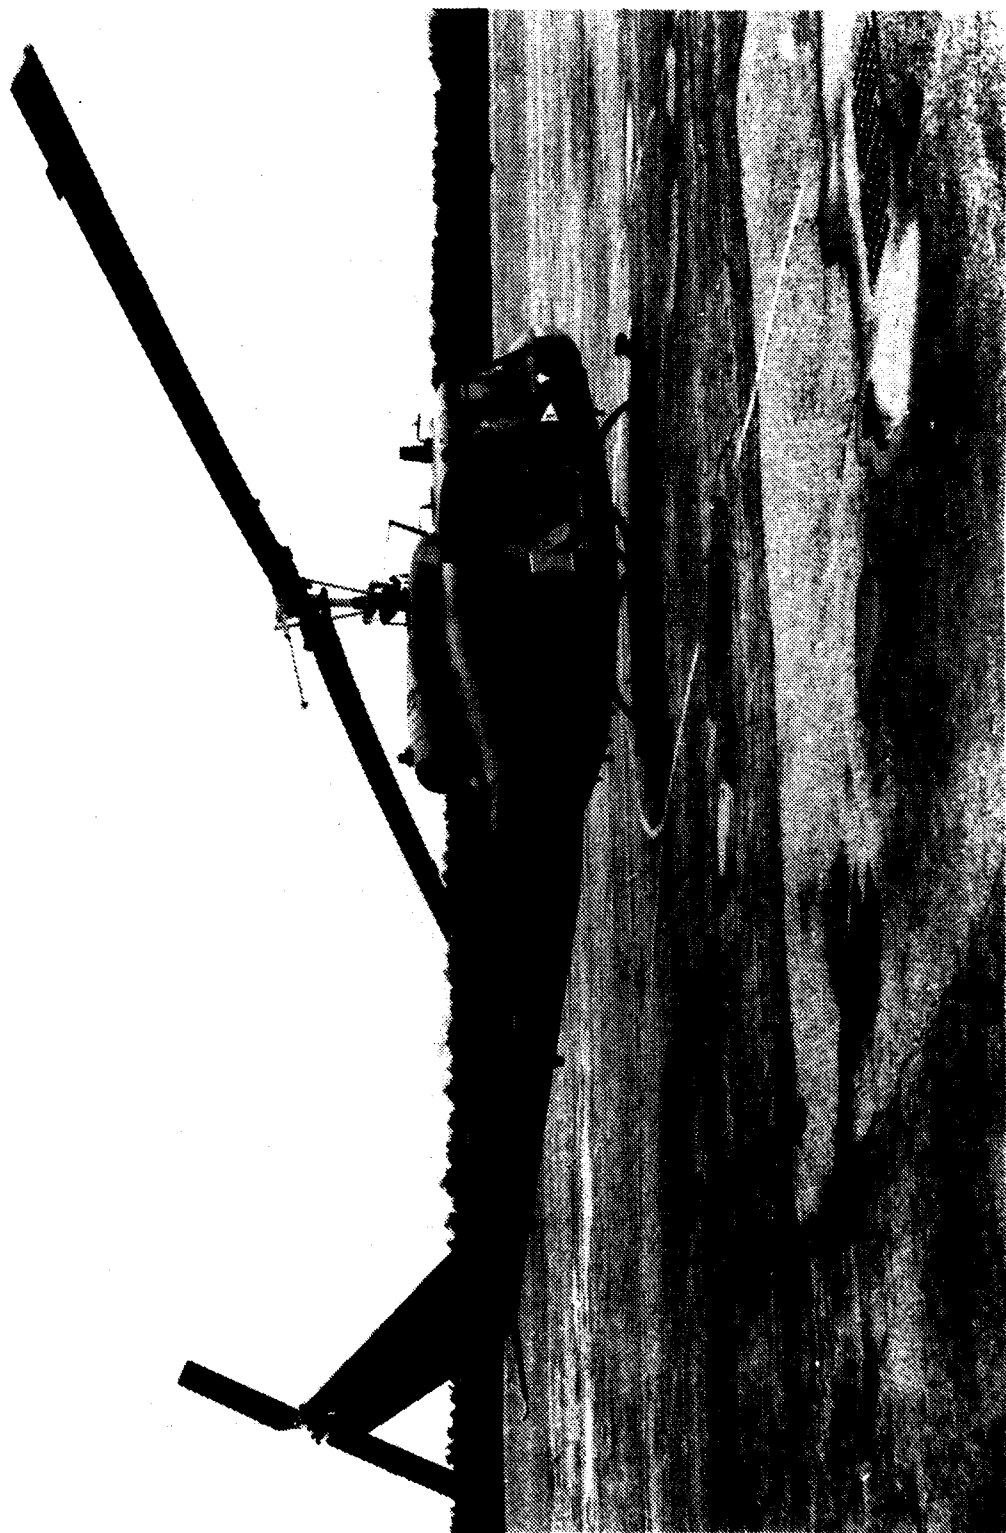
Photo 7. Modified UH-1H Helicopter (Ferry Configuration)

servo motors which positioned the antenna within the full range of motion (+10 deg to -18 deg elevation and +26 deg azimuth) while at a hover. When electrical power is removed from the servo motors, the antenna is free to rotate about any axis. Consequently, the receiver antenna was designed to be mechanically secured to the helicopter with four support tubes when in transit to and from the operational area. A full description of the terrain mapping radar system is contained in the pamphlet "Four Axis Gimbal System Transmitting Model 5550-85 Receiving Model 5050-85" (ref 4). The receiver antenna, yoke assembly, and cantilever beam may be removed for ferry flights, leaving only the vertical support structure and antenna electrical components mounted in the antenna area (photos 6 and 7).
