Aircraft Materials Technical Memorandum 393

LABORATORY STUDIES RELATED TO IN-FLIGHT
ACOUSTIC EMISSION MONITORING (U)

S.R. Lamb

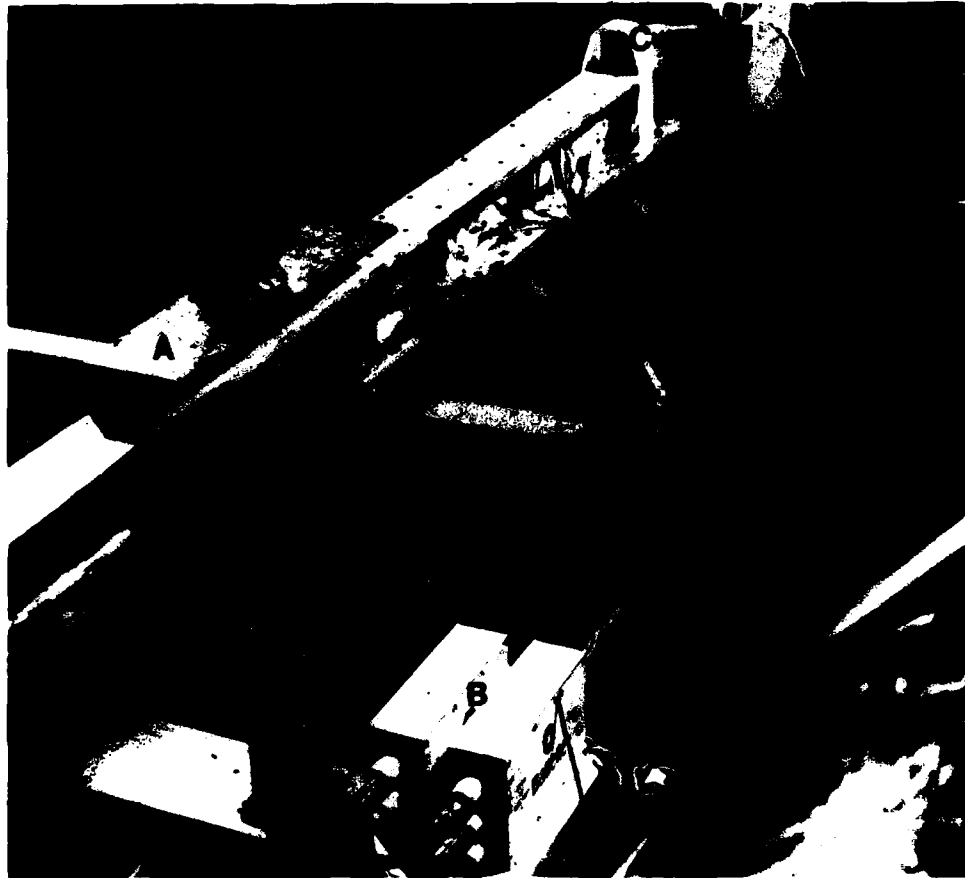
FIGURE 3.

Detail of tension boom in test rig showing centre support framework (A); aircraft AE system pre-amplifiers (B); aircraft AE system transducers (T) and one of the two AET 3000-LOCATOR system transducers (C). Note that all cabling was taped clear of the component during testing to prevent injection of spurious AE signals.

- (i) the cross-heads of the hydraulic fatigue testing machine; and
- (ii) the centre support framework (labelled A in Figure 3) linking the specimen to the frame of the testing machine, to limit bending loads during compressive loading.

Photographic records of the AET 3000-LOCATOR CRO screen taken at the end of several of the laboratory test loading programs, are shown in Figure 5. In each case the location of the zone of interest, containing the cracked holes, is indicated on the horizontal scale. Of particular interest is the marked increase in AE activity in the specified region recorded by the system after program 5, confirming the record of the aircraft monitoring system for the same zone (Figure 4) over the same period of laboratory testing. The noise 'peaks' at approximately the centre of each of the photographic records of Figure 5 have been generated by the centre support framework, labelled A in Figure 3.

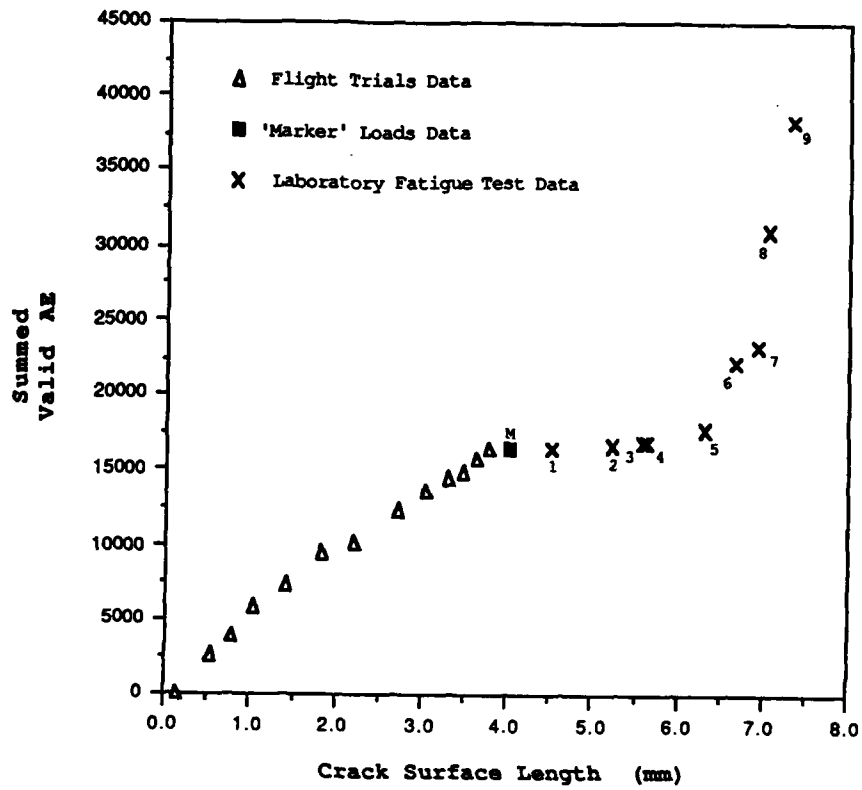
FIGURE 4.

Summed AE versus Crack Surface Length over the duration of the flight trials, together with data from the laboratory fatigue test. The first point (M) of the laboratory data corresponds to the application of the 'marker' loads sequence.

The 'marker' loads applied to the test component produced a surface crack extension of 0.25mm, during which the total number of AE counts recorded was 18. The progressive number of counts, from the start of the in-flight monitoring to the completion of the laboratory test, are plotted against crack surface length in Figure 4.

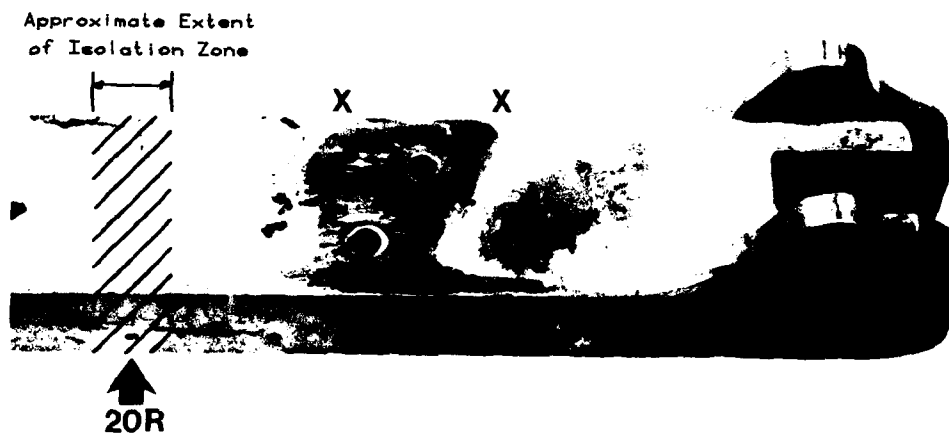
FIGURE 6. Starboard end of centre section component showing imprint (X-X) of contacting structural member produced by rubbing/fretting action during operation of the aircraft. The approximate location of transducer A (on under-surface, refer Figure 1) is shown together with the position of hole 20R.

Upon completion of the programmed loading, the test component was closely re-examined. Evidence (Figure 6) was found of heavy surface damage on the tension boom close to the cracked zone (but outside the isolation zone). This damage was caused by rubbing and/or fretting between the top surface of the boom and the surface of another structural member of the centre-plane assembly. This must have occurred when the component was in the aircraft.

As stated in section 5, no evidence of fretting/rubbing could be found in (or at) either of the holes within the isolation zone (i.e. 20F and 20R). All magnetic rubber plugs of holes 20F & 20R taken during the flight phase of the test were examined closely for any evidence of fretting/rubbing damage to the hole - no such evidence was seen. Indeed the only regions containing heavy rubbing/fretting damage to the centre section member were outside the extent of the isolation zone (Figure 6).
