MISCELLANEOUS PAPER SL-87-5

# ALKALI-CARBONATE ROCK REACTION AT CENTER HILL DAM, TENNESSEE

G. Sam Wong

Structures Laboratory

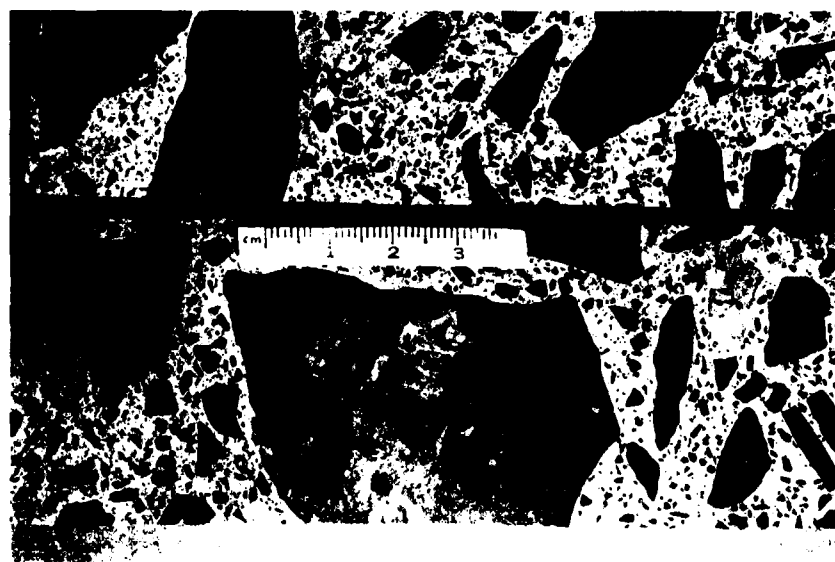
Photograph 2. Center Hill Dam concrete (core NASH-8 CON-23) with bottom piece from 0.9-ft to 1.55-ft depth and top piece from 210.3-ft to 210.9-ft depth. Reaction rims are readily visible on these ground surfaces. Magnification 0.9X

21. The concrete contains many aggregate particles with reaction rims (photograph No. 2). When these carbonate particles were acid etched, the rims were less soluble and were left in relief.
