EFFECTS OF ION IMPLANTATION ON  
CAVITATION EROSION OF A COBALT BASED  
METAL/CARBIDE ALLOY

Sara A. Dillich  
Department of Mechanical Engineering  
Worcester Polytechnic Institute  
Worcester, Mass. 01609

Final Report  
Contract No. N00014-86-K-0391

Office of Naval Research  
Materials Division, Code 1131M  
800 N. Quincy Street  
Arlington, Va. 22217

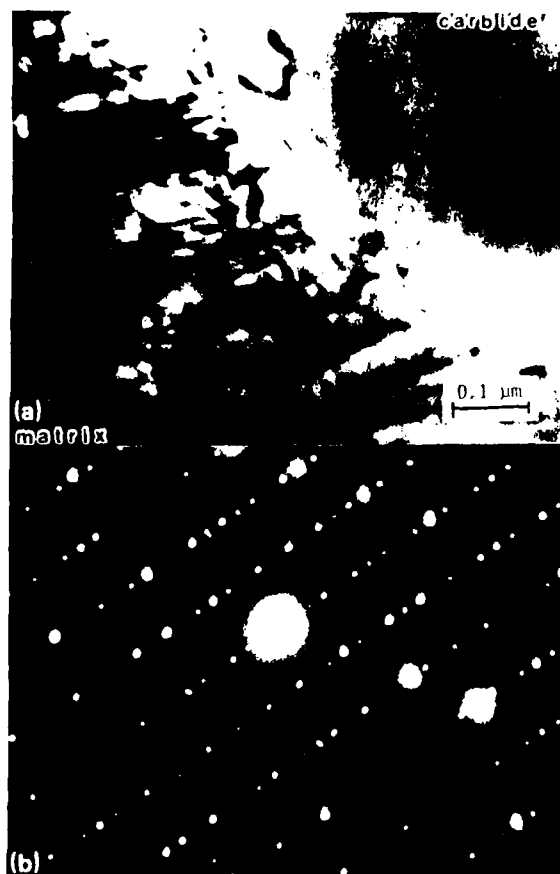
Fig. 5. (a) Bright field micrograph of a carbide-matrix interface; (b) an SAD pattern from the carbide.

Bright field TEM micrographs and SAD patterns from unimplanted foils are shown in Figs. 3-5. The matrix phase of the alloy is characterized by networks of planar defects (predominantly stacking faults) running through the grains and extending occasionally from one matrix grain to another (Figs. 3 and

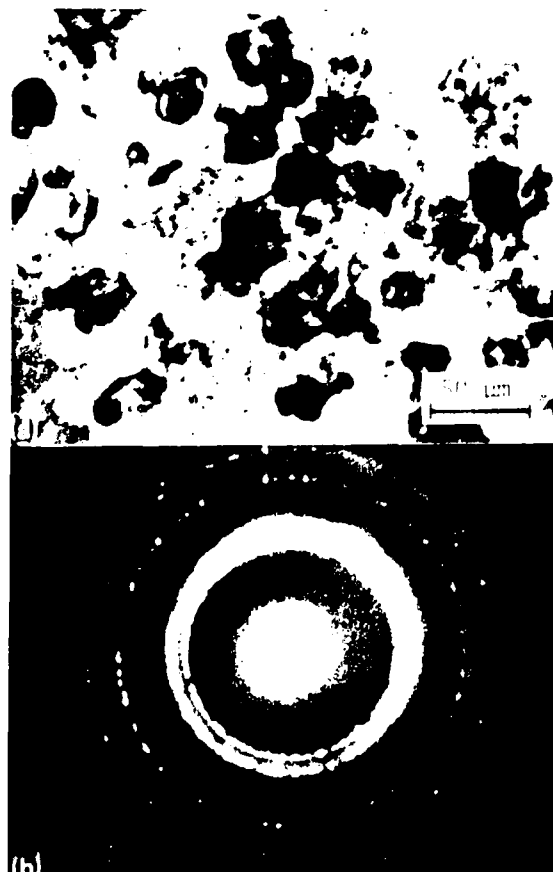
Fig. 8. (a) Bright field micrograph of a carbide in the titanium implanted foil; (b) the corresponding SAD pattern. The rings in the pattern indicated a polycrystalline phase. Partial amorphization of the carbide surface is suggested by the diffuse nature of the rings.

absence of defects, *i.e.* dislocations and planar faults (Fig. 7). Similarly, the carbides were transformed from monolithic single crystals to fine-grained polycrystals (Figs. 8 and 9), with diffraction spots forming ring patterns (Fig. 8). Partial amorphization of the carbide surfaces is suggested by the diffuse nature of the rings.

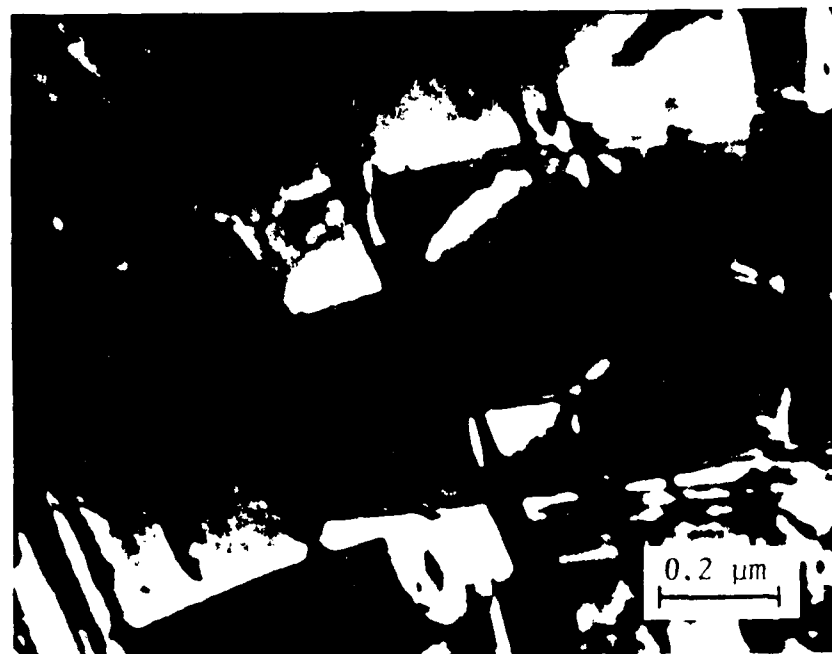
Figure 7. Bright field micrographs of the Cr-rich matrix phase in (a) a nonimplanted foil and in (b) a B-implanted foil.
