Technical Report 84049

May 1984

GARTEUR/TP-007

**IMPACT DAMAGE TOLERANCE OF A  
CARBON FIBRE COMPOSITE LAMINATE**

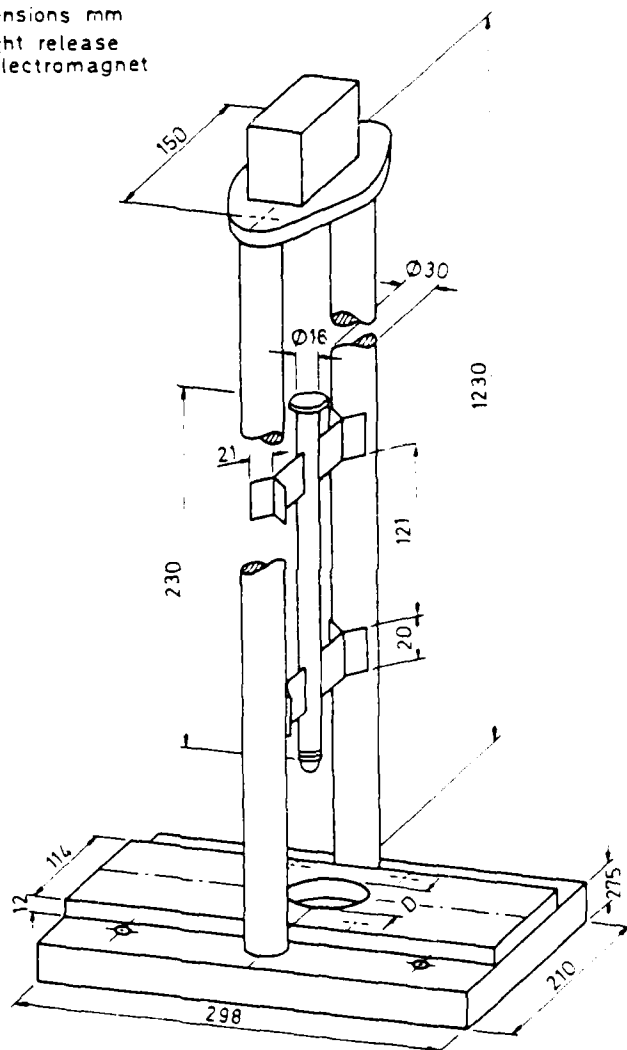
Dimensions mm  
Weight release  
by electromagnet

Fig 3 The DFVLR apparatus for dropweight impact

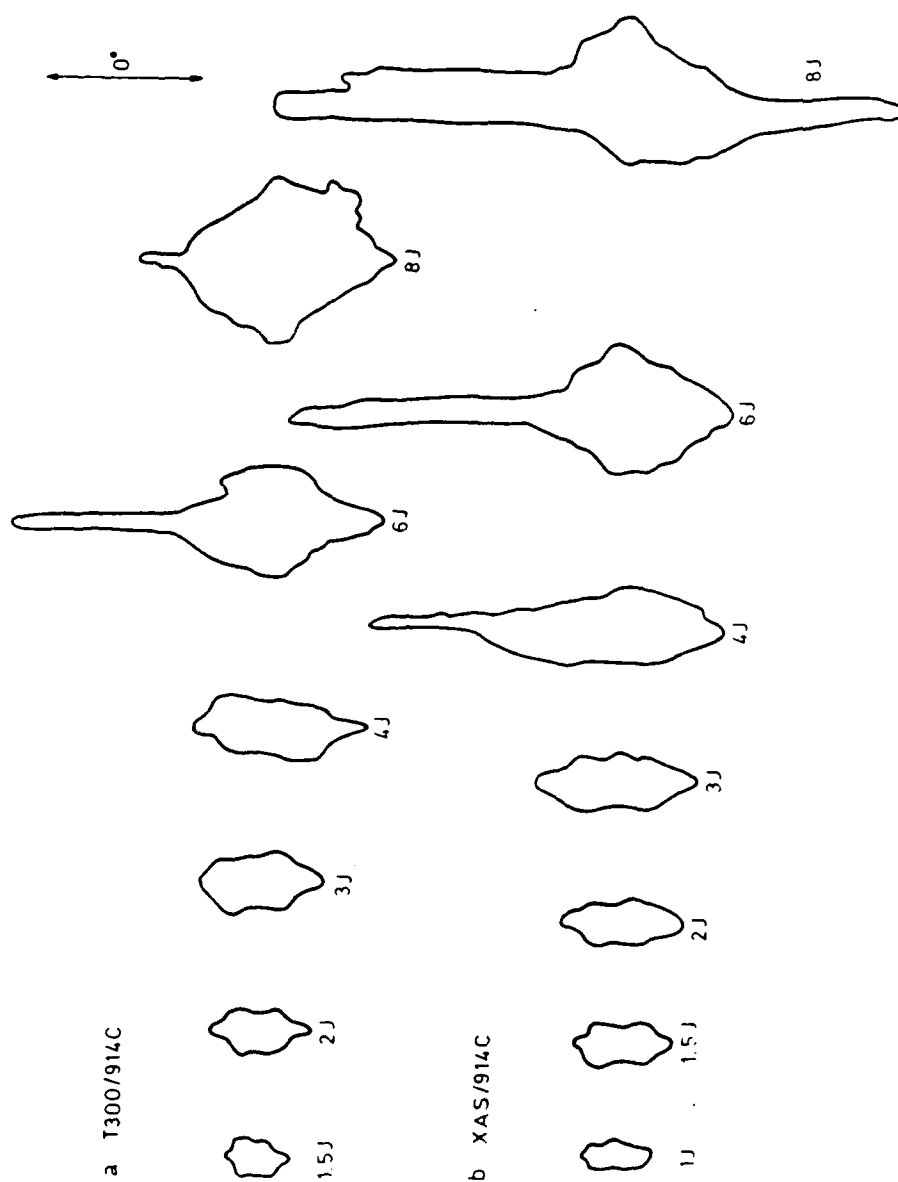
Fig 6a&b Areas of damage measured by ultrasonic C-scan for various levels of incident dropweight energy on [0/90/0/-45/0]<sub>s</sub> carbon fibre laminates (RAE)

The panels were examined by ultrasonic C-scan in all four laboratories. Fig 6 shows the RAE results for various levels of incident energy, showing the areas of damage elongated in the direction of the  $0^\circ$  fibres. The reproducibility of the damage is shown in Fig 7 (ONERA) and Fig 8 (DFVLR) where delaminated areas were 212 mm<sup>2</sup> (CV 19%). Because the NLR specimens were more compliant under impact loading (thinner laminates and less rigid supports) more of the incident energy was taken in elastic deformation and

The RAE results shown in Fig 17 indicate that for the undamaged specimens there was very little difference between XAS/914 and T300/914. For damaged specimens, the slightly greater area of delamination in XAS/914 (see Fig 6) led to slightly lower fatigue strengths, but for both materials there was no evidence of any further reduction in fatigue strength up to  $10^7$  cycles. The NLR results (Fig 18) showed no significant difference between the specimens impacted by 3 J and those impacted by 3.5 J. The ONERA results (Fig 19) show, for undamaged specimens, that specimens failing in the gauge length and those failing near the ends had similar fatigue lives. The DFVLR results (Fig 20) show the importance of the restraints on the T-pieces to avoid out-of-plane movement; the open circles for unrestrained ends all showed lower fatigue lives than the filled circles for specimens with restrained ends.

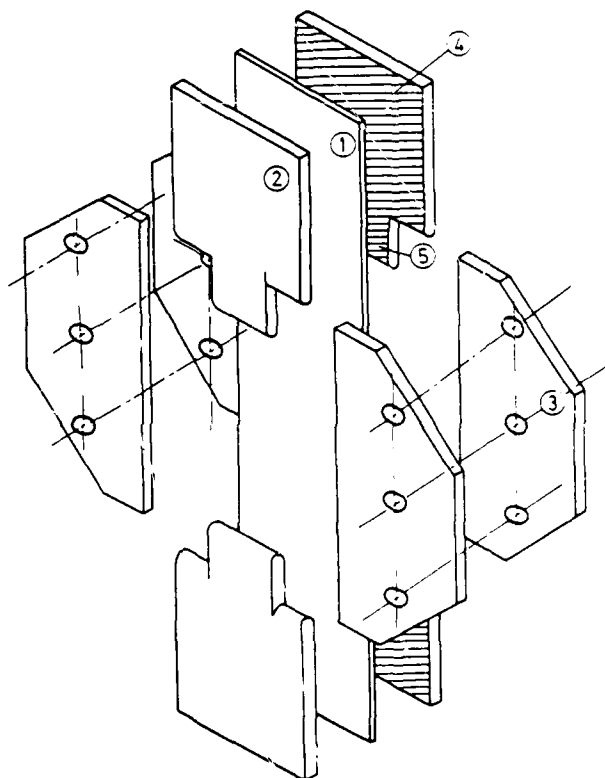
**Fig 12**

- ① Specimen
- ② End plate
- ③ Anti-buckling guide
- ④ Emery paper
- ⑤ PTFE film

**Fig 12 Exploded view of ONERA anti-buckling device**

After impact and inspection the panels were cut into specimens 250 mm × 50 mm, so that the damage was at the centre, and tested in either axial tension or axial compression. In compression an anti-buckling device was used to prevent gross buckling of the specimen but to allow local buckling of damaged plies. All four laboratories used similar anti-buckling devices based on a design by DFVLR and shown in Figs 11 to 14. The side plates, coated with PTFE to reduce friction, provided edge restraint approximately 12 mm in from each side over most of the gauge length, leaving a gap of only a few mm to allow for compressive strain. The T-pieces were used so that the small gap did not extend in a straight line across the specimen. These T-pieces had roughened surfaces (except on the tongue of the T) so that they could be clamped on to the specimen in the test machine's grips, without having to use adhesive. It was found that the T-pieces had to be restrained by the cross members (see Figs 11 and 13) to prevent out-of-plane movement. Thus the unrestrained portion of the gauge length was 70 mm × 26 mm with the damaged area approximately 25 mm × 10 mm at the centre. NLR tested some undamaged specimens in compression with gauges on each side (see Fig 14) and found that the unrestrained portion buckled for applied loads greater than about 33 kN corresponding to a strain of 0.55%. For the thicker specimens used by the other three laboratories this would occur at about 0.79% strain or 530 MPa applied stress. Fig 15 shows some results for damaged specimens tested in tension; the load strain curves were almost identical for the two strain gauge locations, confirming that the delamination damage had had negligible effect on the local in-plane tensile stiffness.

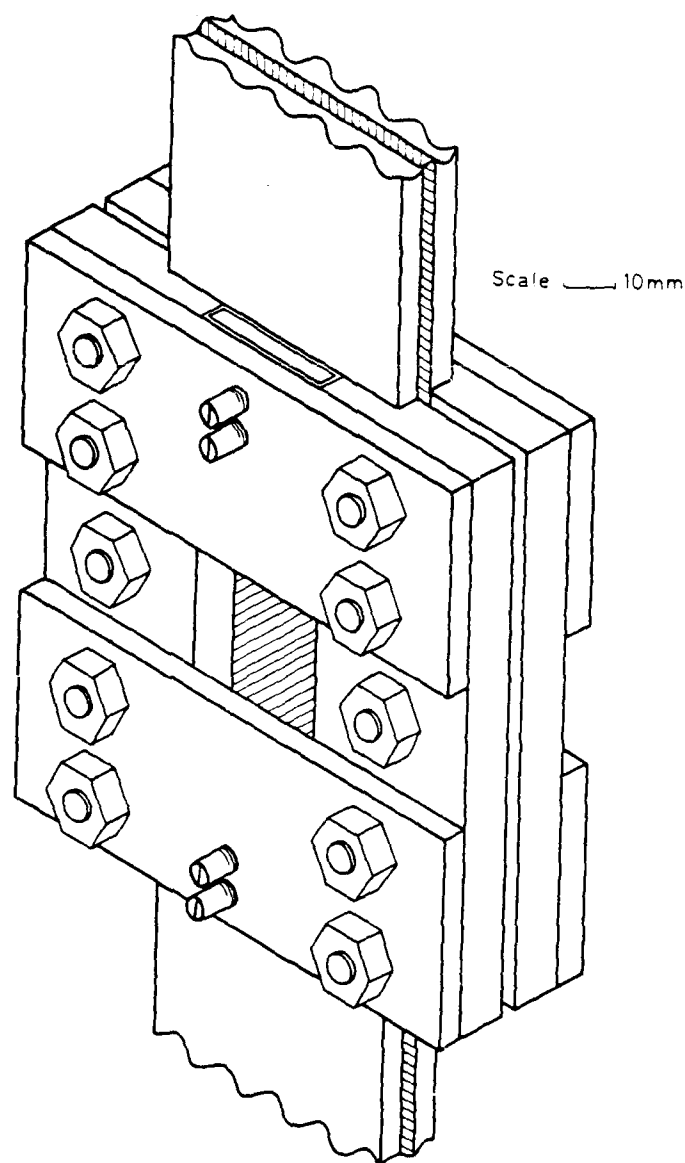
Fig 13 Assembled view of RAE anti-buckling device

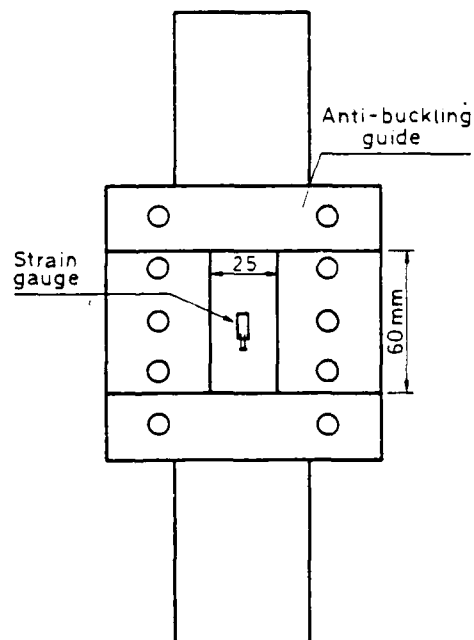
Fig 14 NLR anti-buckling device and load-strain curves of specimens tested in compression

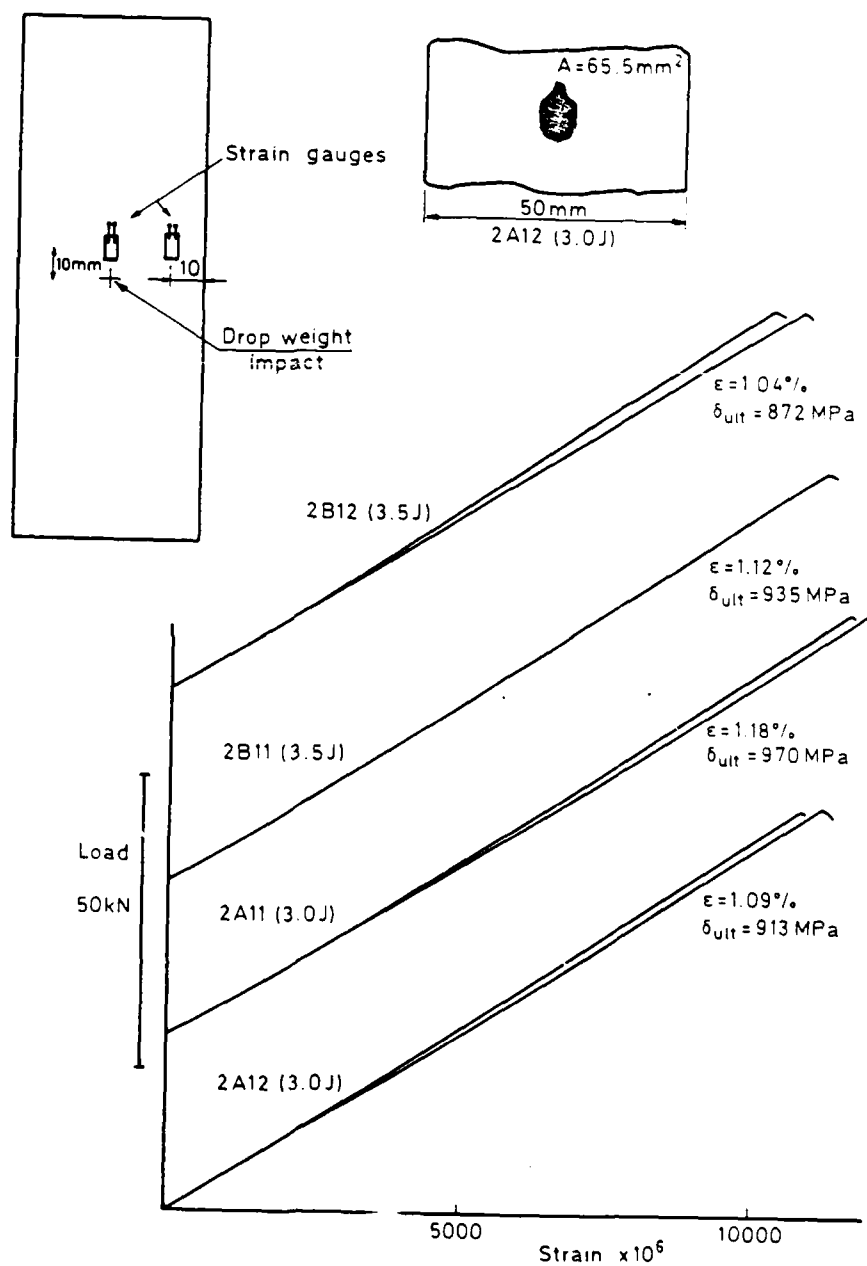
Fig 15 Load-strain curves of impact damaged specimens tested in tension and a typical C-scan of the damage (NLR)

The NLR specimens that had not failed in fatigue were inspected by ultrasonic C-scan and the scans are shown in Fig 25. Comparing these results with that shown in Fig 15 it can be seen that, with the exception of specimen 2A3, there is very little evidence of major delamination, even though specimens 2A6, 2A9 and 2A10 had indicated a reduction in stiffness: there was however a small amount of damage growth in the  $0^\circ$  direction.

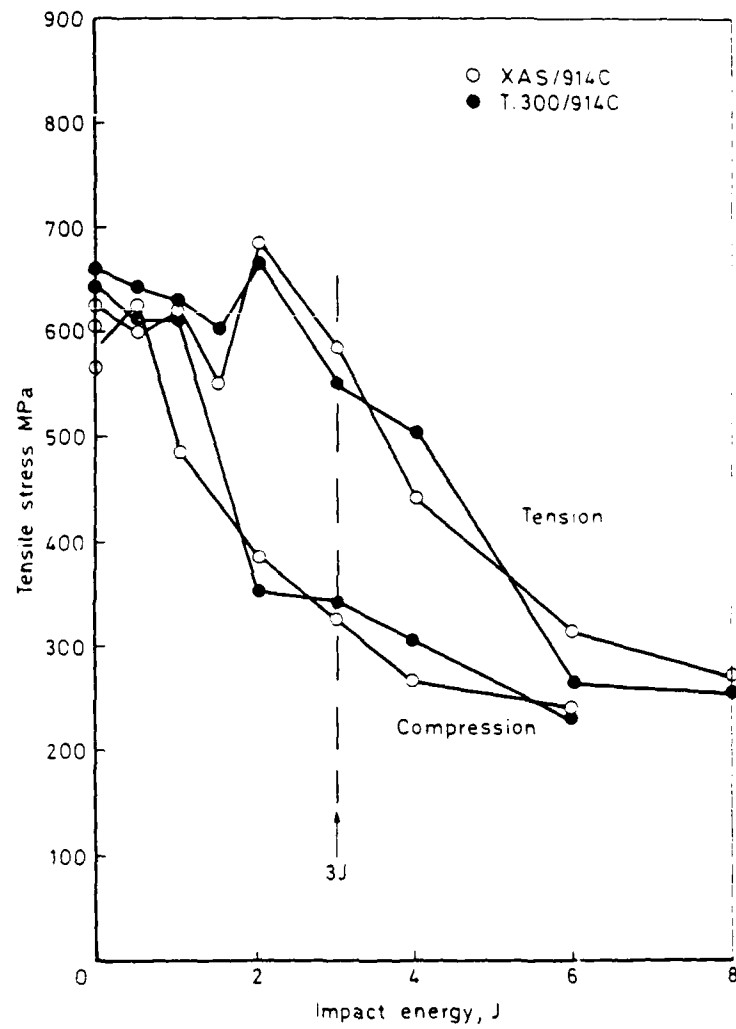
Fig 16 Effect of dropweight impact on the residual tensile and compressive strengths of  $[0\ 90\ 0\ -45\ 0]_s$  carbon fibre laminates (RAE)

RAE had damaged some of the laminates over a range of incident dropweight energies and the residual tension and compression strengths are shown in Fig 16. The results for XAS 1914 and T300/914 were very similar. The tensile strength was not affected much by

the delamination damage that occurred up to 3 J incident energy, but the fibre damage at 4 J and above caused significant reductions in strength. The delamination however did reduce the compressive strength for incident energies greater than 1 J. From these results it was decided that the standard damage for the subsequent fatigue tests would be that caused by 3 J incident energy. Tables 2 to 4 give the results of the static tests. There was reasonable agreement for the compressive strength:  $590 \pm 50$  MPa for undamaged specimens and  $340 \pm 40$  MPa for damaged specimens. For the tensile strengths there were much greater differences between the laboratories for both damaged and undamaged specimens: 630 MPa to 930 MPa for undamaged specimens and 490 MPa to 960 MPa for damaged specimens. It is assumed that these differences in tensile strengths found by the laboratories was caused by differences in stress concentrations associated with gripping the test specimens, and this is supported by photographs of broken specimens shown in section b.

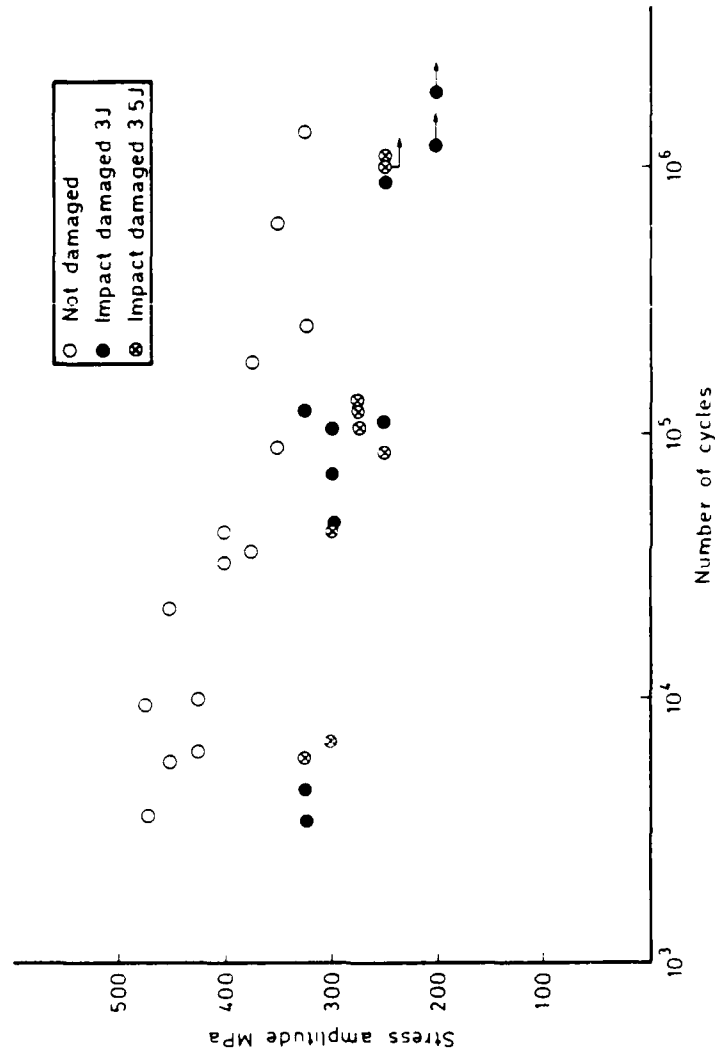
Fig 18 Fatigue curves ( $R = 1$ ) for undamaged and impact damaged  $[0/90/0/45/0]_s$  carbon fibre laminates (NLR)

The results are given in Tables 5 to 7 and plotted in Figs 17 to 20. The results for all four laboratories are plotted together in Fig 21. It can be seen that there is much better agreement for the fatigue results than for the static results. The values for undamaged specimens fall from about 600 MPa at short lives to about 300 MPa at  $10^7$  cycles. The slope of the curve for damaged specimens shows less degradation, from just over 300 MPa at short lives to over 200 MPa at  $10^6$  cycles.

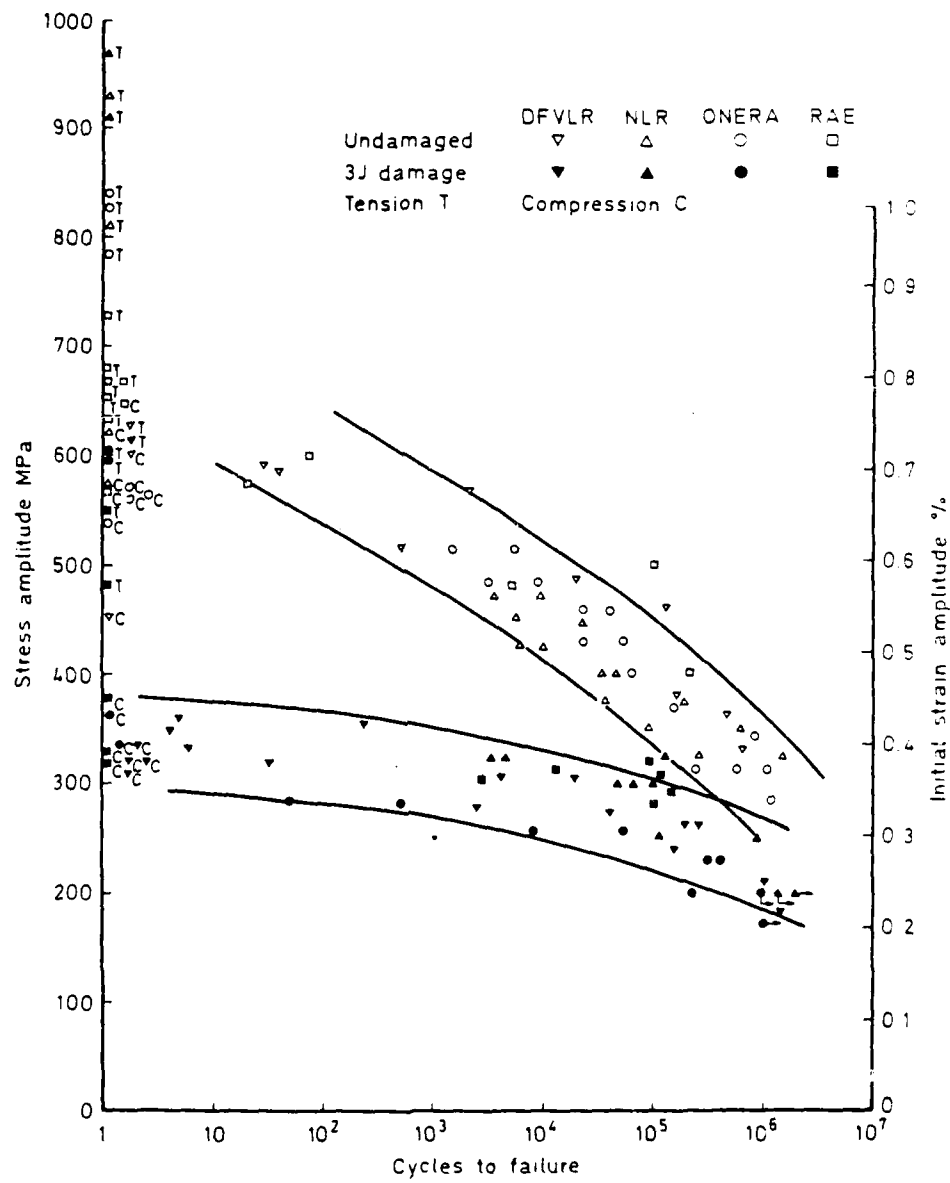
Fig 21 Combined fatigue results ( $R = -1$ ) from the four laboratories for undamaged and impact damaged  $[0\ 90\ 0\ \pm 45\ 0]_s$  carbon fibre laminates

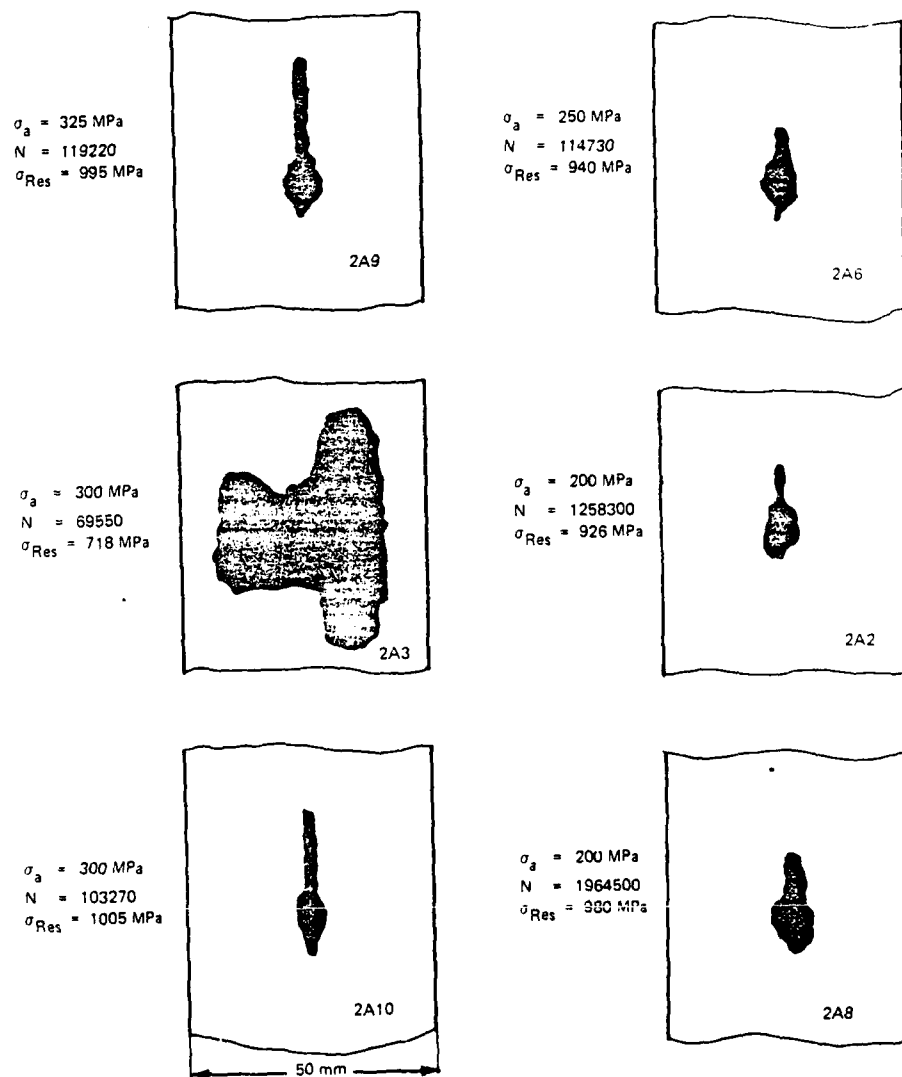
Fig 25 Ultrasonic C-scans of damage after fatigue loading showing limited damage growth (NLR)

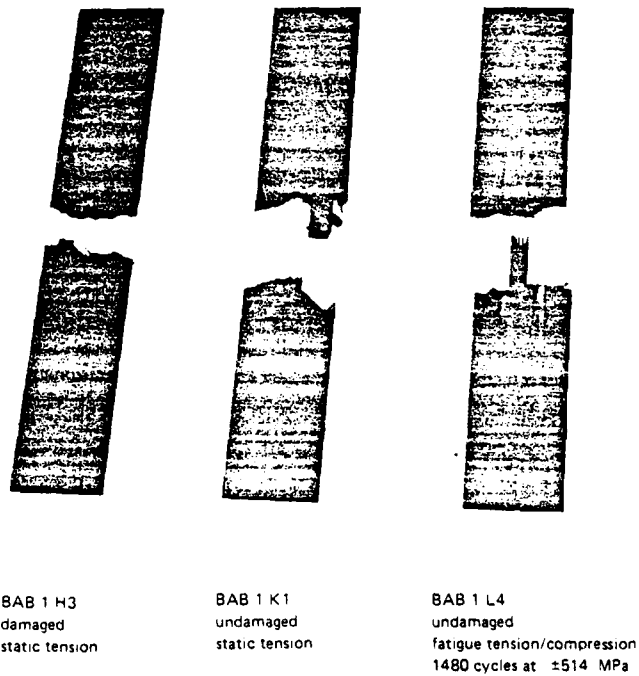
Fig 28 Failed test specimens of  $[0/90/45/0]_s$  carbon fibre laminates (ONERA)

Photographs of fractured specimens are shown in Figs 26 to 31. The static tension specimen shown in Fig 26 (DFVLR) shows evidence of failure from a stress concentration at the end grip; this might explain why DFVLR did not get any static tensile strengths above 630 MPa. Fig 27 shows static tensile specimens for XAS/914 and T300/914; as in the case of C-scans (Fig 6) and fatigue strength (Fig 17) there is evidence of slightly more splitting in the case of XAS/914 even though there was no significant difference in strength. Fig 28 shows ONERA specimens which indicate that fatigue specimens suffer more splitting parallel to the fibres than specimens failed statically in tension. This is also shown for compression specimens, Fig 29. The fracture surfaces found by DFVLR after fatigue testing show that non-impacted specimens had relatively smooth fracture surfaces with much evidence of compression failures (Fig 30) while the impacted specimens showed more splitting and delamination (Fig 31).
