TECHNICAL REPORT SL-87-29

# EVALUATION OF ALTERNATE ROOF-WALL DETAILS FOR THE KEYWORKER BLAST SHELTER

Three 1/4-scale reinforced concrete box-type models were statically tested under uniform water pressure in the 6-foot-diameter Small Blast Load Generator (SBLG) at WES. Two of the models (JD1 and JD3) were reinforced similarly to the original design except for the joint details. The third model (JD2) was similar to the proposed final shelter design as evaluated in the prototype tests conducted by WES. Based on test results, detail JD2 is recommended for use in the final design.

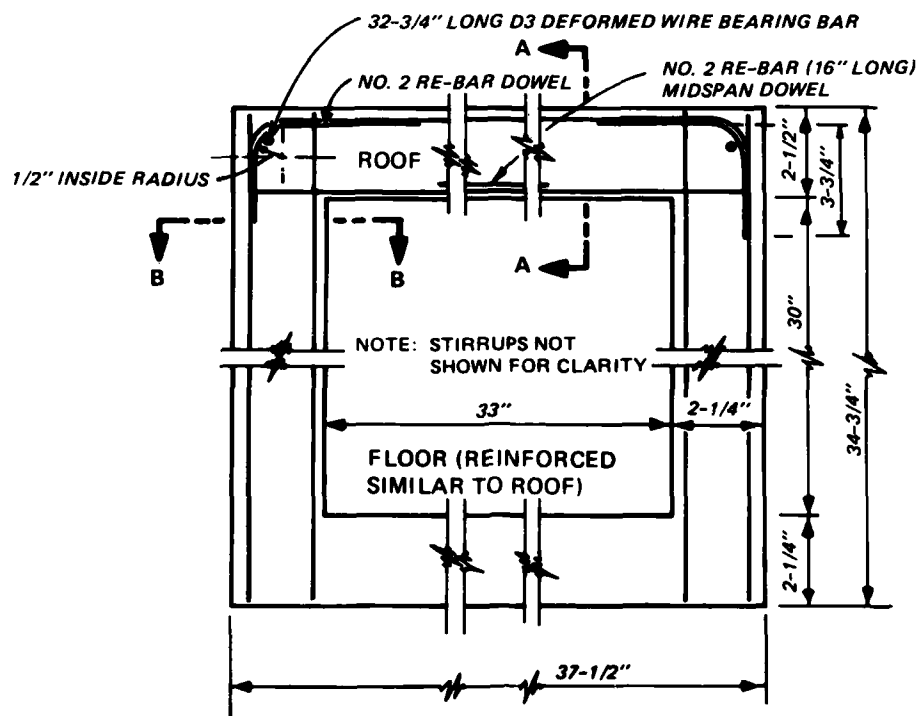
Figure 3. Reinforcement fabrication details for JD1 and JD3.

**SECTION A-A**

b. ROOF-WALL CONNECTION DOWEL

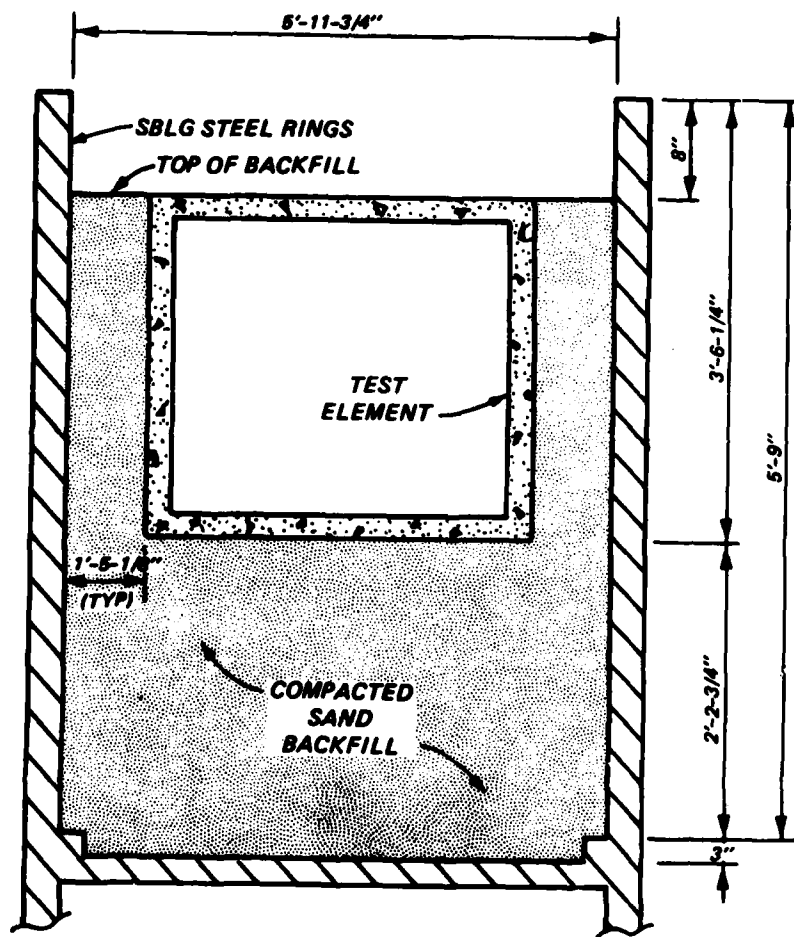
Figure 14. Test configuration.

#### TEST CONFIGURATION

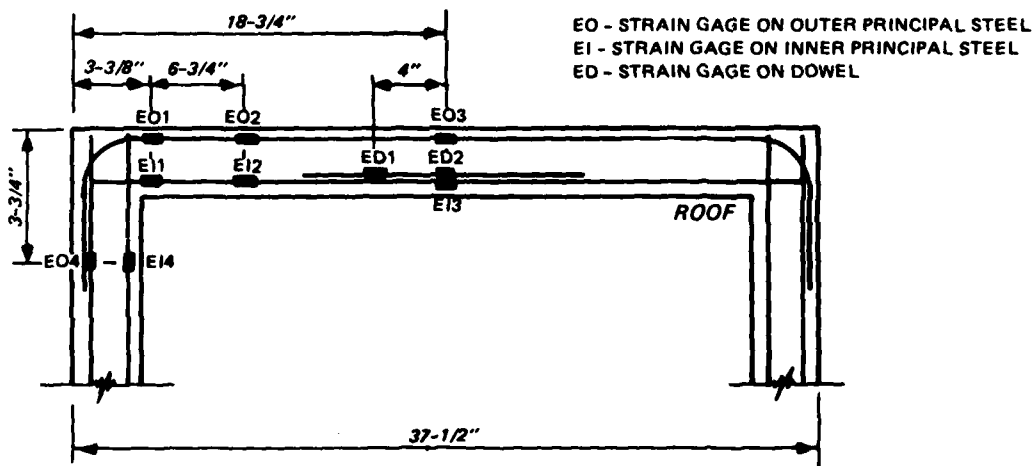
Figure 15. Strain gage locations for JD1 and JD3.

b. JD3 STRAIN - GAGE LOCATIONS

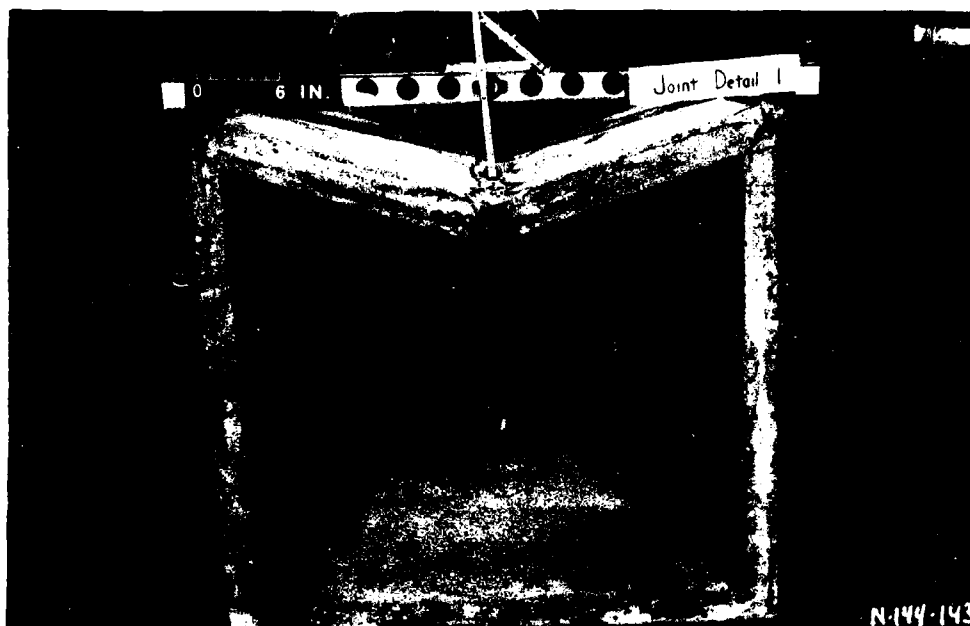
Figure 20. Posttest end view of JD1.

Maximum permanent roof mid-span deflection for Test JD1 was 5-1/8 inches, exposing reinforcing at mid-span and at the supports. Cracks at mid-span and at the roof supports ranged in depth from 1/4-inch to the thickness of the roof. Although the band of cracking at mid-span was primarily narrow on the top of the roof slab, the bottom surface revealed additional hairline cracks across the roof span. Wall cracks occurred near the top of both supports and exposed a large percentage of principal reinforcement from the roof-wall connection. See Figures 18 through 21 for posttest photographs of Test JD1.

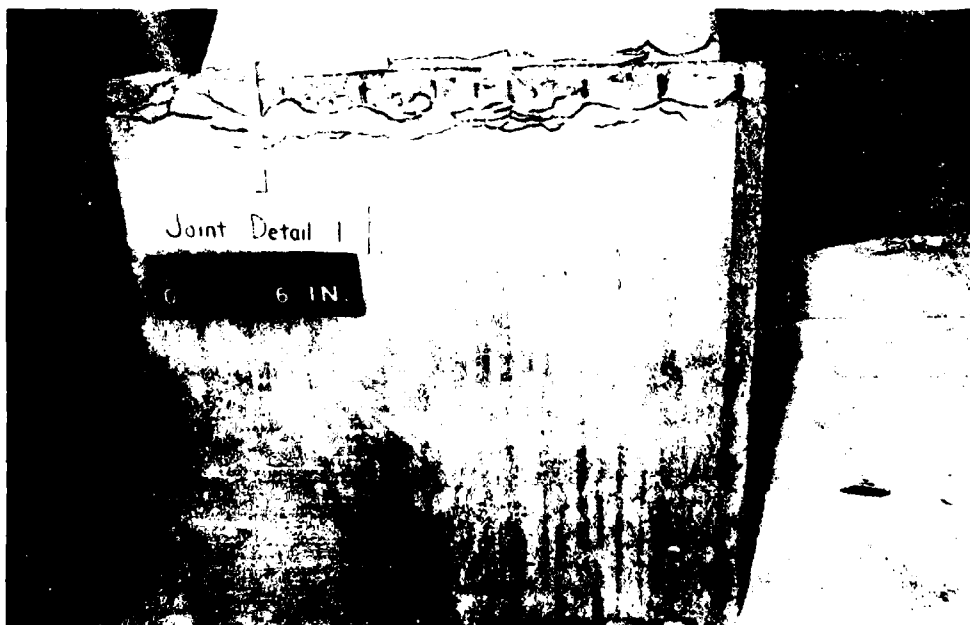
Figure 21. Posttest side view of JD1.

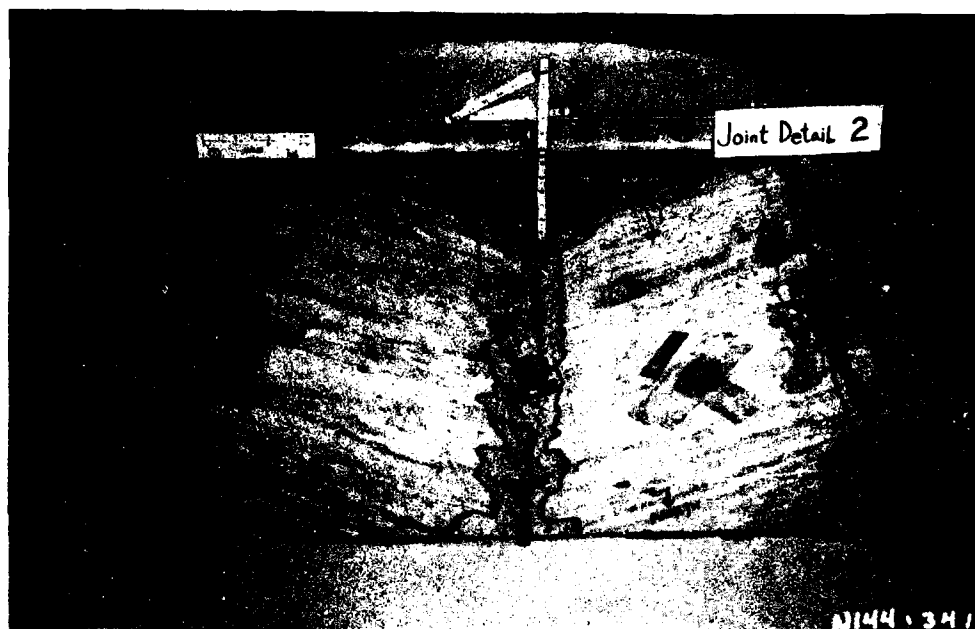
Figure 22. Posttest view of the roof surface of JD2.

Test JD2 resulted in a permanent mid-span roof deflection of 5-1/2 inches. Significant cracking occurred at mid-span and at the supports. The crack at mid-span was the depth of the roof across the entire structure. All roof reinforcing at mid-span was exposed and all bottom mid-span bars were broken, except one. Although the mid-span crack was much more extensive than that of Test 1, there were fewer hairline cracks across the top and bottom surfaces of the roof. The width of the crack zone at mid-span

ranged from 2-1/2 to 11-1/2 inches on the top surface of the roof. Cracks ranging from 1/2- to 1-1/2-inches deep occurred at the supports. Posttest photographs of Test JD2 are shown in Figures 22 through 25.

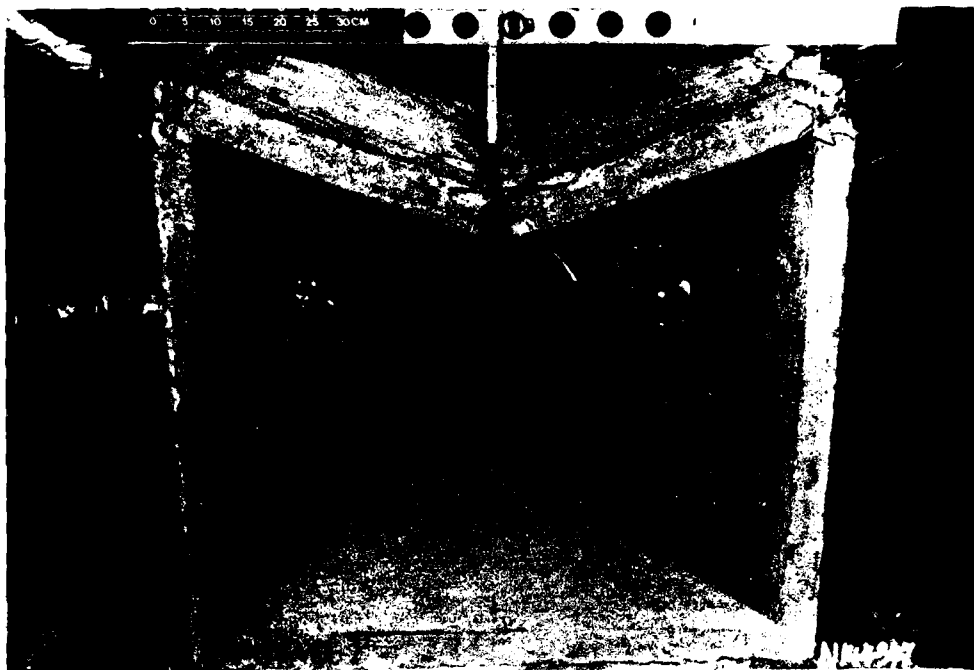
Figure 24. Posttest end view of JD2.

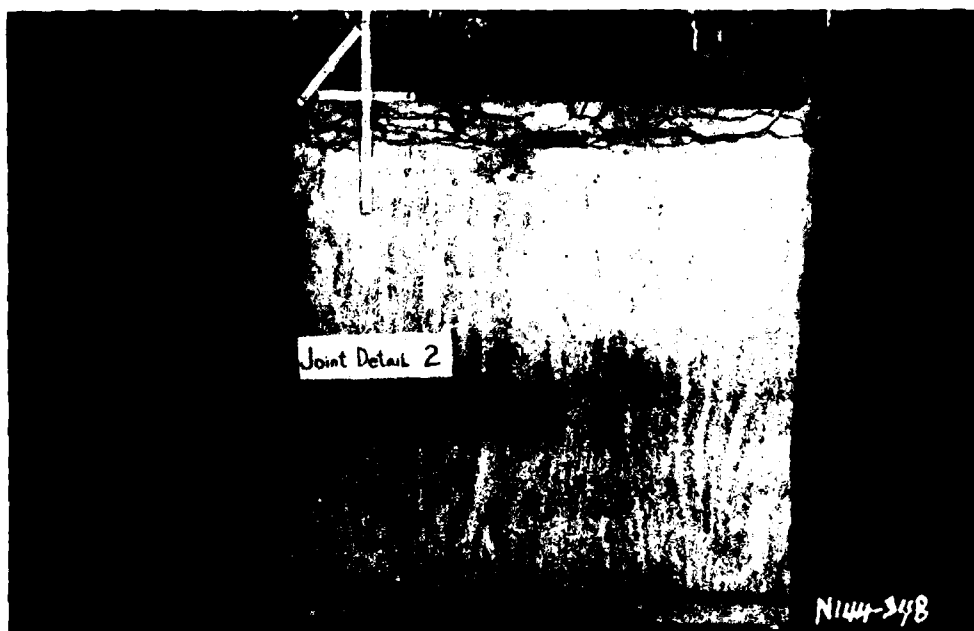
Figure 25. Posttest side view of JD2.

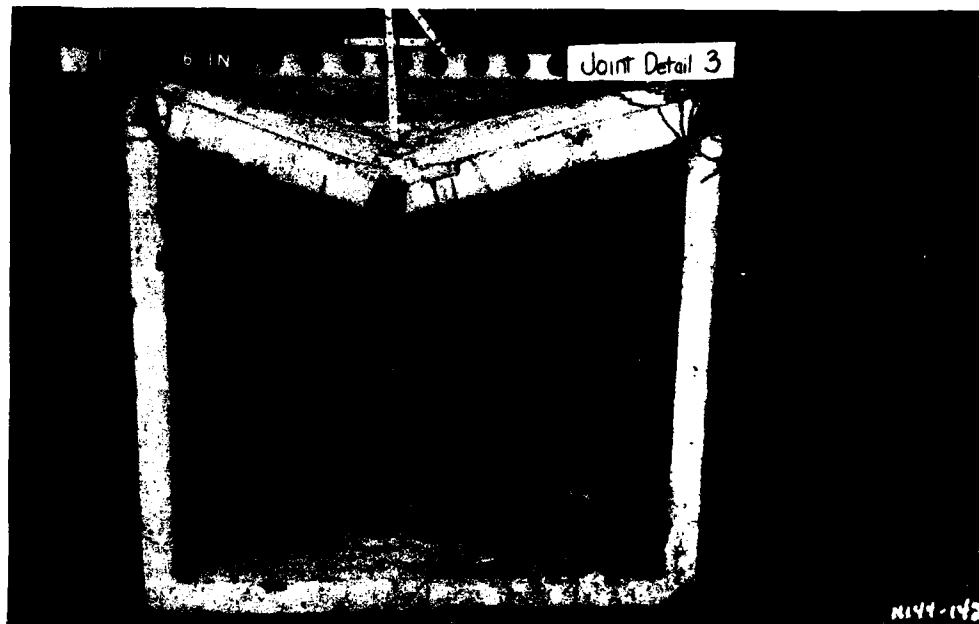
Figure 28. Posttest end view of JD3.

The response of the model in Test JD3 was very similar to the model in Test JD1. Permanent roof deflection was 5-1/4 inches. The supports were severely damaged as much cracking and exposure of reinforcement was observed. The mid-span crack zone was much more widespread across the top and bottom surfaces of the roof. Cracks occurred heavily at the top of the walls as well (See Figures 26 through 29). The roof-wall joints in tests JD1 and JD3 failed by diagonal splitting. The joints of test JD2 did not fail during the test.

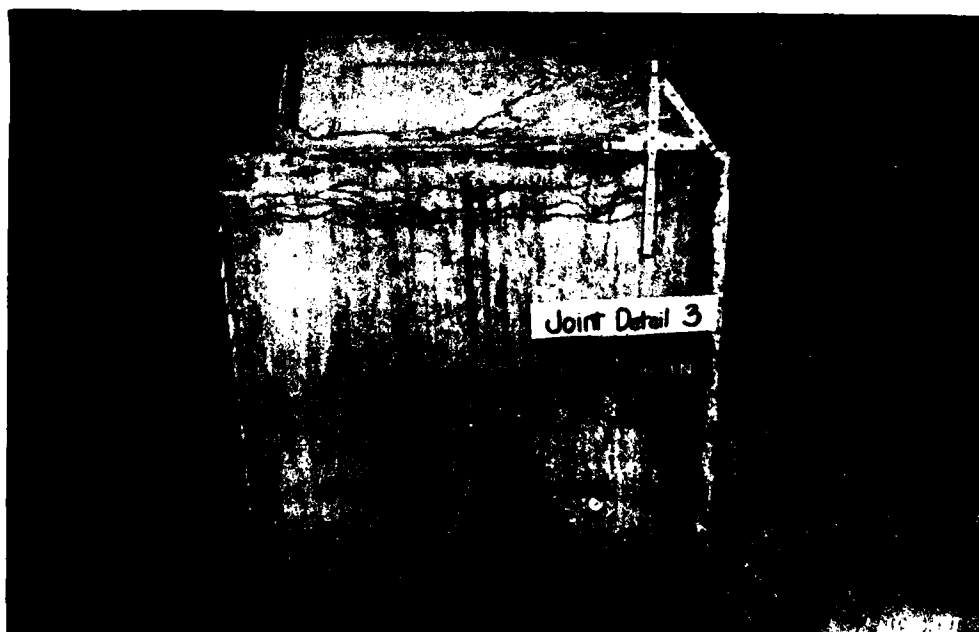
Figure 29. Posttest side view of JD3.

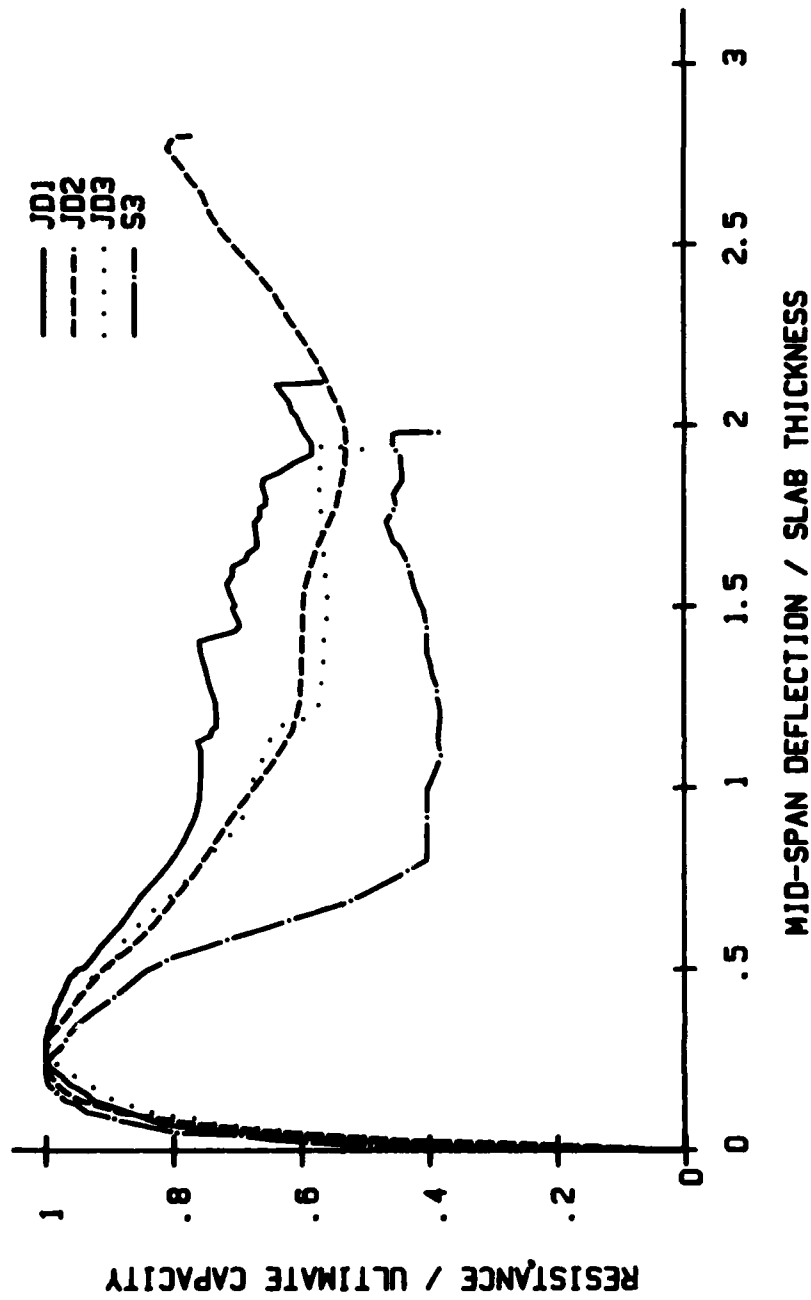
Figure 30. Comparison of load-deflection behavior.

Element S3 reached an ultimate capacity of 44 psi and the test resulted in a permanent mid-span deflection of 4.5 inches. The pressure at point D (end of tensile membrane region) was 21 psi. No tensile membrane capacity enhancement was observed in this test. A comparison of the load-deflection curves for the joint detail tests and test S3 is presented in Figure 30. Although premature joint failure occurred in JD1 and JD3 the overall performance of the roof slabs was similar to Test S3. The ultimate capacities of models JD1 and JD3 were 35 and 20 percent greater, respectively, than that of model S3 due to the additional tension zone reinforcement provided by dowels. Test JD2 did result in enhanced tensile membrane behavior as shown.
