**BUHNE POINT SHORELINE EROSION  
DEMONSTRATION PROJECT**

**FINAL  
MAIN REPORT**

**SAN FRANCISCO AND LOS ANGELES DISTRICTS  
CORPS OF ENGINEERS**

**AUGUST 1987**

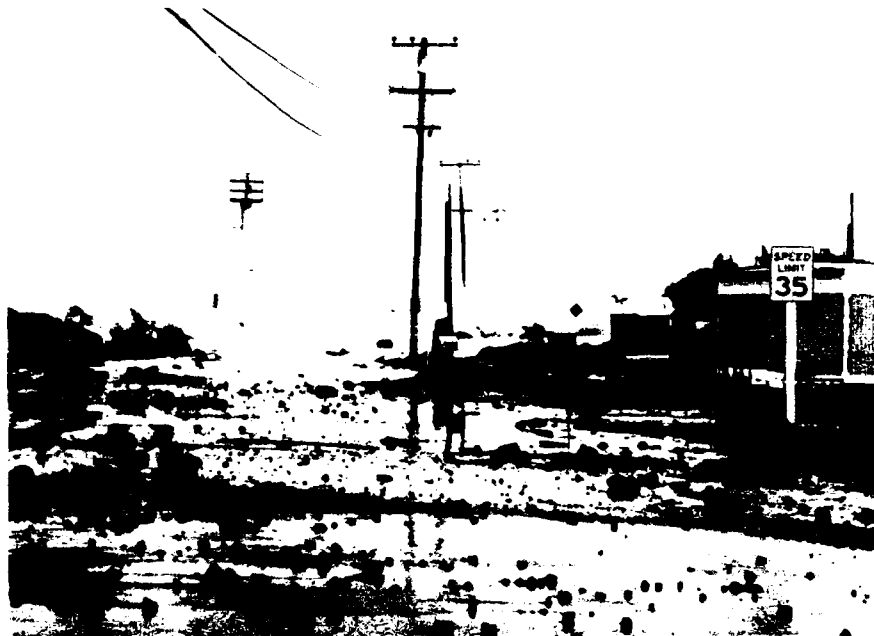
Figure 4. Waves Breaking on Buhne Drive.

during severe storms. Larger waves were breaking onto the revetment with wave runup overtopping the revetment and running onto the roadway, disrupting traffic and causing localized flooding of homes. (See Figure 4.) During severe storms, smaller rocks from the revetment were carried onto the roadway and into nearby homes, breaking windows and causing minor structural damage. An earthquake in November 1980 settled the revetment by approximately 3 feet and caused it to unravel at various locations. Buhne Drive became undermined by wave runup and collapsed in numerous locations. (See Figure 5.) These conditions created an extreme safety hazard during moderate to large storm wave conditions.

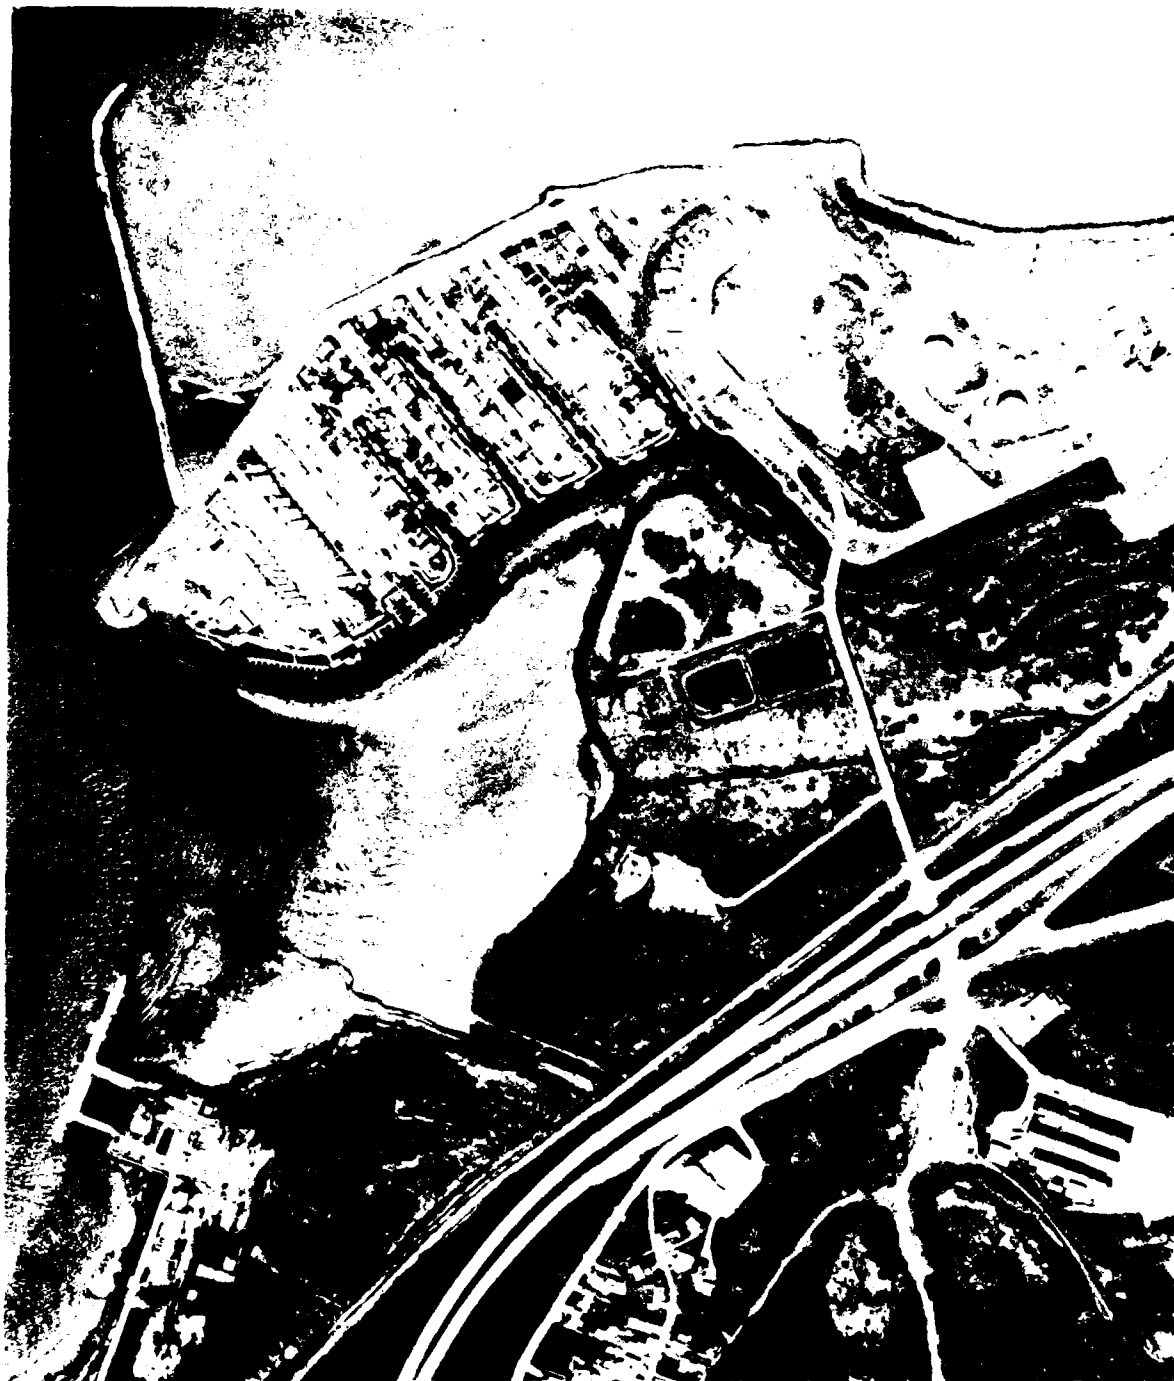
Figure 10. Phase I Aerial March 1984.

It was determined during initial Steering Committee Meetings that the State's funding amount of \$495,000 would be insufficient to construct both the groin and the rubble-mound head. It was decided that the construction of all rockwork for Phase I would be added to the construction of the Phase II sandfill, and the cost would be covered under the FHWA funds. Figure 9 shows the Phase I structure; Figure 10 is an aerial photograph of the structure after completion of construction.
