TECHNICAL REPORT SL-87-31

# DYNAMIC TEST OF A CORRUGATED STEEL KEYWORKER BLAST SHELTER MISTY PICTURE

November 1987

Prepared for Federal Emergency Management Agency  
Washington, DC 20472

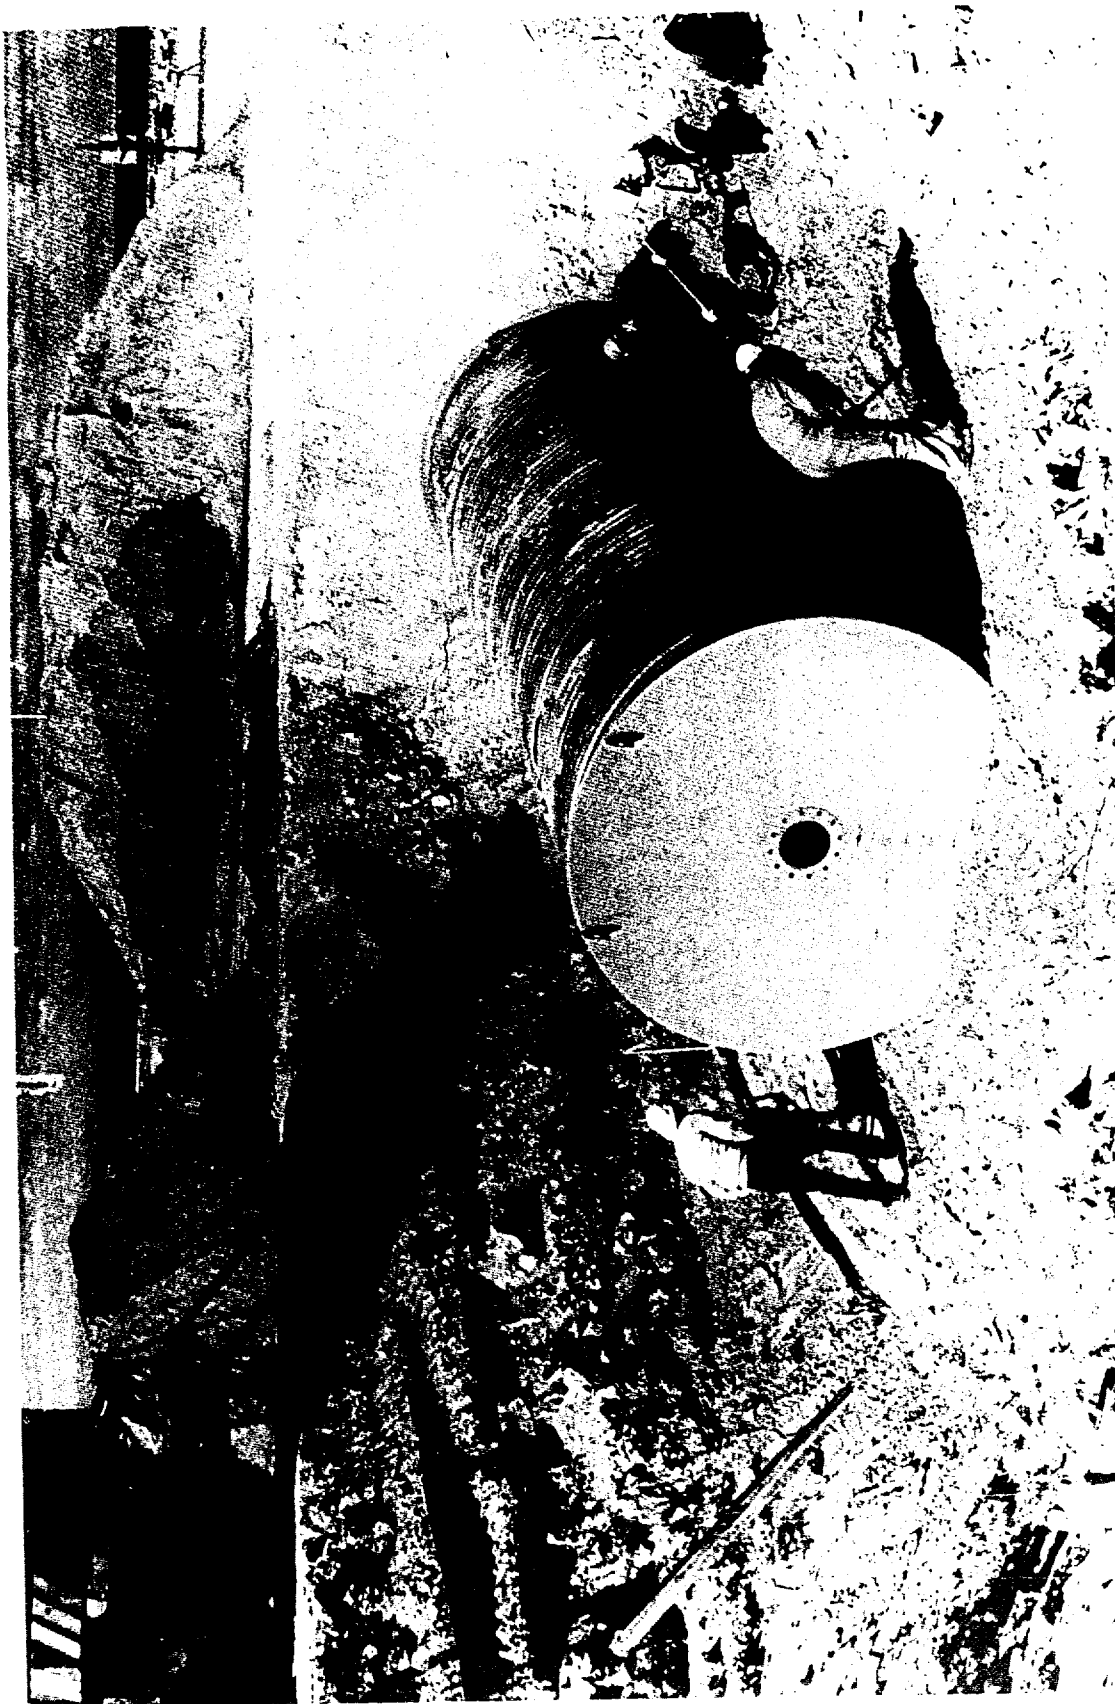
Figure 2.1. The 18-man shelter without the entryway and ventilation system attached.

The blast shelter shown in Figure 2.1 was furnished by HND. It was constructed by a private contractor in accordance with the plans and specifications provided by HND. Detail drawings of the shelter are presented in Appendix A.

The main section of the shelter was fabricated from a 9-foot-diameter, 27.5-foot-long section of 10-gage, galvanized, corrugated steel culvert. The entryway shaft and ventilation stacks were constructed from 14 gage, 36- and 12-inch-diameter culvert sections, respectively. The entry hatch was constructed from a 1/8-inch-thick dished plate that was filled with vermiculite and covered with fiberglass as shown in Appendix A, Detail 1. The endwalls were constructed from ASTM A36, 3/16-inch-thick steel plates. All structural connections, splices, and joint connections were waterproofed. Steel blind flanges were provided for the air intake and exhaust stacks. These flanges were used to prevent the blast pressure from entering the shelter during the test since blast valves were not included.

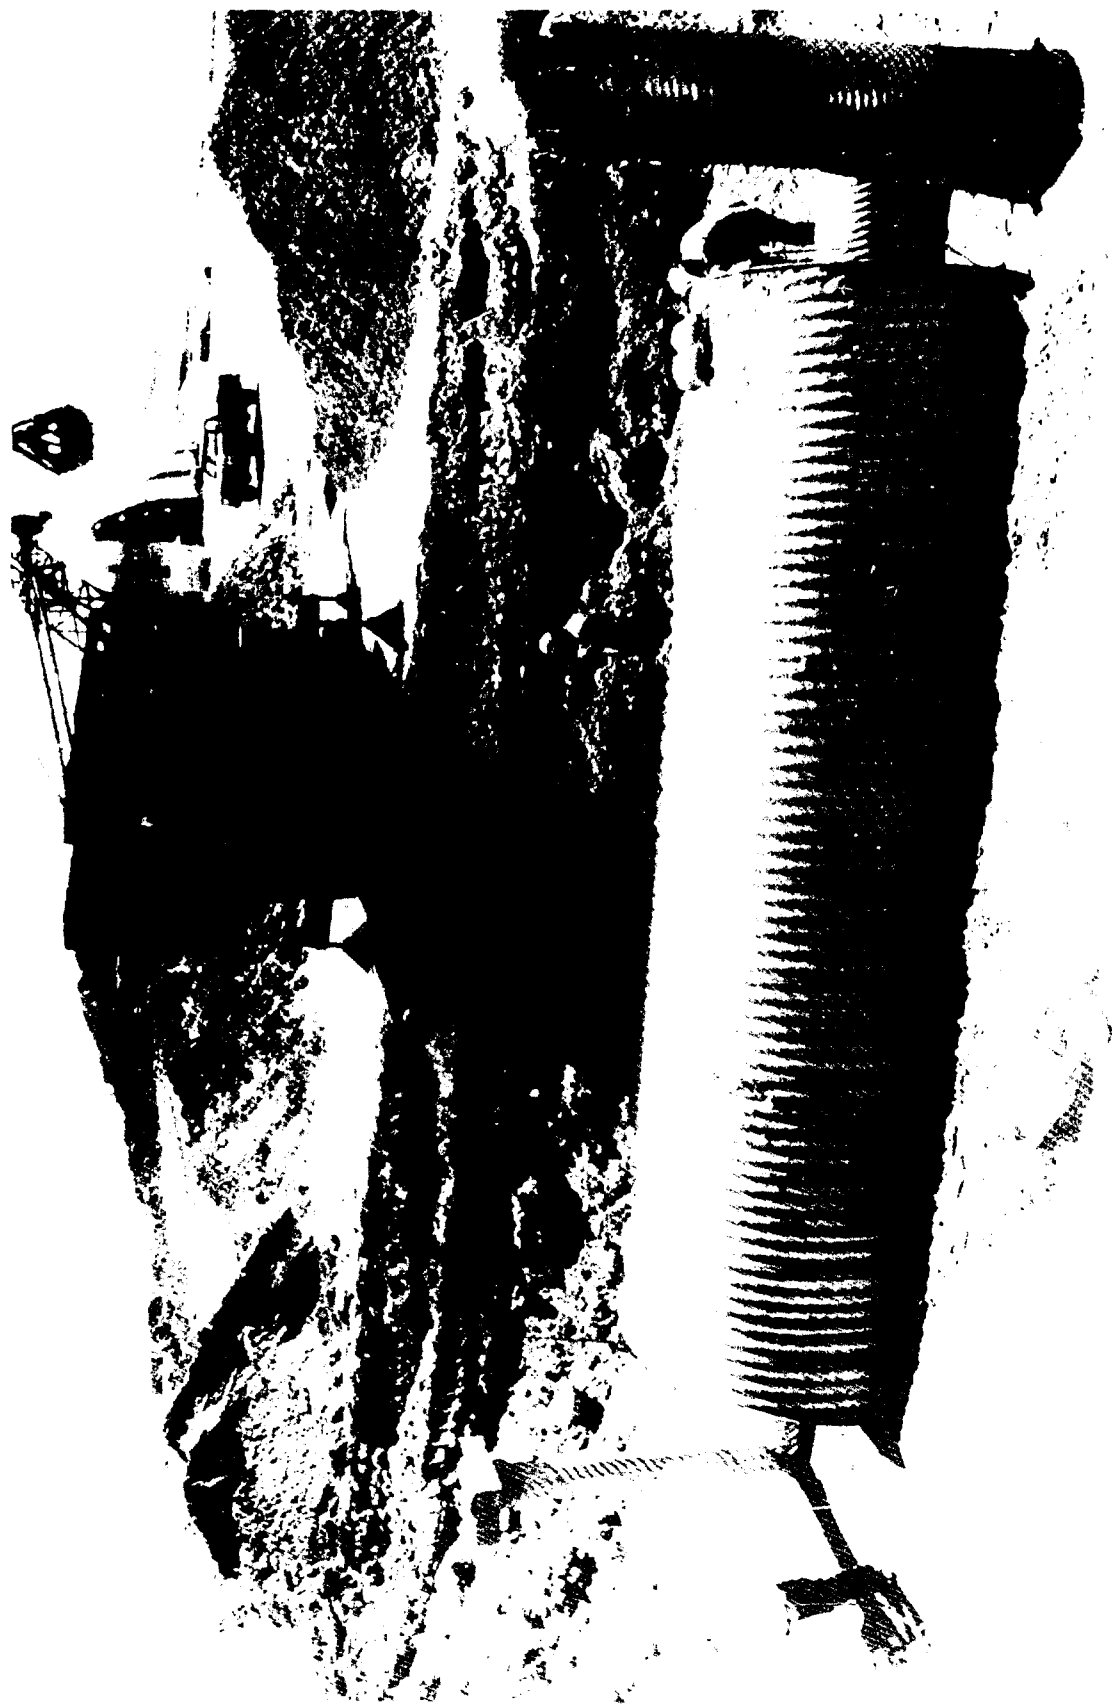
Figure 2.3. The 18-man shelter with the entryway and air exhaust stack attached.

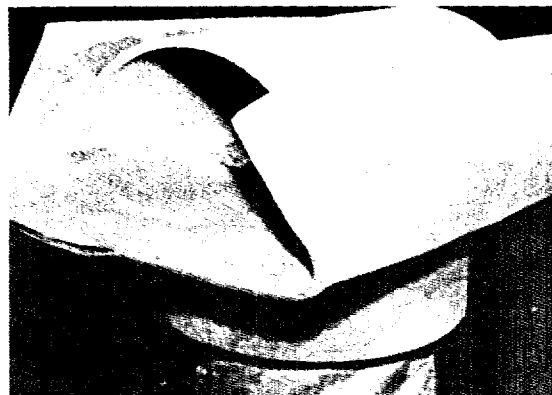
Figure 3.1 shows a posttest over view of the 18-Man Shelter. The damage sustained by the entryway hatch and the air intake stack is shown in Figure 3.2. The fiberglass cover on the entryway hatch had a maximum deflection at the center of 3.2 inches. Although the entryway frame was deformed at various locations and the top of the hatch was damaged, the entryway hatch was operational. The damage sustained by the intake stack (Figure 3.2) and the exhaust stack (Figure 3.3) was minor. Posttest inspection revealed that the ventilation system remained structurally sound.

a. Entryway hatch and air intake stack.

b. Close-up view of the entryway hatch.

c. Close-up view of the air intake stack.

Figure 3.2. Damage sustained by the entryway and the air intake stack.
