LOCH LINNHE EXPERIMENT DATA SUMMARY

23 November 1987

TRW Space & Technology Group
One Space Park
Redondo Beach, California 90278

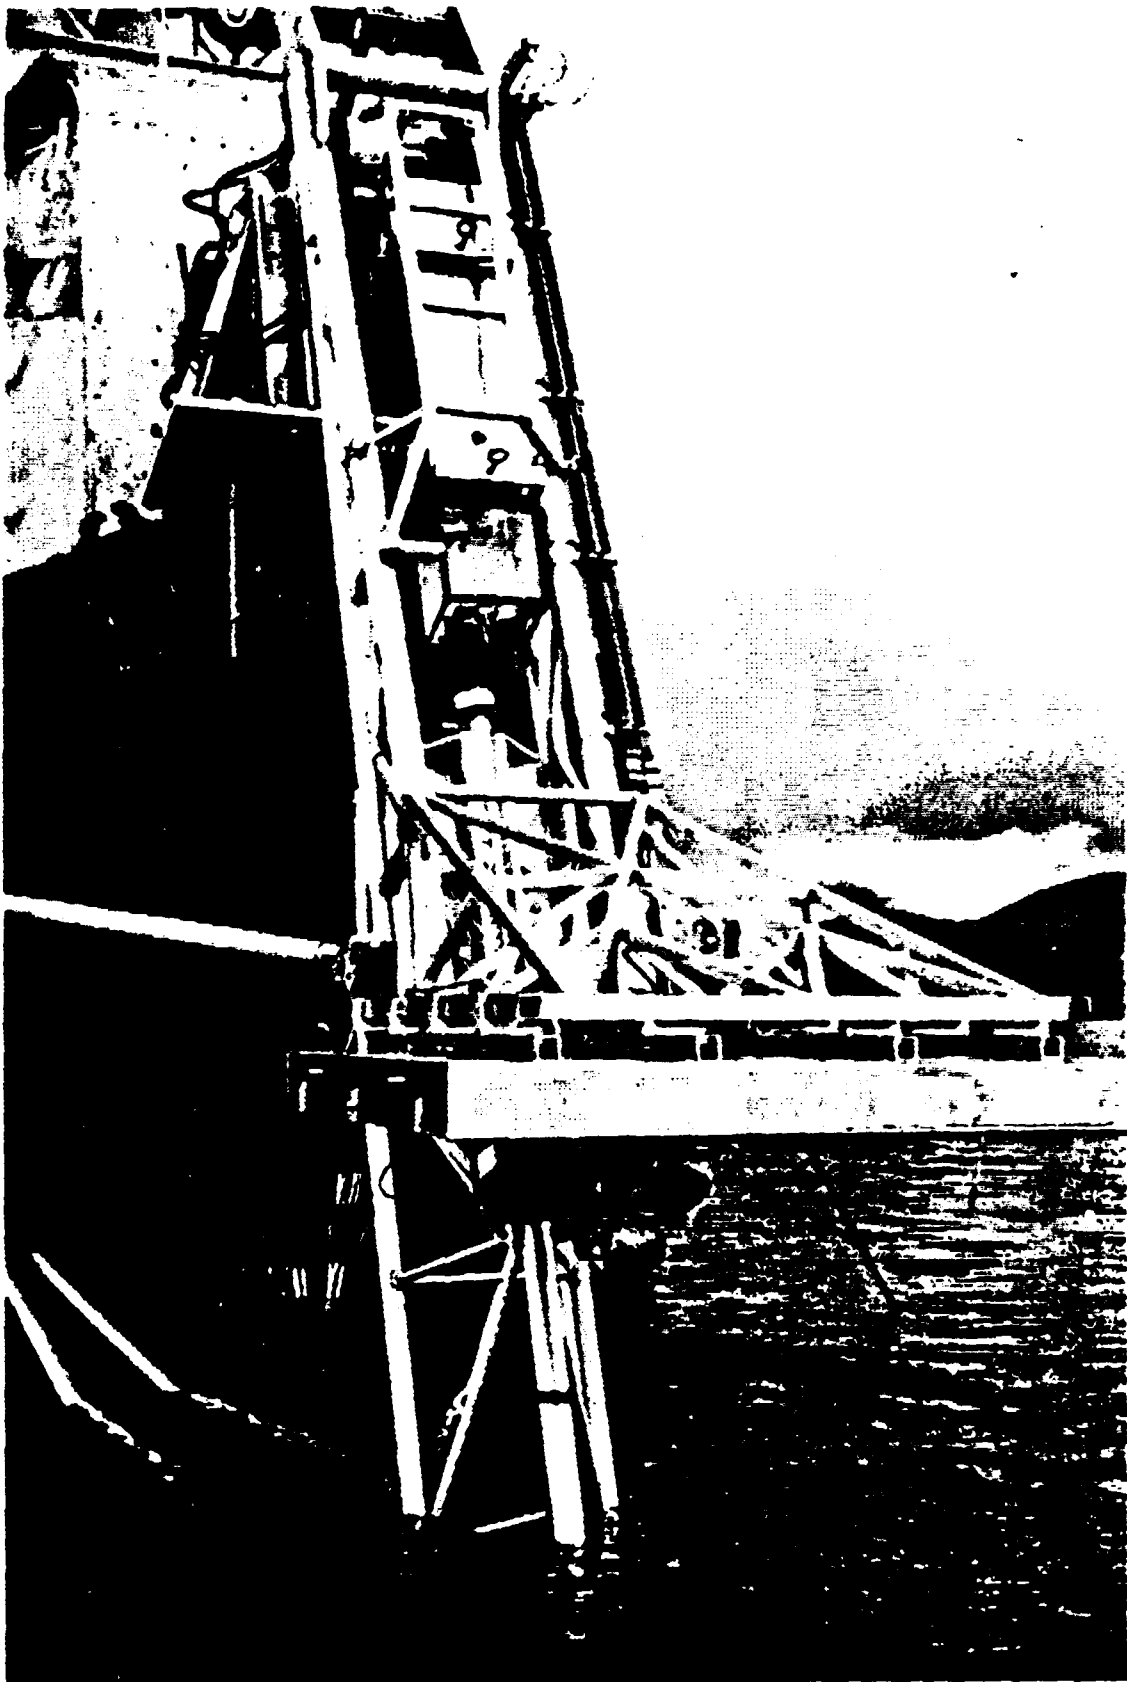
Figure 3. Front view of TRW ground truth instrumentation
