TEC REPORT R-87-015

RESEARCH AND DEVELOPMENT PROGRAM  
TO DEVELOP A NONDESTRUCTIVE EVALUATION  
INSTRUMENT (X-RAY DIFFRACTION) FOR MEASURING  
RESIDUAL STRESSES IN A WIDE RANGE OF  
NAVAL AVIATION MATERIAL  
SBIR PHASE II - FINAL REPORT

Contract No. N00019-85-C-0419

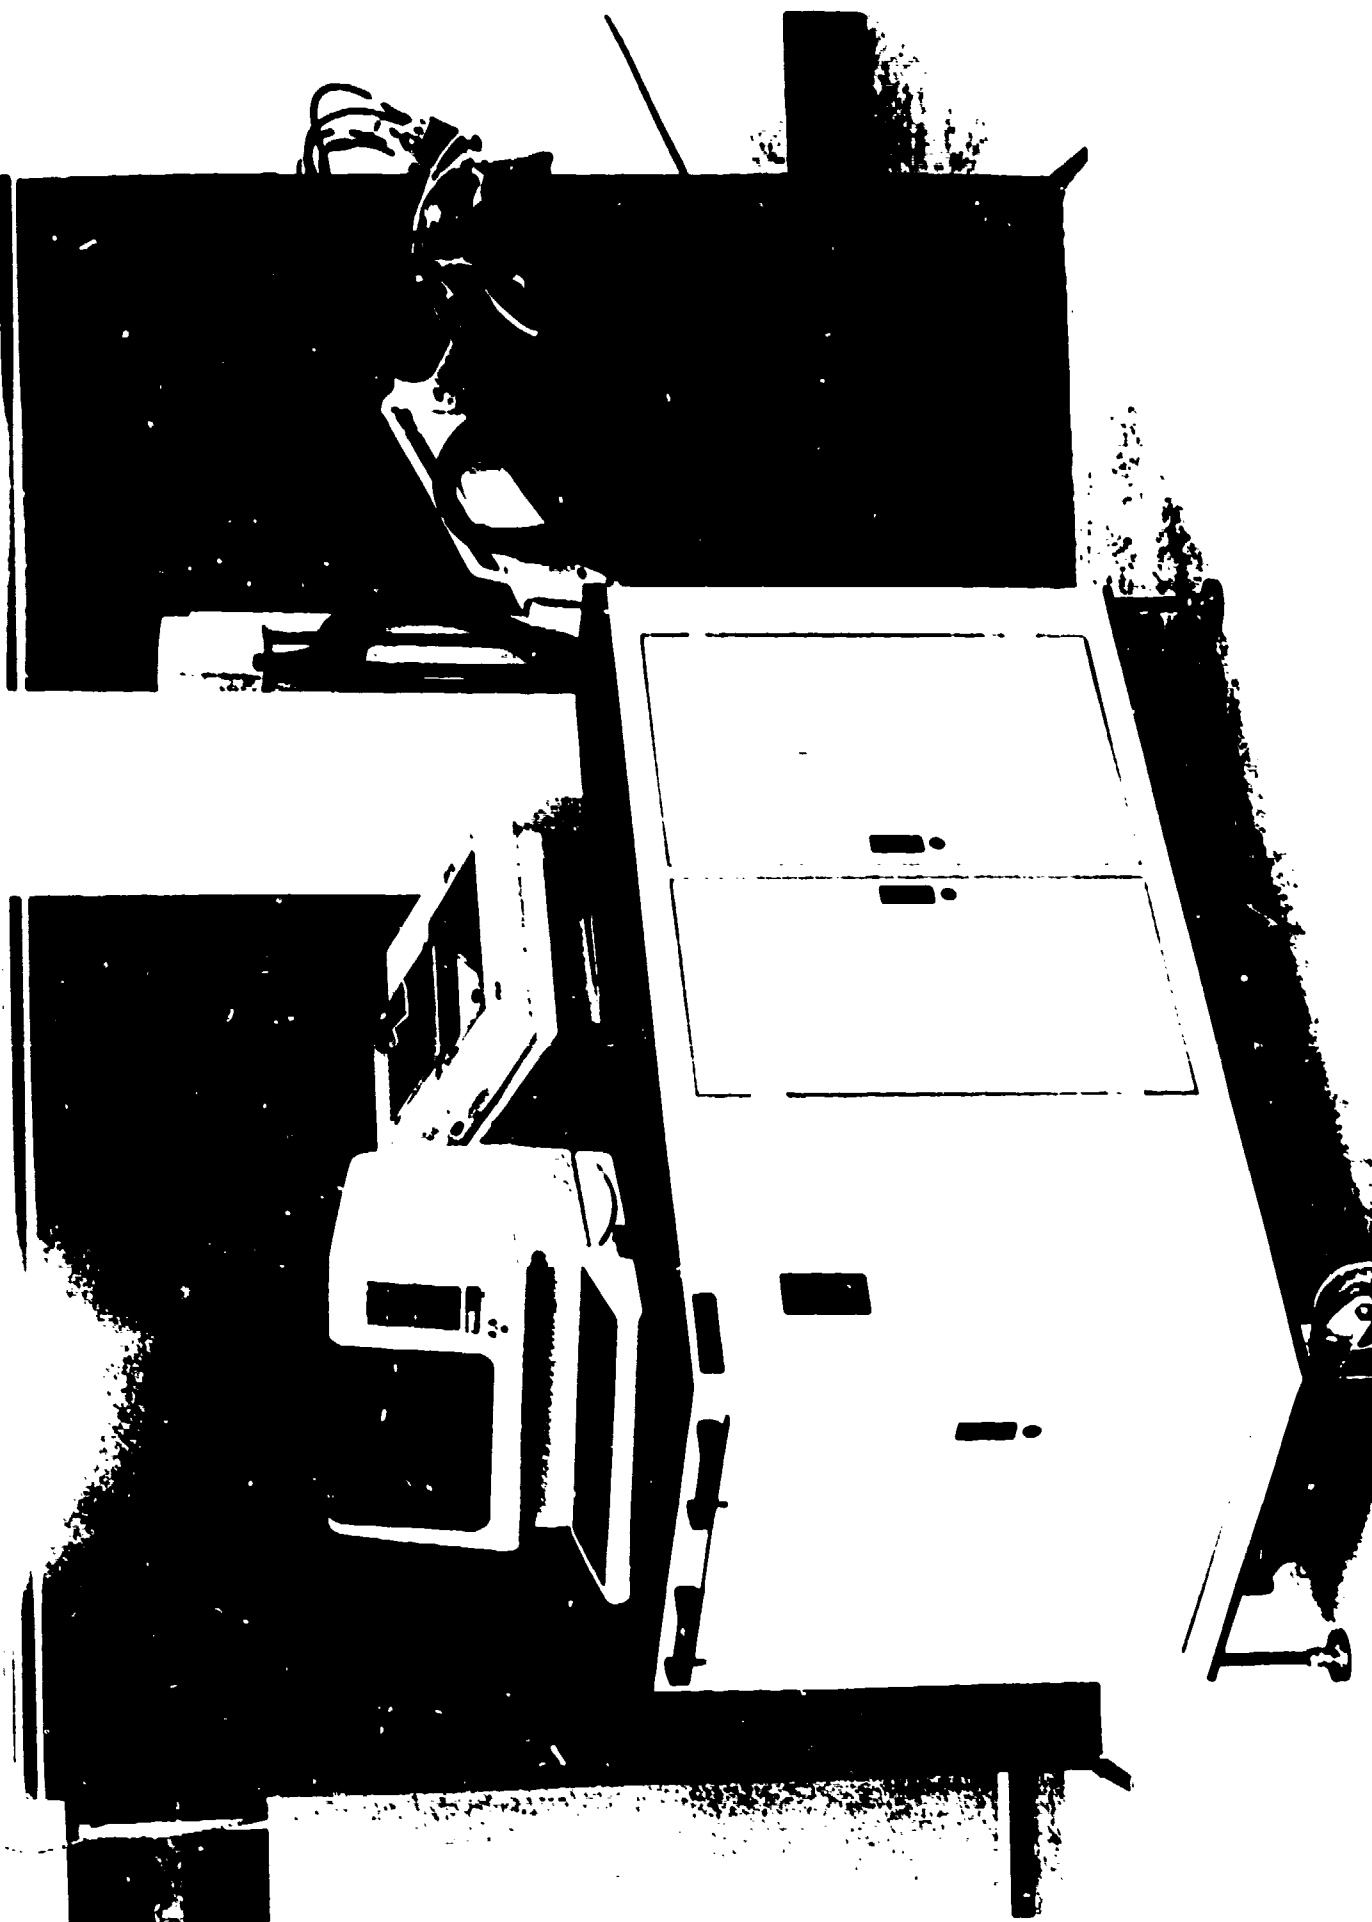
Figure 1-1  
Photograph of Deliverable Prototype Unit

The Phase II program had two major objectives. The first was to design, construct, test and deliver to the Navy a prototype stress analysis unit (Figure 1-1) that was smaller, lighter and easier to use than TEC's existing design. The second was to make a large number of residual stress measurements on components and materials of interest to Naval Aviation.

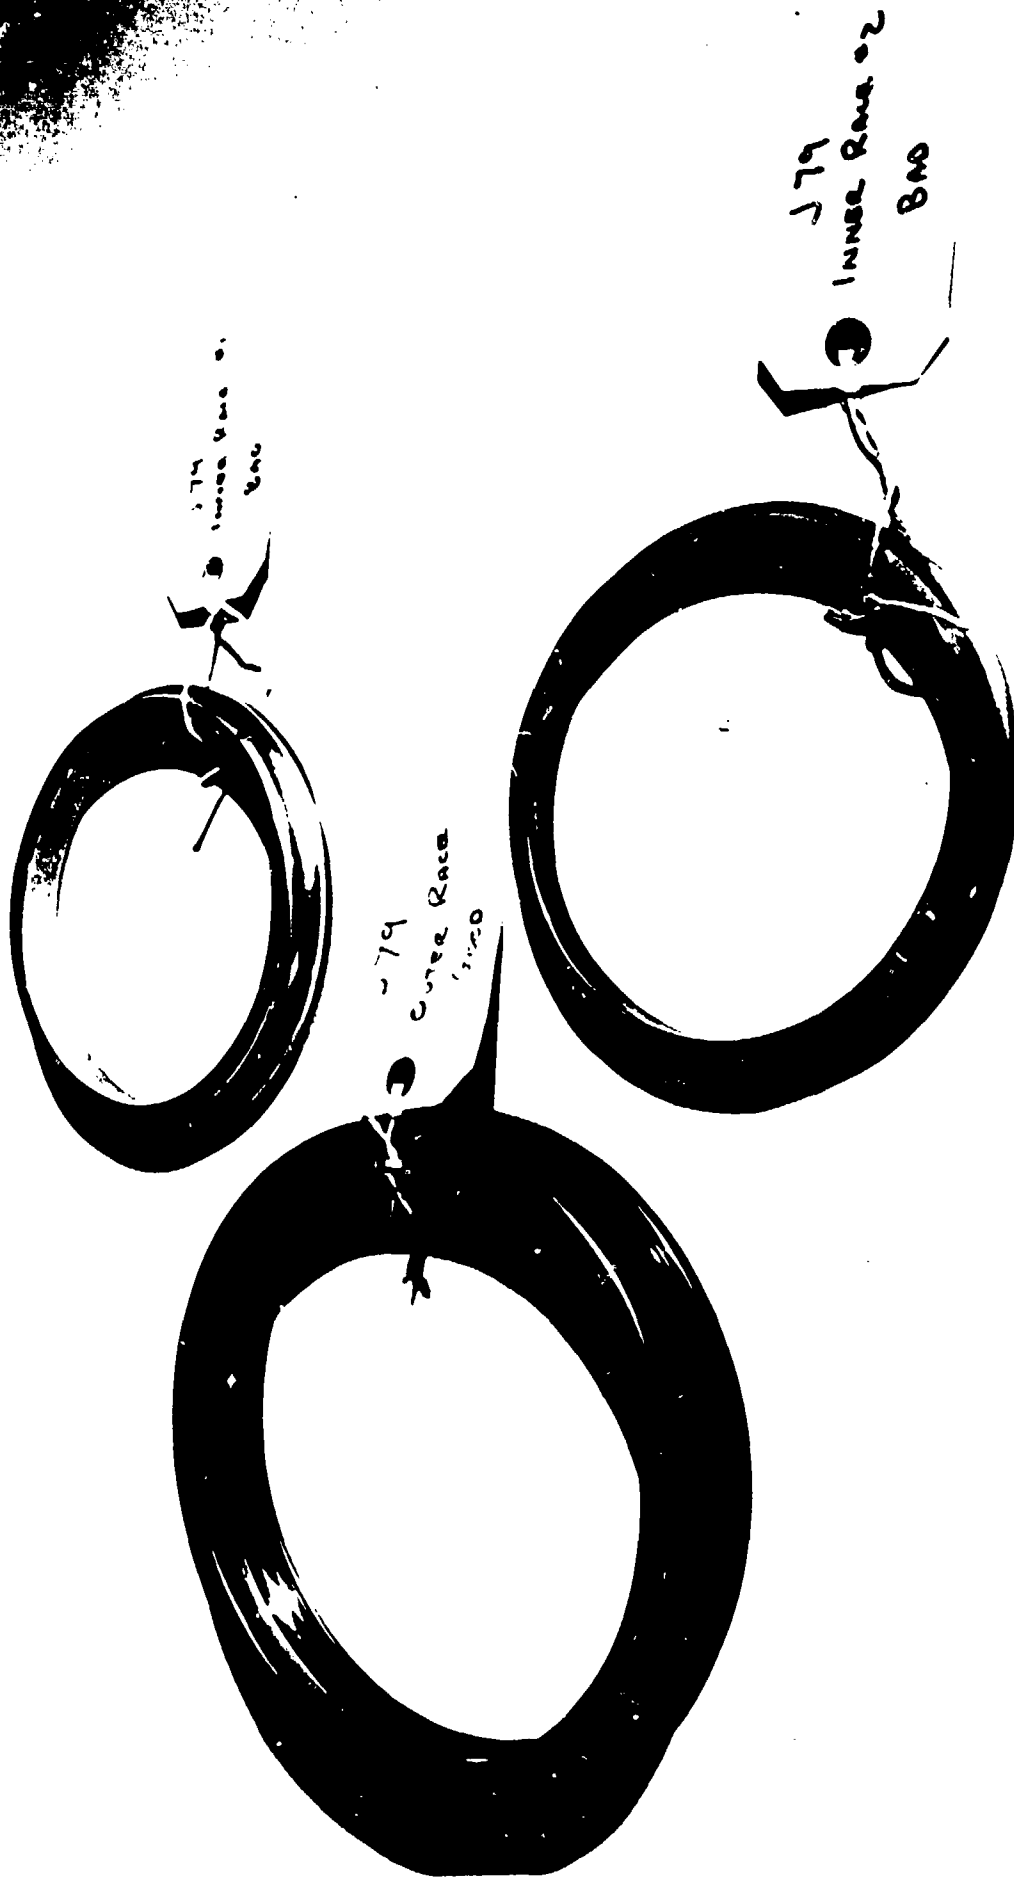
Figure 3-7  
J-79 Inner and Outer Bearings

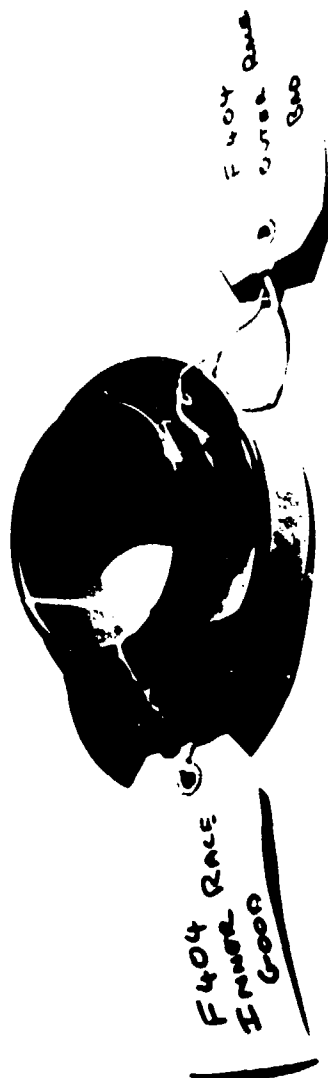
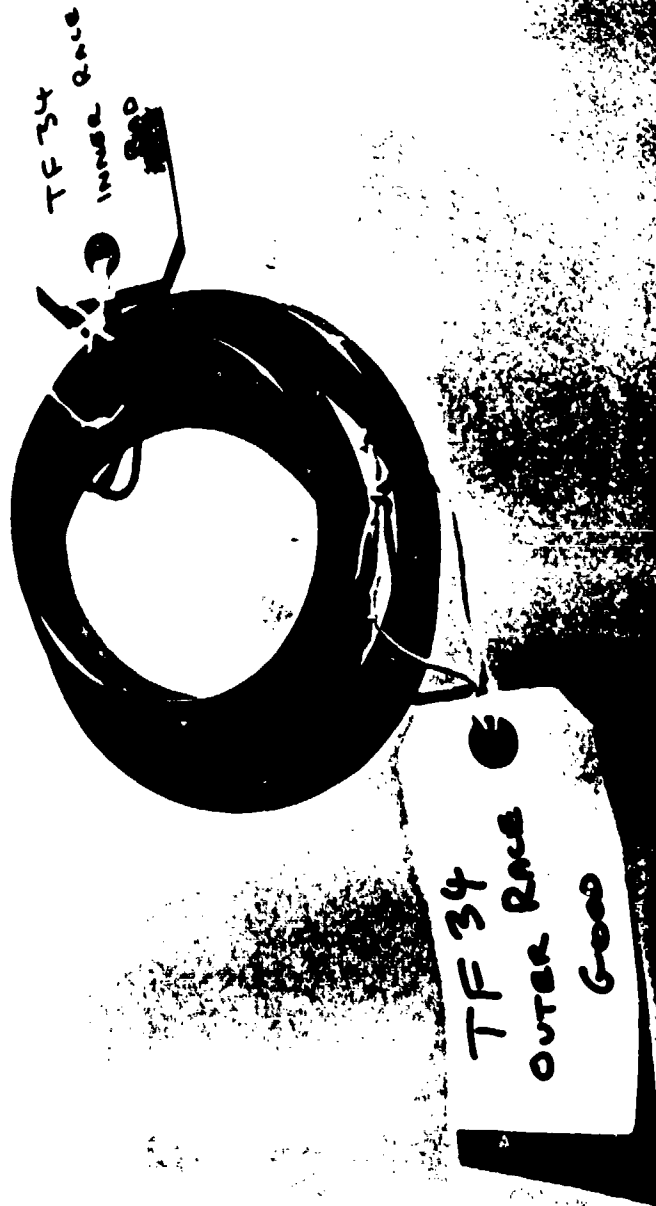
Figure 3-8  
TF-34 and F-404 Inner and Outer Bearings
