T85-L-714 ENGINE  
DEVELOPMENT AND QUALIFICATION

ENGINE M11  
LOW CYCLE FATIGUE TEST REPORT  
LYC 87-14  
(0213-005-87)

DECEMBER 1987

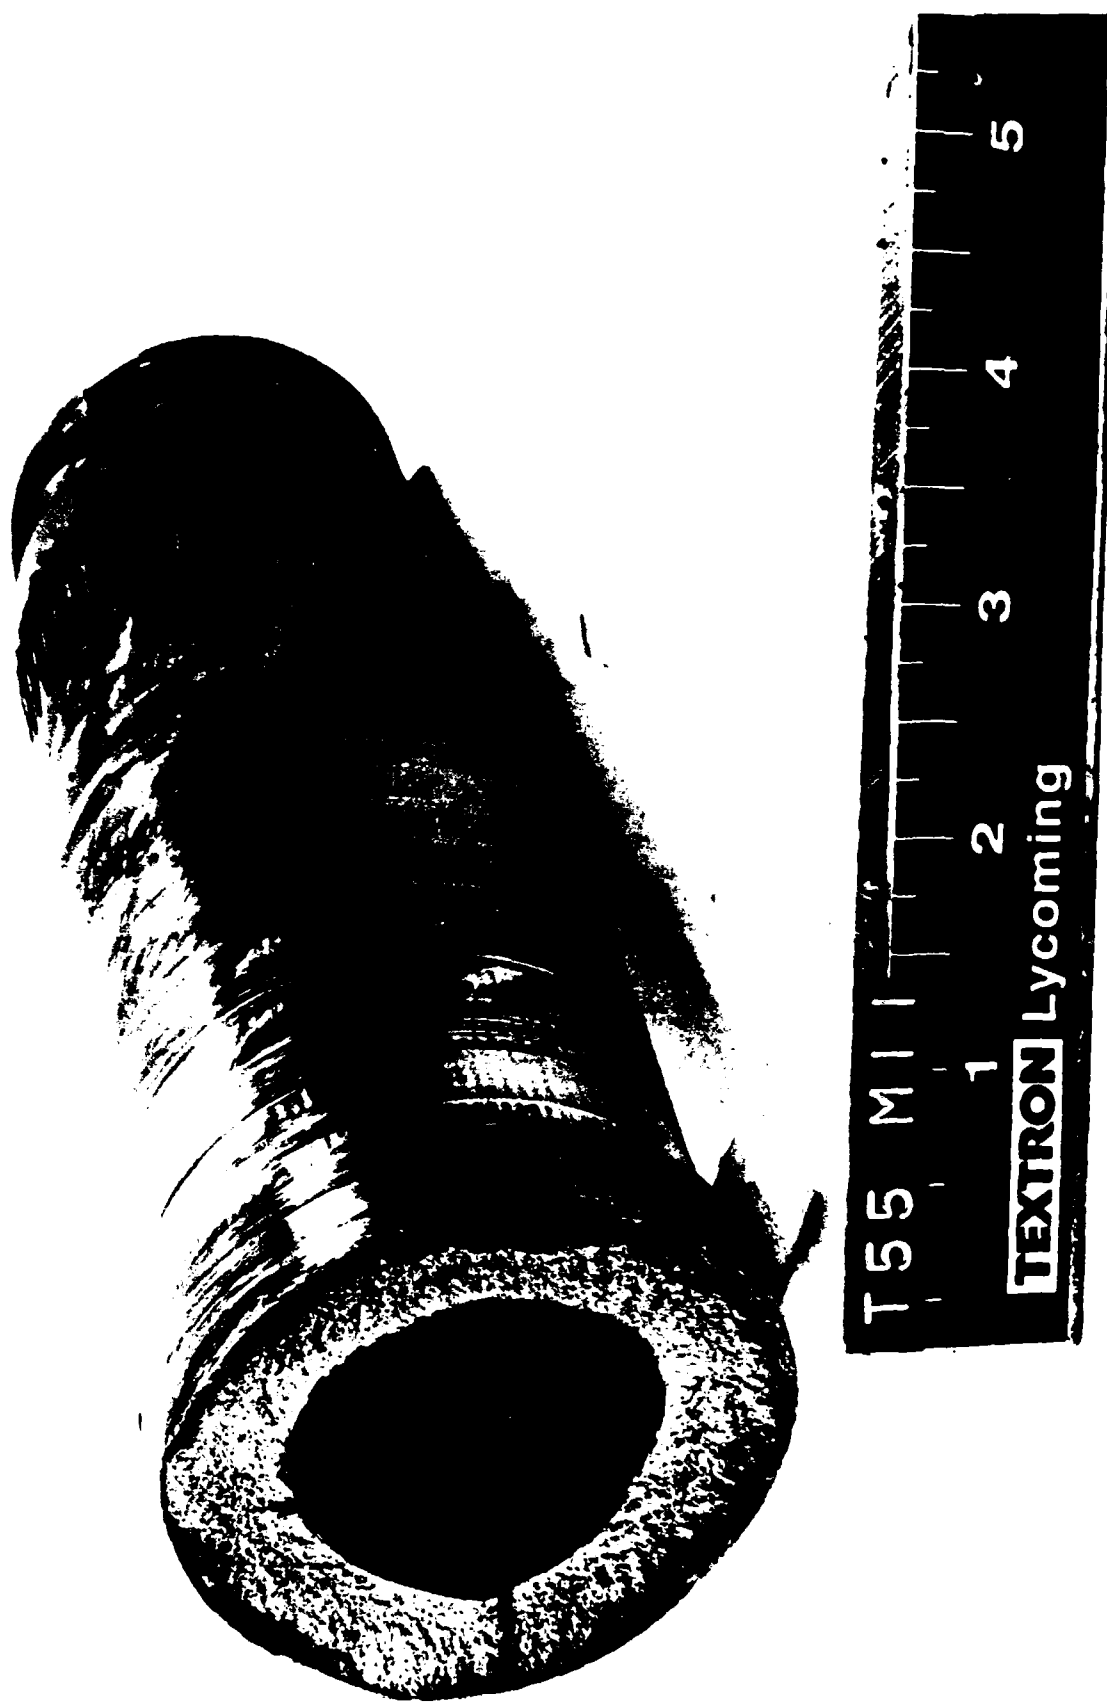
Third Turbine and Power Shaft - There were no significant discrepancies noted at the post 1500 cycle inspection. As the photographs show, posttest damage was extensive. Regarding the blades, there was no evidence of radial pull out from the disc or fatigue on non damaged fractures. Separation of most blades was by impact/bending. Some blades were displaced axially though of the remaining blades in the disc, none were found to be loose. The separation of the power shaft forward of the disc, near the weld interface was the result of axial/torsional tensile overload. Separation forward of the weld is radial tensile (impact/bending). The separation forward of the aft inertia weld was primarily axial with a torsional component (all tensile). Figures 34-39.

Figure 34 Third Turbine and Output Shaft, Front, Post 1500

Figure 35 Third Turbine, Closeup of Blade Roots and Rivets, Post 1500

Figure 36 Third Turbine and Output Shaft, Rear, Post 1500

Figure 37 Third Turbine and Shaft Fracture Surface, Front

Figure 38 Third Turbine and Shaft Fracture Surface, Rear

Figure 39 Output Shaft, Rear Section, Fracture Surface and Scoring

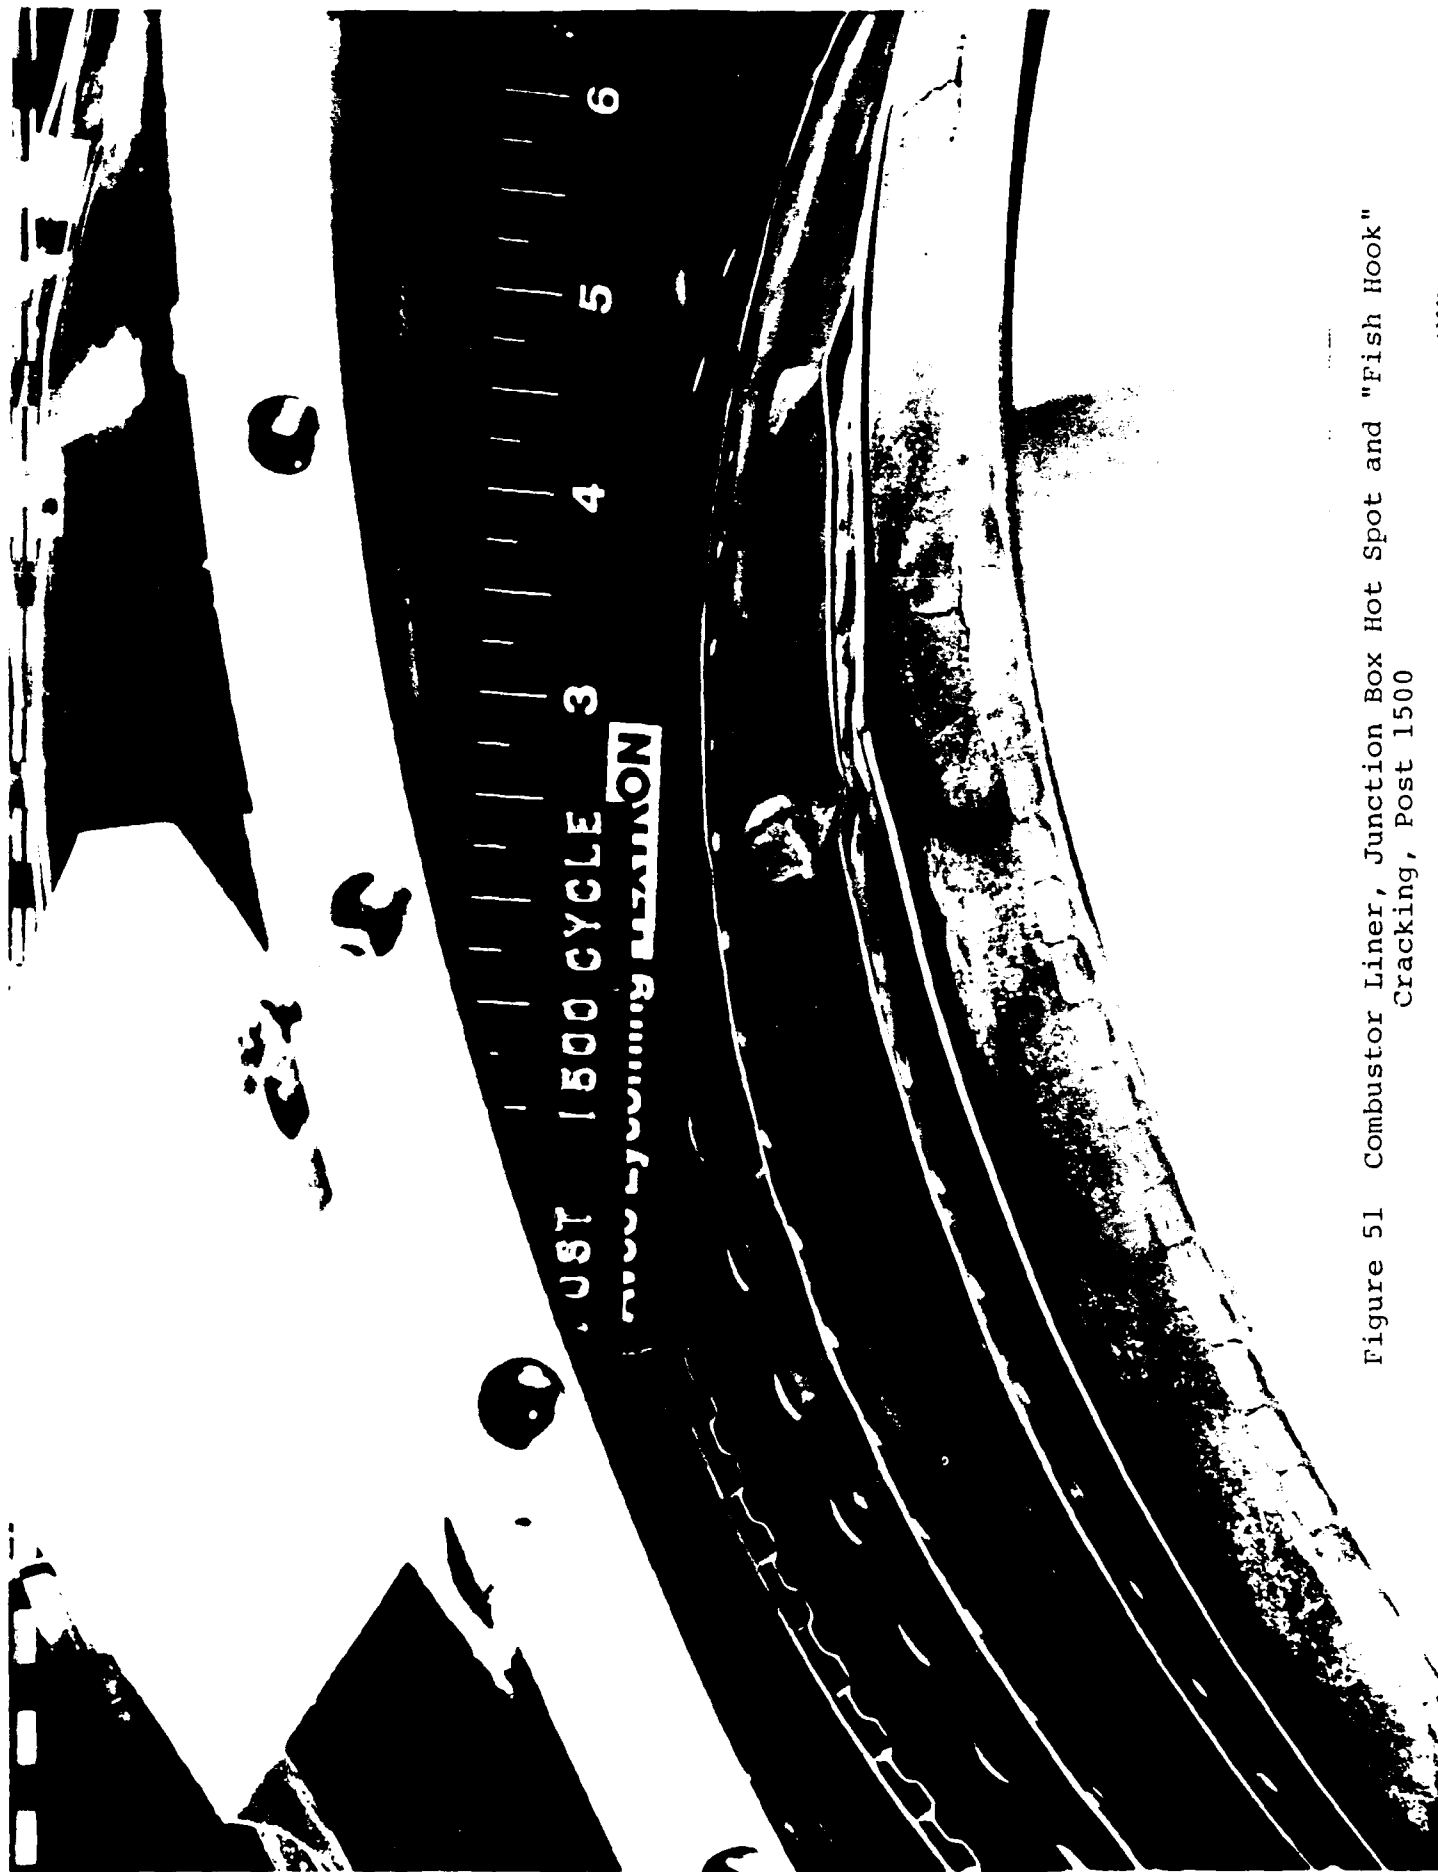
Combustor Liner - The liner completed 1500 cycles in very good condition overall. There was some cracking in several panels and the "fish hook". Figure 51.

A notable discrepancy was five "bumps" that formed during testing. Figures 51-53. They coincide with the location of the five MGT harness junction boxes and were first noticed during the post 500 cycle inspection. The bumps and cracks increased slightly by the end of 1000 cycles. Observations made at the 1500 cycle inspection and during the MGT probe replacement at 1700 cycles revealed little change. It is felt these are a result of the higher operating temperatures for this test and a restriction of the cooling airflow, in that area, by the junction boxes; their presence was not deleterious to engine durability and operation.

Figure 51 Combustor Liner, Junction Box Hot Spot and "Fish Hook"  
Cracking, Post 1500

Figure 52 Combustor Liner, Junction Box Hot Spots and  
Panel Cracking, Post 1500

Figure 53 Combustor Liner, Junction Box Hot Spots and  
Panel Cracking, Post 1500
