STREAMBANK PROTECTION GUIDELINES(U) ARMY ENGINEER  
WATERWAYS EXPERIMENT STATION VICKSBURG MS H P KEOWN  
OCT 83

# Streambank Protection Guidelines

...For Landowners  
and Local Governments

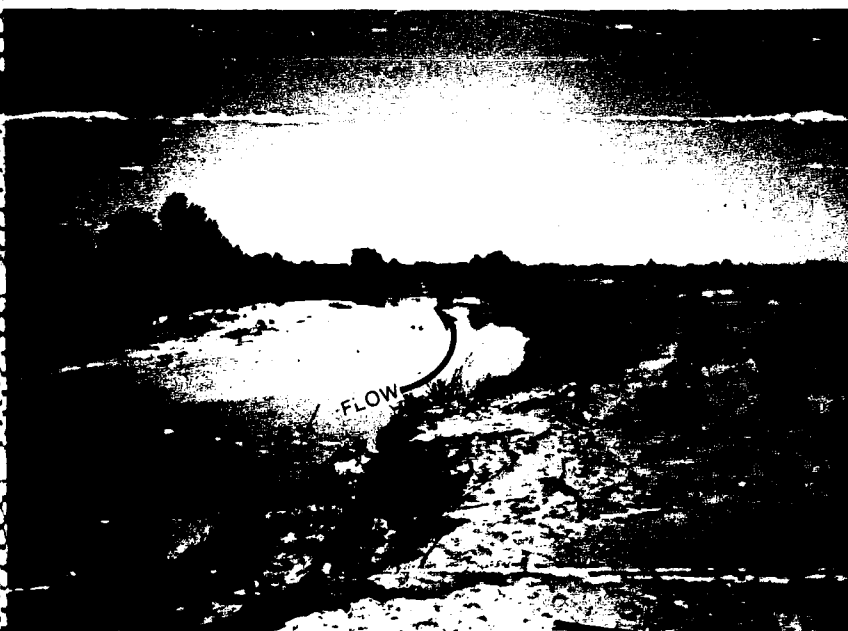
Serious streambank erosion is occurring on the right bank of this bend, while a point bar is building up on the left bank.

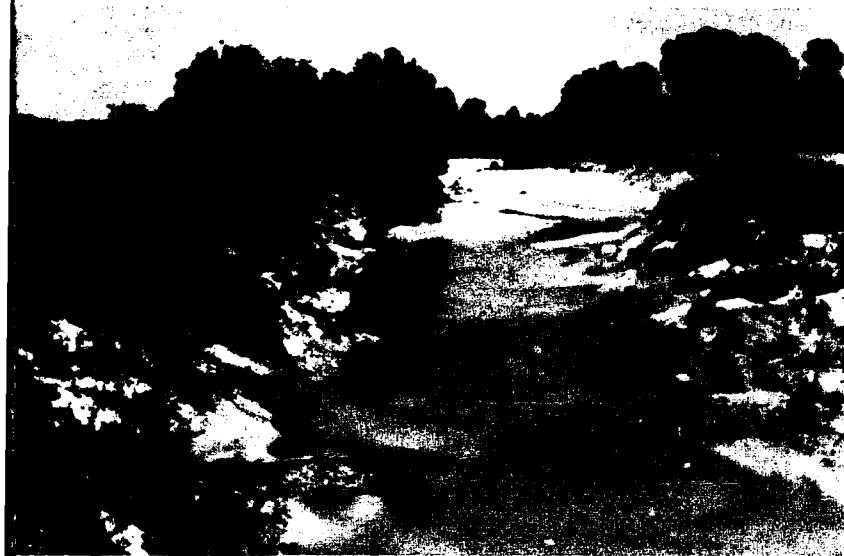
*Bed scour in effect raises the height of top bank which in turn may lead to bank failure.*

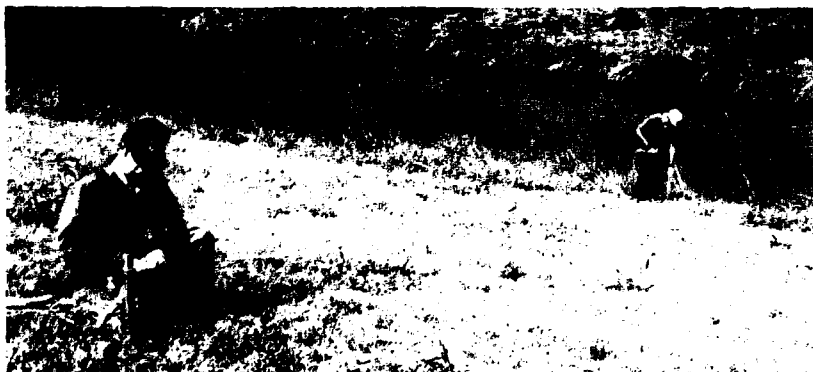
**RIGHT:** A plumbed rod driven at least 8 feet into a bank can be used to determine if bank movement is occurring.

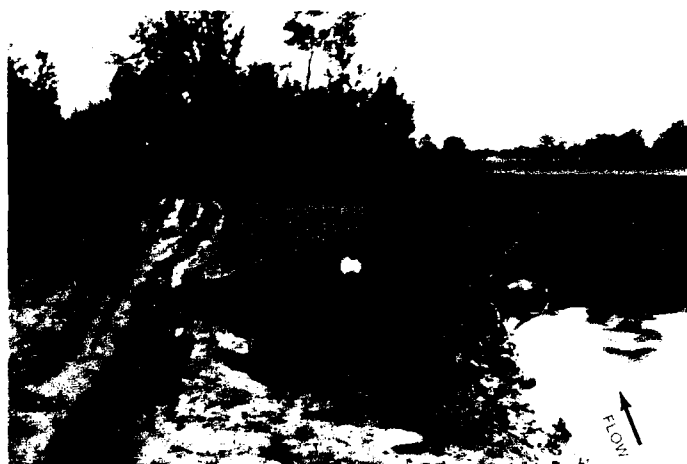
**RIGHT:** Selective tree removal can eliminate problems caused by large trees toppling into a stream. The chain around the trunk of the tree is tied off to another tree further up the bank slope. After the tree has been cut down, the chain can be used to drag the tree out of the floodplain so it will not become floating debris or contribute to a log jam during the next floodflow.

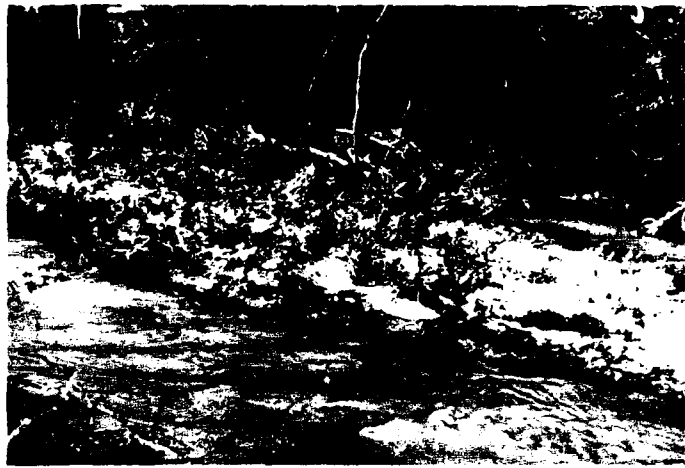
*Formation of a midchannel sand and gravel bar forces current against the far bank. Tilt of tree stems indicates that severe erosion is occurring around the roots.*

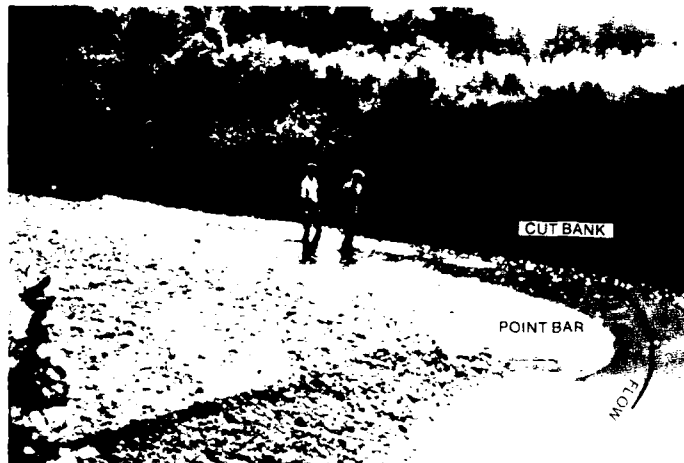
*Point bar deflects stream current against cut bank.*

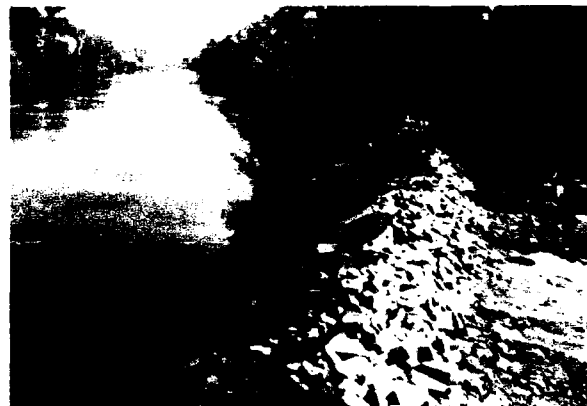
*Rubble revetment constructed from broken pavement, concrete blocks, and house brick.*

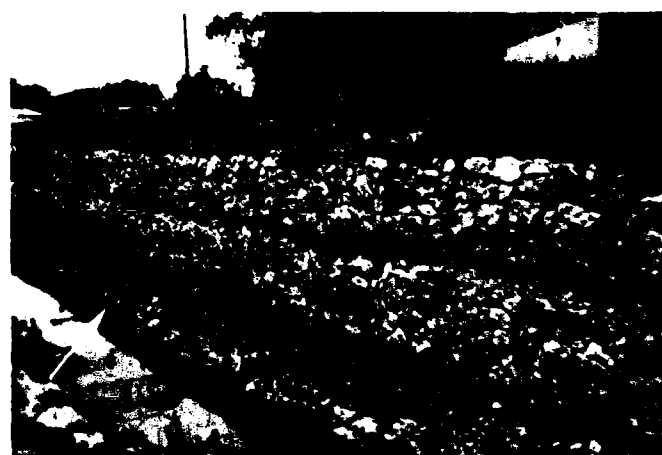
*Completed gabion revetment made from prefabricated baskets. Note support apron (arrow) extending from toe of structure.*

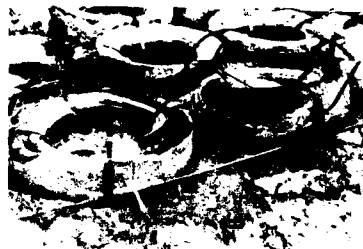
*LEFT: Used-tire mattress with tires banded together.*

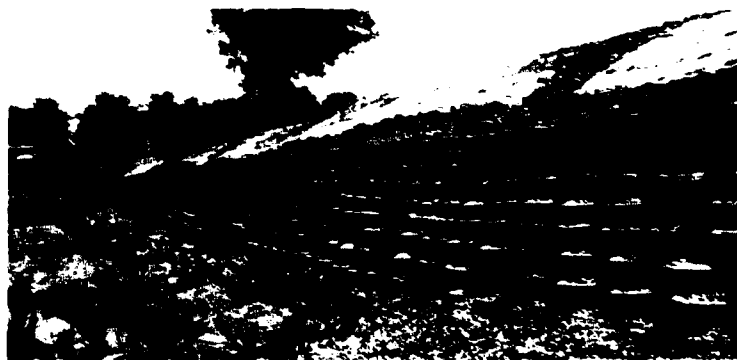
*BELOW: Stacked-tire revetment.*

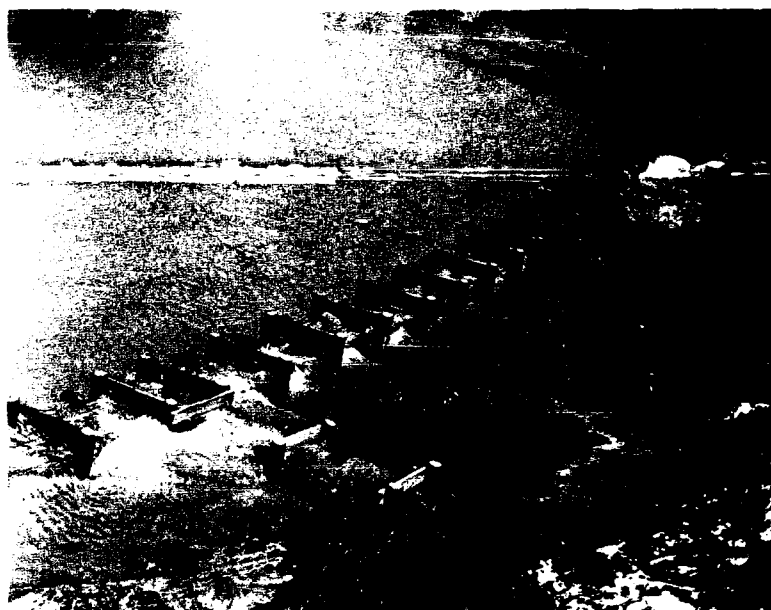
*Kellner jacks assembled from angle iron.*

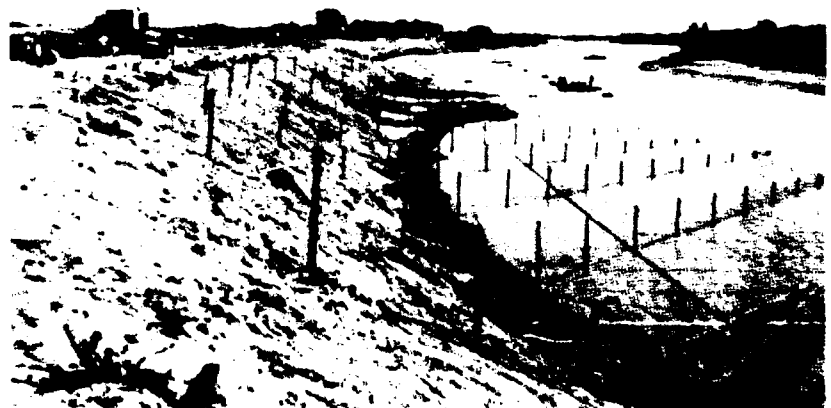
*BELOW: Wire fence dike field. Note that the top of each fence post is guyed to the bottom of the fence post immediately upstream and that each fence line is tied into the bank.*
