TITLE: Workshop on Avionics Corrosion Control: Meeting of the Structures and
Materials Panel of AGARD (62nd) Held in Hovik (Norway) on 16-17 April 1986.

**AGARD Report No.733
WORKSHOP ON AVIONICS CORROSION CONTROL**

AVIONIC CORROSION

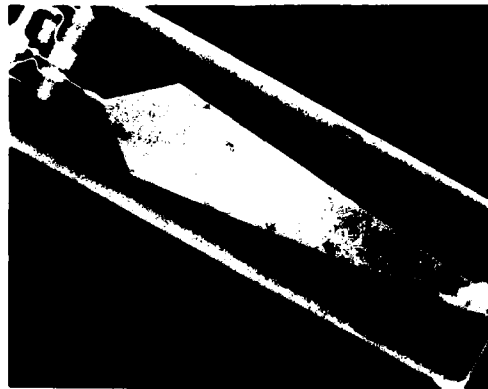
Figure 7. X-ray radiograph shows areas of corrosion.

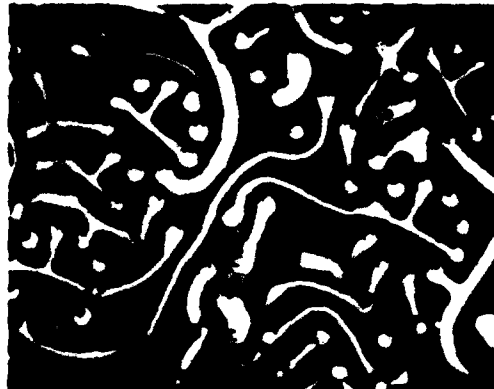
Figure 28. Corrosion on board resulted from chloride contamination. See Figure 29.

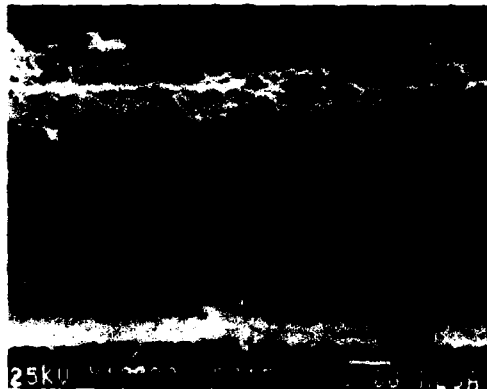
Figure 44. Cross-sectional area of good connector.
