SOME EFFECTS OF NITRATES ON THE TENSILE PROPERTIES OF  
AL 7075-T7351(U) ARMY BELVOIR RESEARCH DEVELOPMENT AND  
ENGINEERING CENTER FORT BELVOIR VA D HARRIS ET AL  
MAR 88 BRDEC-2461

**Report 2461**

## **Some Effects of Nitrates on the Tensile Properties of Al 7075-T7351**

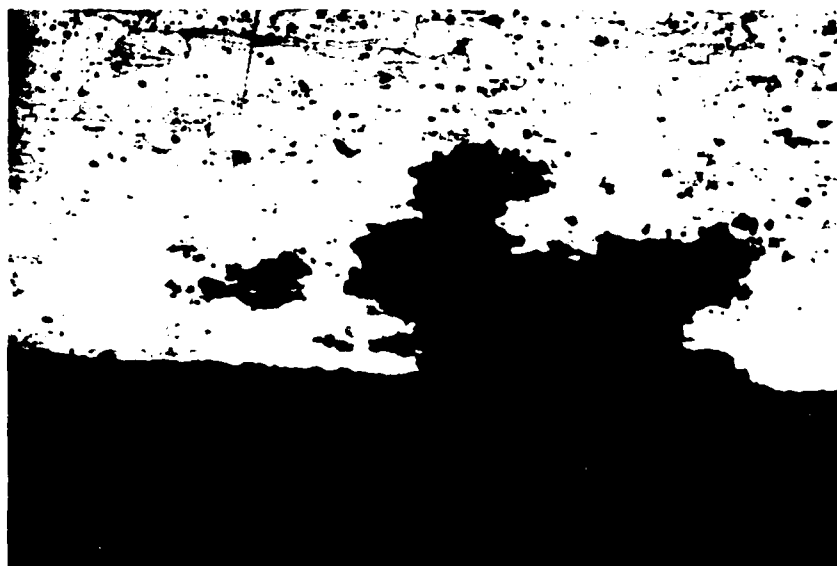
**Figure 8. Pit in which grain removal was part of the cause of damage (200X)**

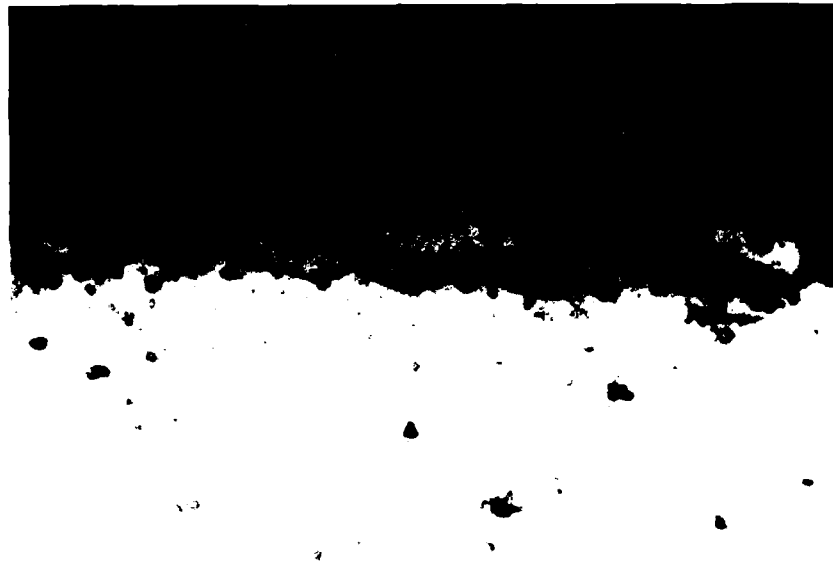
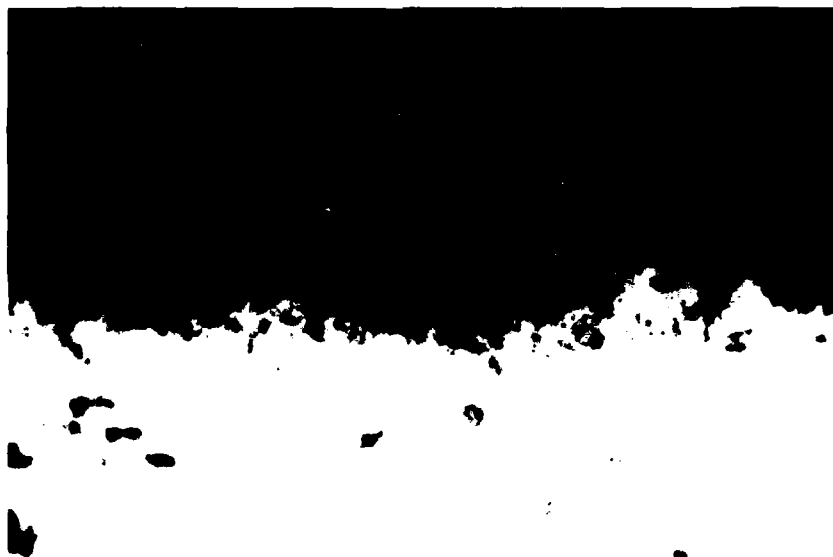
Figure 22. A. Incipient grain removal which results in  
B. Shallow surface corrosion (removal) after exposure to baseline environment

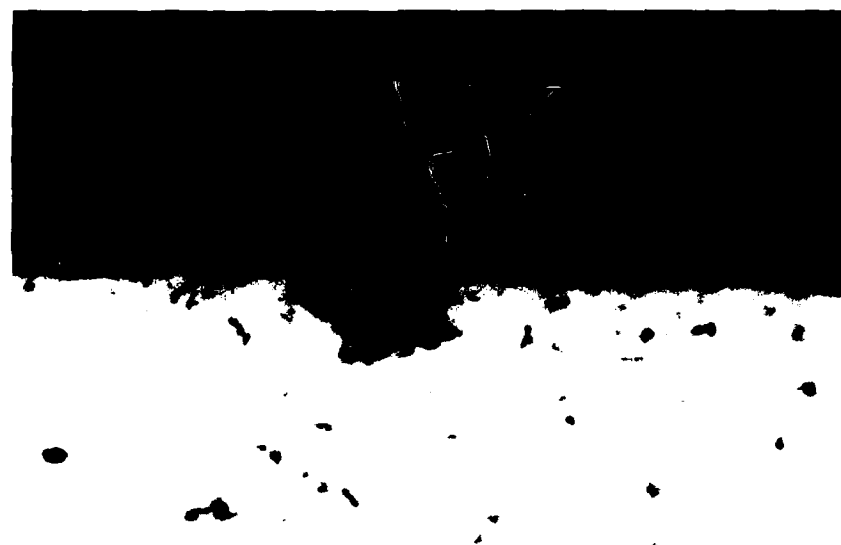
**Figure 23. Pitting on the flat specimens. A. Pit with a crack. B. Normal pit.  
C. Pit which has a small orifice with respect to its volume after exposure to  
baseline environment**
