# NONDESTRUCTIVE ANALYSIS OF MK 607 HARPOON MISSILE CONTAINER

FINAL REPORT  
SwRI Project 17-7958-829

Prepared For  
United States Navy  
Pacific Missile Test Center (PMTC)  
Pt. Mugu, California 93042

August 1987

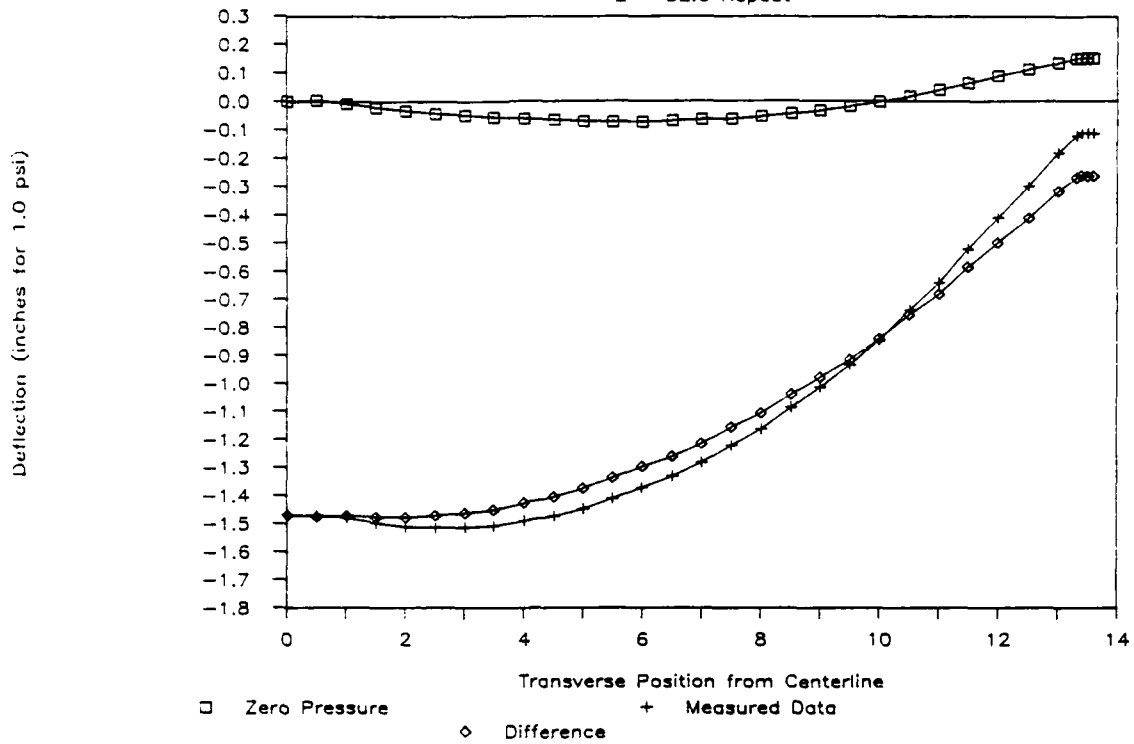
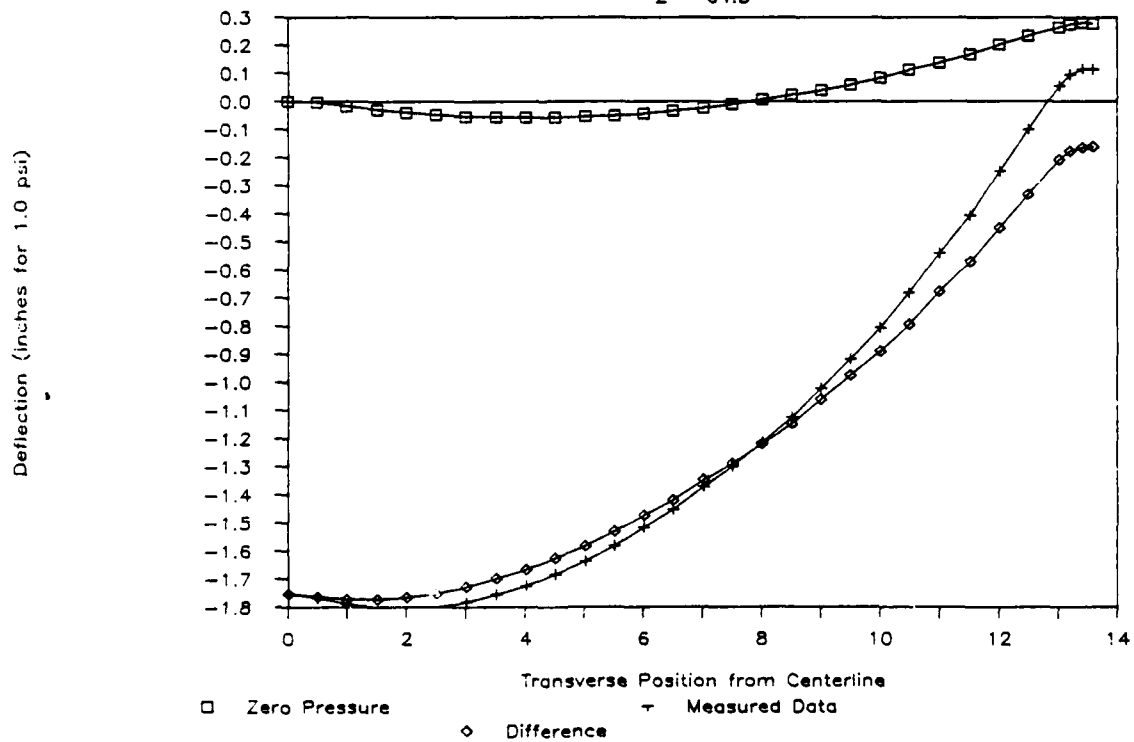
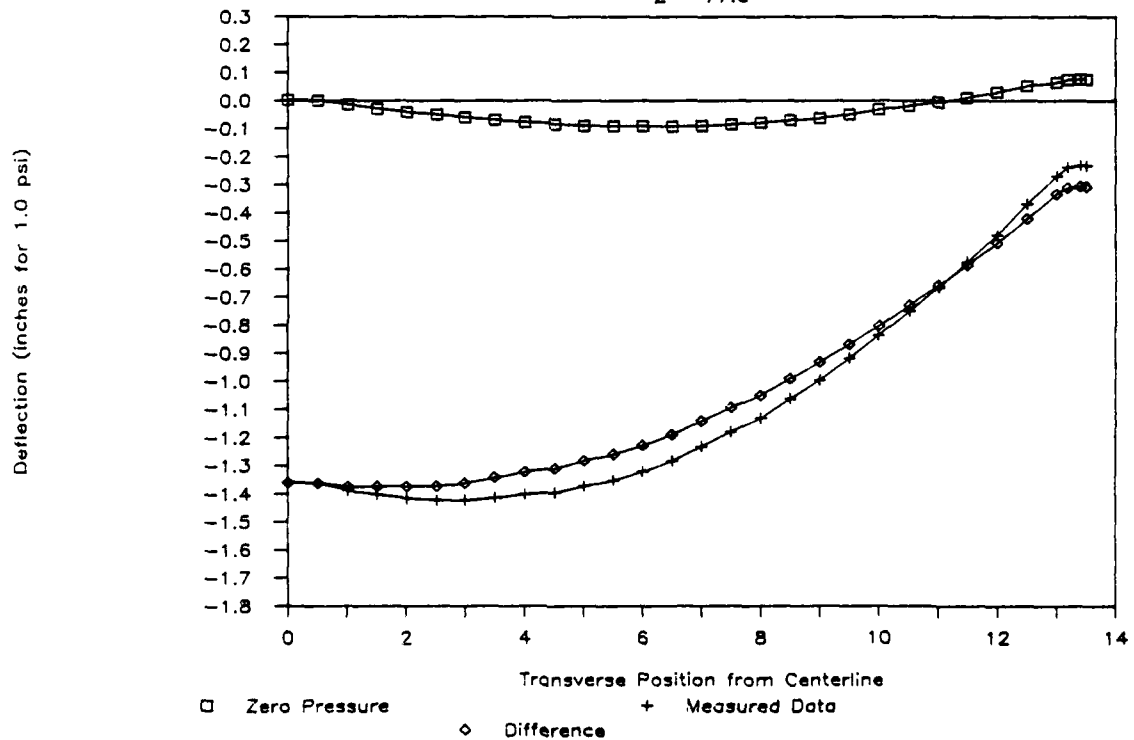
Results of the traversing mechanism measurement for various longitudinal locations are given in Figures 4-8 to 4-19. Displacements are presented for both the vacuum and concentrated loading conditions. The first thing to notice is the fact that the zero load deflection is different than expected. From the drawings of the shell supplied, there should be a crown at

the transverse centerline. For all locations plotted, the centerline is always lower than the edge of the shell. This condition is most likely the result of creep in the fiberglass as a function of time. This initial geometry will allow for water to collect on the top surface of the shell.

The plots given include three sets of data: two corresponding to each of the measured zero and load conditions and the third corresponding to the difference between the two. This third set corresponds to the amount of deflection due to loading. As with the previous test results, the deflections have been scaled from the applied 14 inches of water (0.5 psi) up to 1.0 psi. For the plots, the horizontal scale corresponds to the transverse position with 0 corresponding to the centerline and 13.6 corresponding to the edge. Displacement values are in inches. These plots present the results of digitizing the original data and replotting to obtain consistent scales.
