## SOILING, CLEANING, AND WEATHERING EFFECTS ON AIRCRAFT POLYURETHANE TOPCOATS

Donald J. Hirst and Charles R. Hegedus

Air Vehicle and Crew Systems Technology Directorate  
Naval Air Development Center  
Warminster, PA 18974-5000

PHASE REPORT  
PROJECT NO. R534A52  
WORK UNIT ZM 540

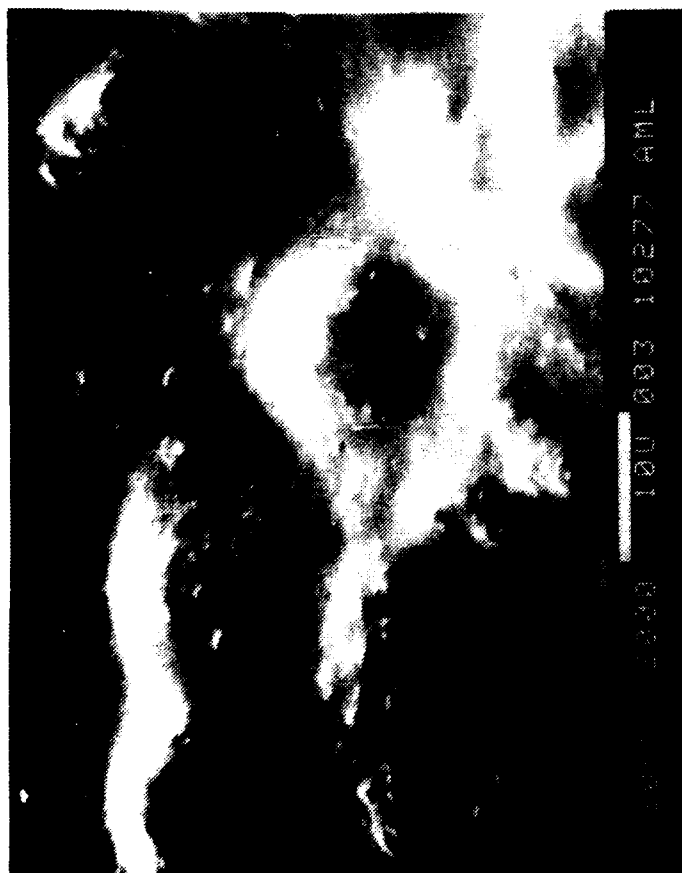
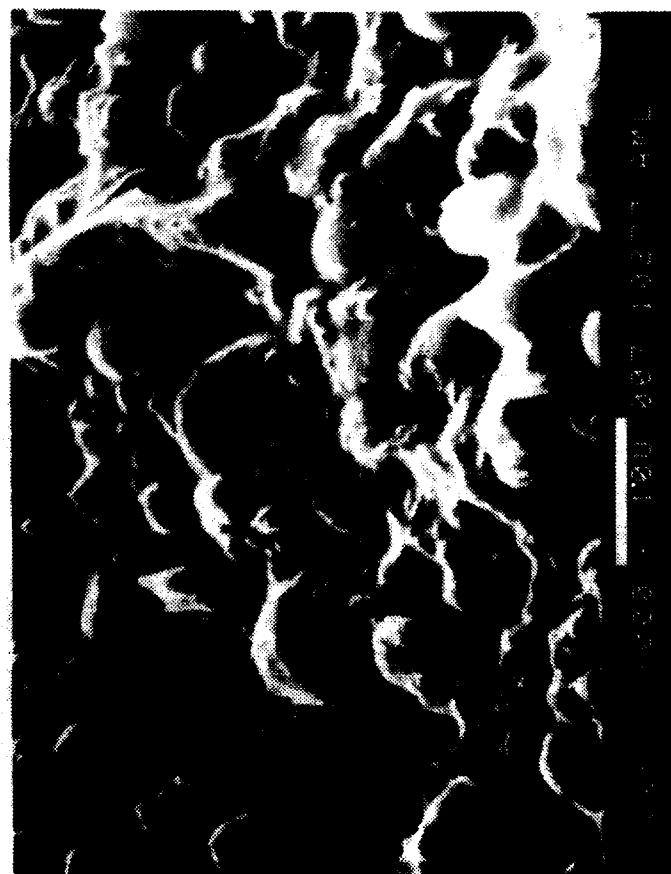
FIGURE 1. SCANNING ELECTRON MICROGRAPHS (2000X) OF POLYURETHANE AIRCRAFT TOPCOATS

- A. DEFT
- B. DESOTO
- C. CAMOLITE

The higher dE is, the greater the color change and the poorer the coating cleanability.) The effect observed in Figure 1 is caused by the surface roughness required for low gloss coatings, allowing carbonaceous soil particles to become entrapped in the coating surface. A second trend was found with the hydrophilic nature of the coating surface and cleanability. As suggested in Figure 2, coatings which were more hydrophilic (lower contact angle) were more cleanable than those which were hydrophobic. This effect is attributed to the smoother surface of the hydrophilic coatings and the ability of the cleaner to wet these surfaces more efficiently. Reference (1) also discusses the improved cleanability of low gloss (<3) coatings which contain polymer bead pigments. The bead coatings have a thin layer of resin which coats the surface, and rounded surface protrusions while conventionally pigmented topcoats of equivalent gloss (1.0) were resin starved at the surface and had jagged surface protrusions. This effect is illustrated in the scanning electron micrographs in Figure 3. The surface exhibited by the polymer bead coatings was far less

likely to entrap and retain soil particulates.

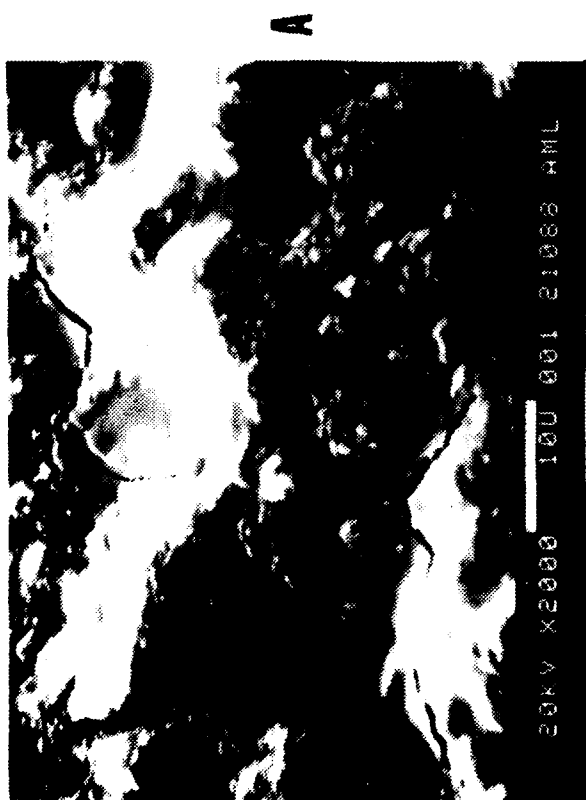
FIGURE 8. SEMs (2000X) OF WEATHERED SPECIMENS

- A. DEPT
- B. DESOTO
- C. CAMOLITE

SEMs at 2000X of the DeSoto coating show some differences between the unexposed and weathered/soiled/cleaned specimens. The unexposed specimen is extremely rough with a resin starved surface, exposing pigment. It has a surface roughness on the magnitude of 5 to 10 microns, but also a microroughness at the sub-micron level. The weathered specimen exhibits very little of the sub-micron irregularities. This is probably caused by the "rinsing" action in the weathering cycle which removed any loose debris from the surface. The weathered/soiled/cleaned specimen appears slightly smoother than the weathered specimen, caused by the burnishing action of the cleaning cycle.

Figures 7 through 10 show obvious cracking of Deft and DeSoto MIL-C-83296 polyurethane topcoats upon accelerated weathering in a xenon arc weatherometer. This was unexpected since MIL-C-83286 has an accelerated weathering exposure

requirement of 500 hours with minimal reduction in flexibility. It is suspected that these cracks are caused by internal stresses arising from chemical and surface changes in the coatings during weathering. Although the 1600 hour exposure period of this study significantly exceeds the specification exposure period, it may be a reasonable duration for evaluation of coatings for Navy aircraft which are repainted approximately every 4 to 6 years. During that service time, they are exposed to extremely harsh environmental conditions: sunlight, wide temperature ranges in flight ( $-65^{\circ}$  to  $350^{\circ}\text{F}$ ) and on ground ( $<0^{\circ}$  to  $>100^{\circ}\text{F}$ ), high humidity, salt spray, and carbonaceous oily soils. In order to further understand cracking and other aircraft polyurethane coating responses to weathering, an extensive study has been initiated which will examine chemical, physical, optical, and surface property changes of the coating during exposure in Florida, a xenon arc weatherometer and a QUV chamber (ASTM G-53).
