CENTER FOR BASIC RESEARCH IN RADIATION BIOEFFECTS(U)  
TEXAS UNIV HEALTH SCIENCE CENTER AT SAN ANTONIO DEPT OF  
RADIOLOGY M L MELTZ 15 JUN 88 AFOSR-TR-88-0831

CENTER FOR BASIC RESEARCH IN RADIATION BIOEFFECTS

Final Report for Period October 1987 - March 1988

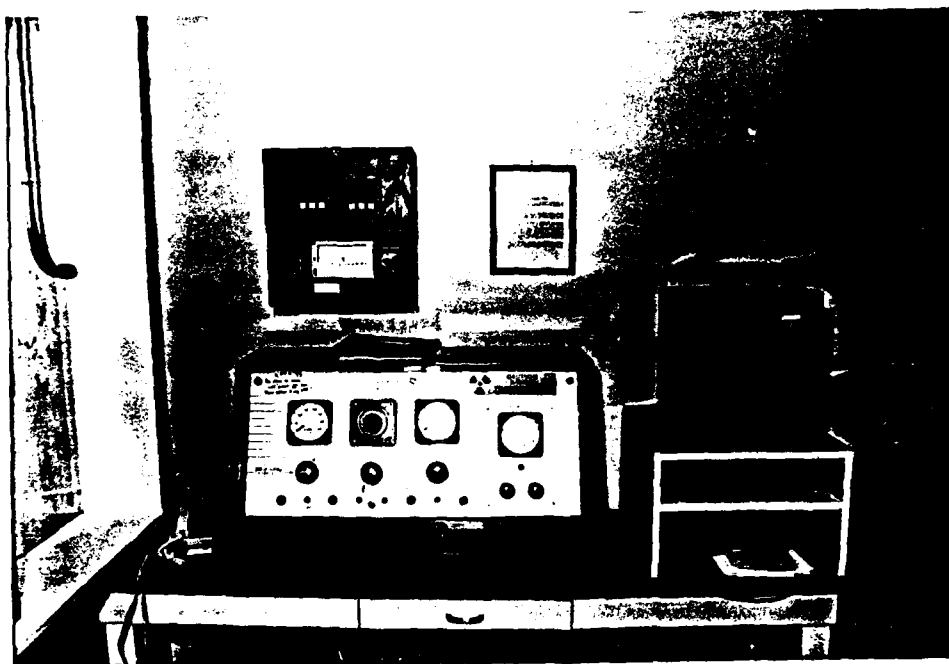
**Figure 5.** Left sidewall of control room. Temperature and humidity controllers are mounted on wall (with two-track recorder). Also shown are X-ray control panel; monitor for camera with pan and tilt and lens zoom controls beneath it.

The heating and cooling are controlled by the same remote thermostat, which is located on the left sidewall of the control room (Figure 5). The humidity is controlled by a remote mounted humidistat also located in the control room. The temperature and humidity of the anechoic chamber system are monitored by probes

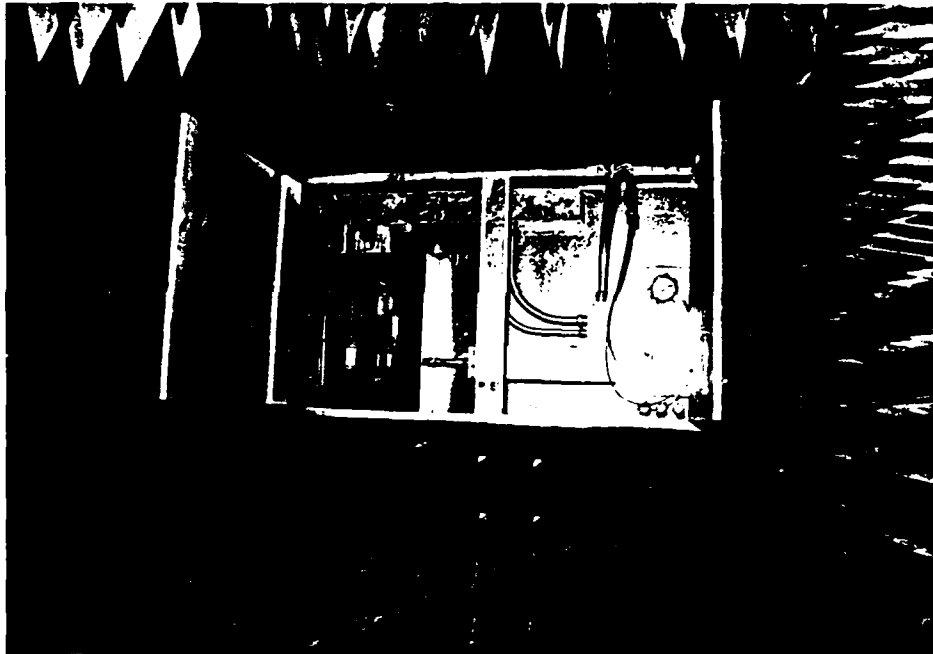
**Figure 14.** Upper Figure (14a) shows left recess with distribution boxes, etc. Lower Figure (14b) shows closed cabinet, with vertical Velcro strips for mounting Eccosorb panels. Black topped wooden table is shown at bottom. Opening on right will be covered with metal plate for mounting BSD-200 temperature box.

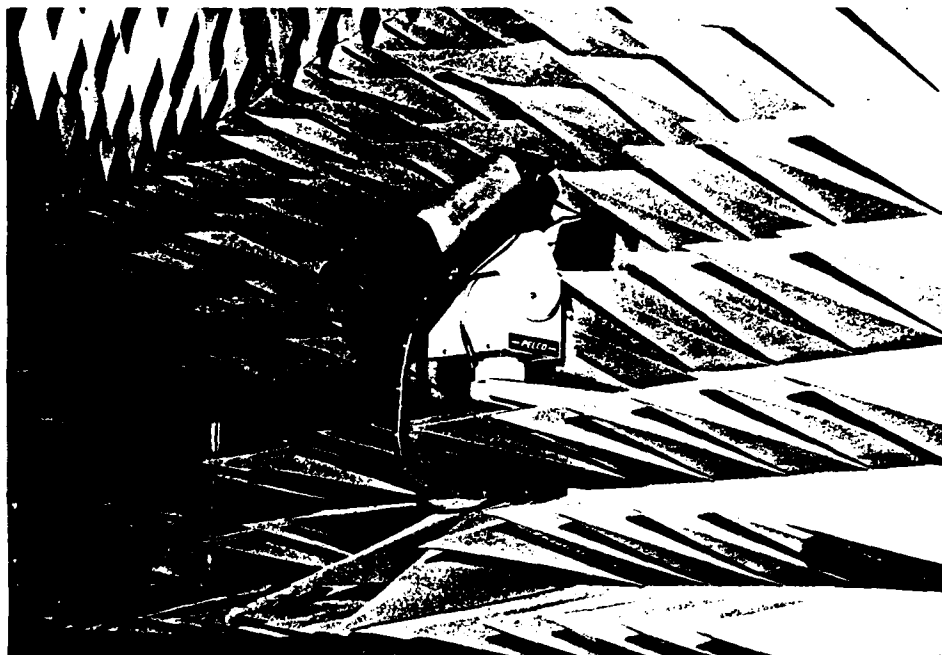
**Figure 19.** Cohu solid-state color camera mounted above the door leading into the chamber.
