Technical Support Document  
For Record Of Decision  
Tatalina, AFS

INSTALLATION RESTORATION PROGRAM  
TECHNICAL SUPPORT DOCUMENT  
FOR RECORD OF DECISION  
TATALINA AIR FORCE STATION  
LRRS SITE

Prepared By  
Woodward-Clyde Consultants  
701 Sesame Street  
Anchorage, AK

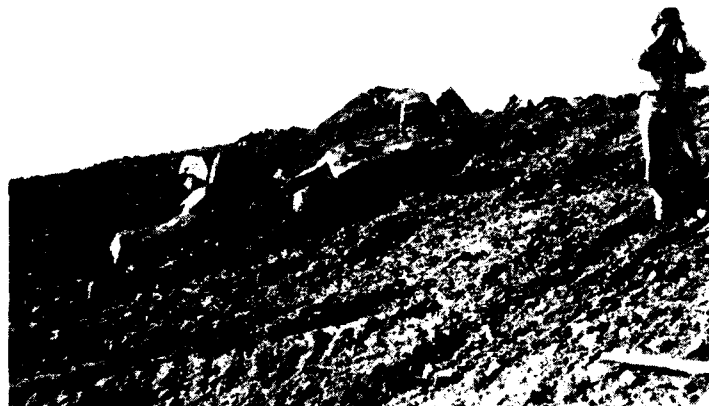
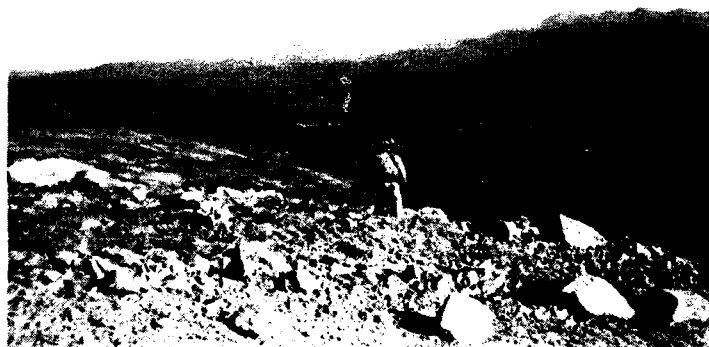
Figure 4

Spill/leak Nos. 6 and 7 (site 1) were recorded near an Upper Camp garage. The garage was recently demolished and the area covered with fill. No evidence of contamination remains. Two dumps also exist at the Upper Camp (site 5, Figure 4). Both sites have been cleaned and graded; no contamination or debris was observed.

Upper Camp Dump  
Tatalina AFB
