TECHNICAL REPORT ARCCB-TR-88040

**MICROSCOPIC ASPECTS OF FAILURE  
AND FRACTURE IN CROSS-PLY FIBER-  
REINFORCED COMPOSITE LAMINATES**

NOVEMBER 1968

**US ARMY ARMAMENT RESEARCH,  
DEVELOPMENT AND ENGINEERING CENTER  
CLOSE COMBAT ARMAMENTS CENTER  
BENET LABORATORIES  
WATERVLIET, N.Y. 12180-4050**

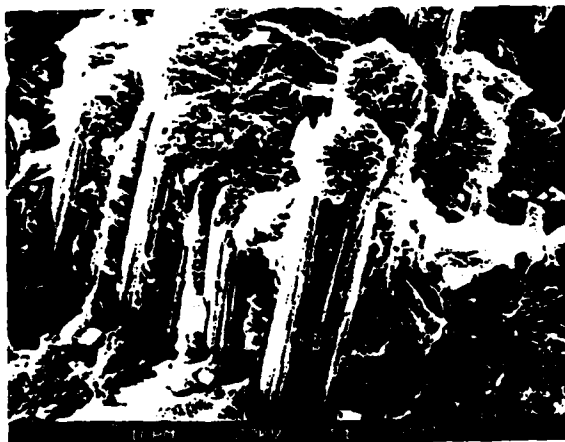
Figure 6. Carbon/epoxy showing clustering without any appreciable debonding.

Further, the fracture surface of carbon/epoxy (Figure 6) is similar to the proposed model of pull-out of fiber-clusters by Bandyopadhyay and Murthy (ref 17). When significant clustering occurs, the energy absorbed in the separation process can be as low as 10 to 25 percent of the total energy required by pull-out of individual fibers. Thus, this model can also partially explain the difference in fracture toughness of carbon/epoxy and carbon/bismaleimide composites in the present study.

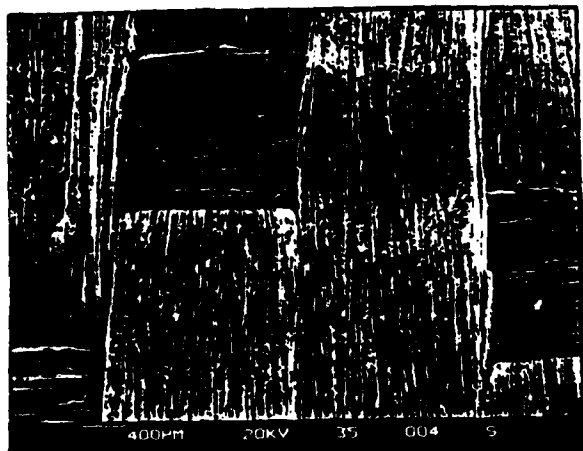
Figure 10. Delamination failure.

Examination of fracture surfaces of the laminates was carried out to understand the micromechanisms of this type of fracture. Figure 10 shows a low magnification view of the general delamination. At high magnification, the glass composite fracture surfaces feature contrasting resin-rich regions (Figure 11) and resin-lean fiber bundles where the crack appears to have deviated from the matrix between plies to a location within plies (Figure 12). There is some evidence of localized plastic deformation in the matrix of carbon/828-DDS composite (Figure 13), while the fracture surface of the carbon/MY720-DDS shows cleaner failure (Figure 14) consistent with the brittle nature of the neat resin.
