The Deep Sea Moorings Fishbite Problem\*

H.O. Berteaux<sup>1</sup>, Dr. Bryce Prindle<sup>1</sup>, and Lt. Daniel May<sup>2</sup>

<sup>1</sup>Woods Hole Oceanographic Institution Woods Hole, Massachusetts 02543    <sup>2</sup>National Data Buoy Center NSTL Station, Mississippi 32592

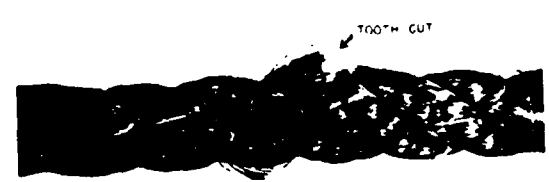
Figure 1. Typical fishbite on 5/16" diameter polypropylene rope.

Ropes of synthetic fiber have been found severed or cut part way with cuts appearing clean as though made with a keen edge (Figure 1).
