# NAVAL POSTGRADUATE SCHOOL

# THESIS

**THE EFFECT OF AGING TREATMENT  
ON THE MICROSTRUCTURE AND PROPERTIES  
OF COPPER-PRECIIPITATION  
STRENGTHENED HSLA STEEL**

December 1988

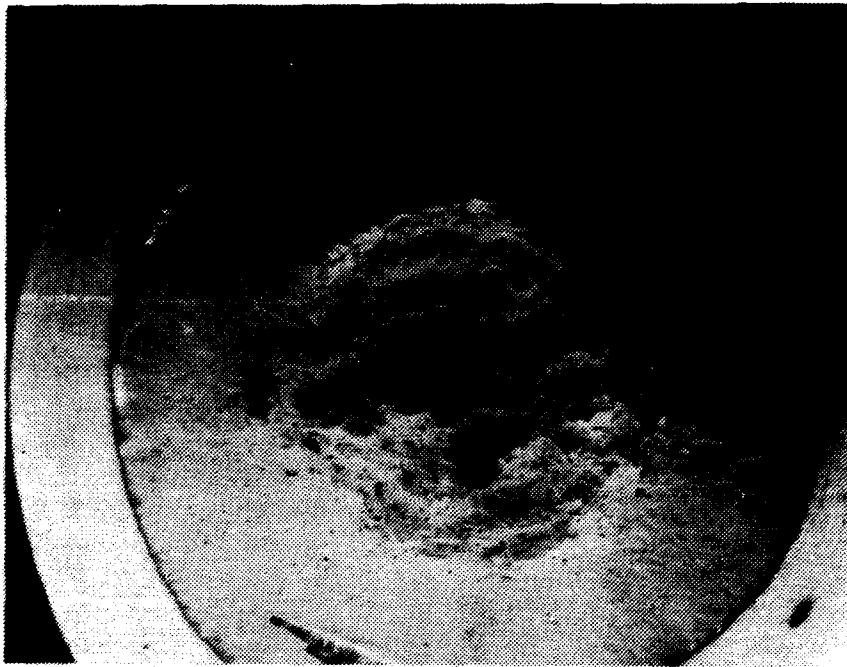
Tensile tests showed that all samples failed in a ductile manner. Figure 28, which shows the tensile fracture surface of HSLA-100 in the as-quenched condition, indicates failure by microvoid coalescence. The classic cup and cone fracture is indicative of a highly ductile condition for this material. The 500 C aged material (Figure 29) exhibits multiple splits in the rolling direction. Although the reasons for this behavior are not precisely understood, various possible causes

**Figure 28. SEM Micrograph of As-Quenched  
Tensile Fracture Surface**
