ESL-TR-87-71

# ENVIRONMENTAL EFFECTS OF SPACE SHUTTLE EXHAUST ON MATERIALS

W.H. ABBOTT

FINAL REPORT

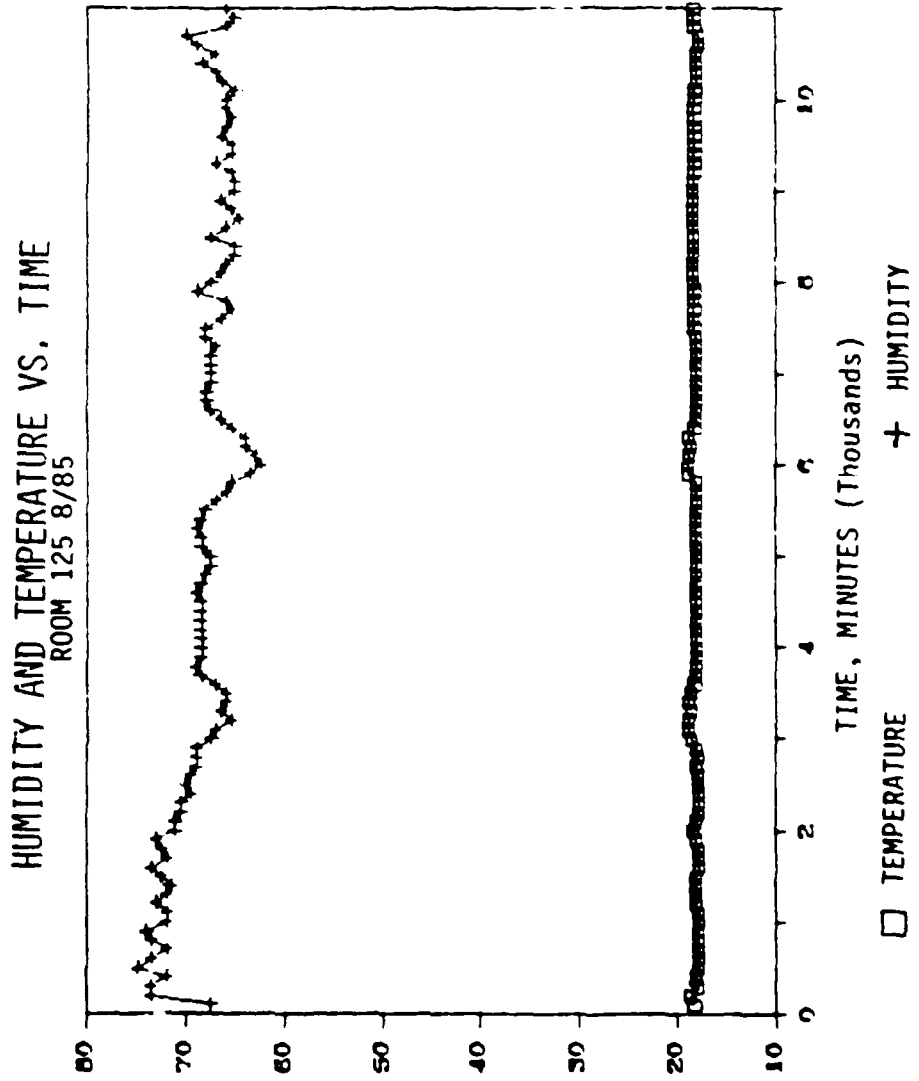
Figure 1. Temperature and Relative Humidity Versus Time for Room 125

The results from four locations at SLC-6 are shown in Figures 1 through 5. These data confirm findings at many other indoor locations within the United States. They indicate that, in general, temperature is well-controlled. However, in many locations humidity is not.

The results from LCC 125 are particularly interesting. They show high, but stable, humidity during the period monitored. This could be attributed to the mode of air-conditioning operation which maintained this room relatively cool, together with the fact that there was a small heat load. This level of humidity, if it were maintained, is believed to approach values which could significantly increase corrosion rates for the levels of indoor chlorides found in the latter stages of monitoring. It is unfortunate, therefore, that temperature-humidity data were not obtained during early 1986 to coincide with the other forms of monitoring. The data may therefore be important to illustrate the subtle effects which operating conditions such as those associated with air conditioning can potentially have on equipment performance. Additional data can be found in Figures 5 through 8, which compare results at different sites.

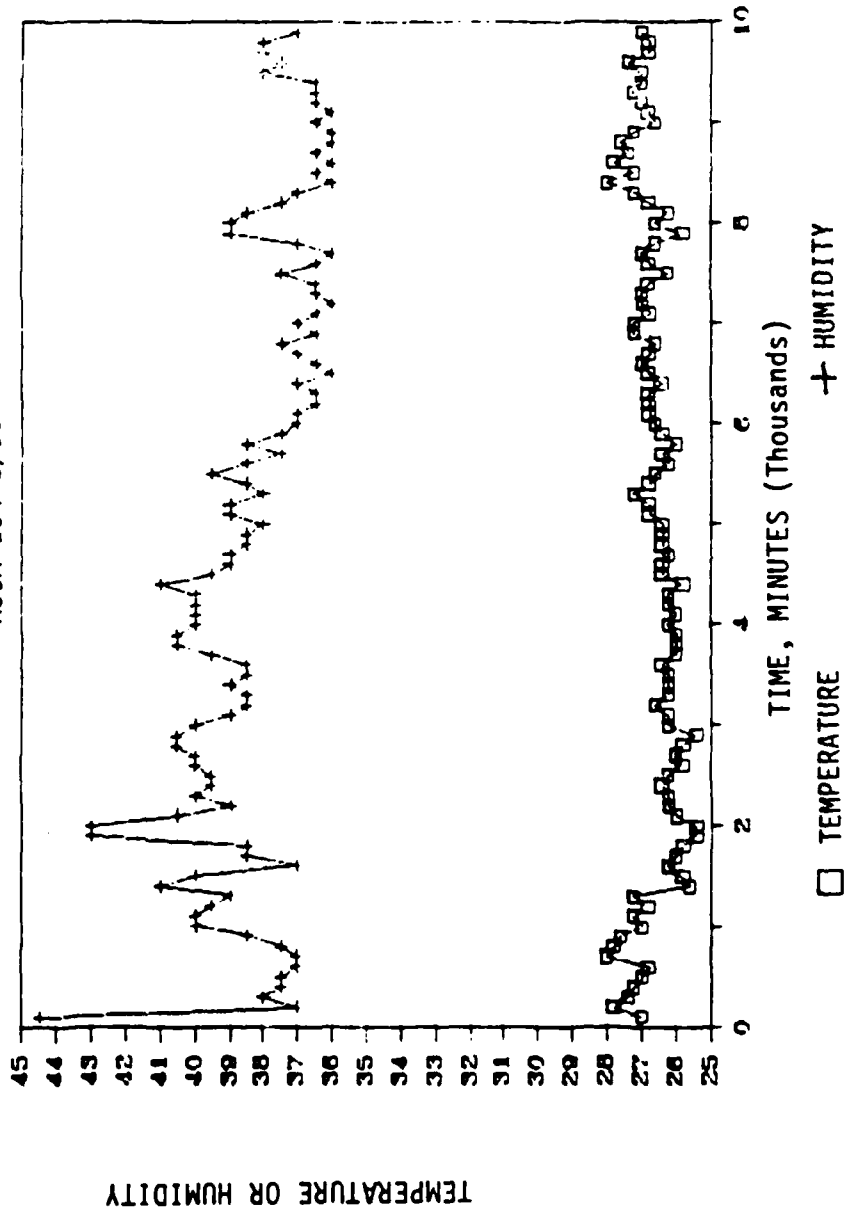
HUMIDITY AND TEMPERATURE VS. TIME  
ROOM 104 8/85

Figure 2. Temperature and Relative Humidity Versus Time for Room 104

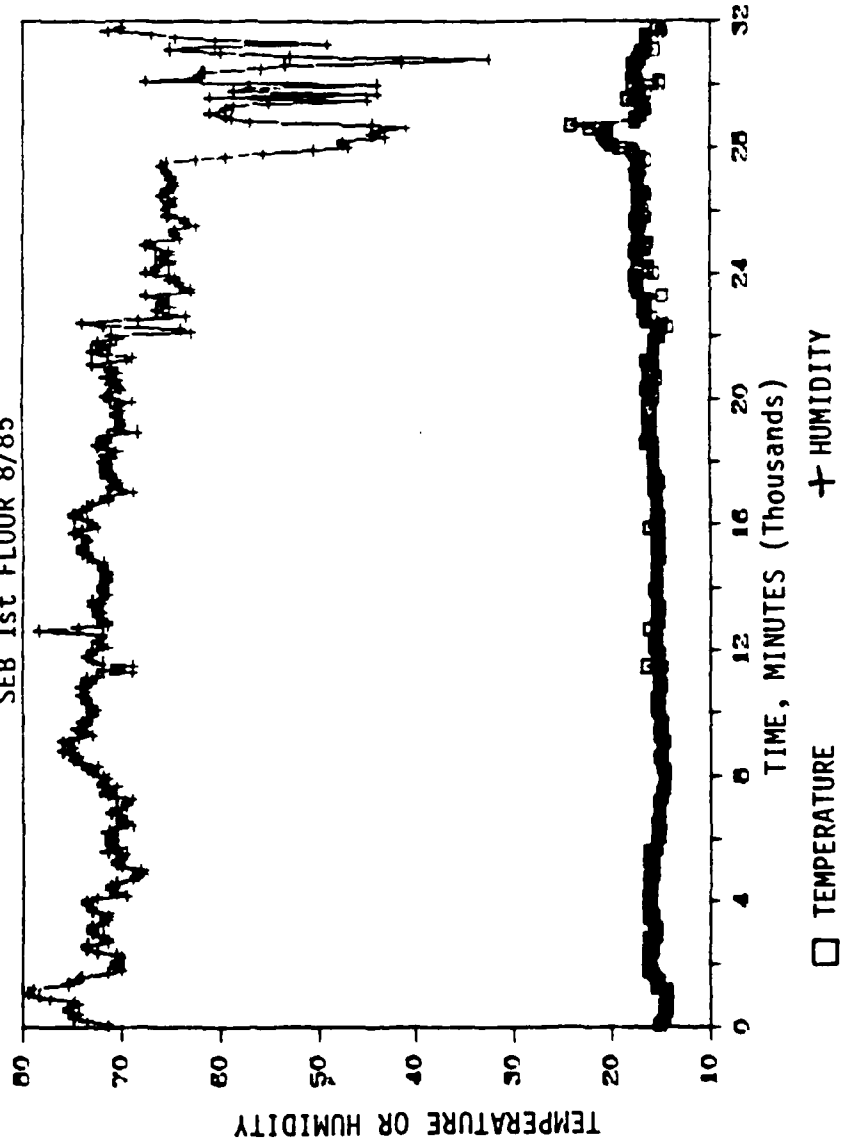
HUMIDITY AND TEMPERATURE VS. TIME  
SEB 1st FLOOR 8/85

Figure 3. Temperature and Relative Humidity Versus Time for SEB 1st Floor

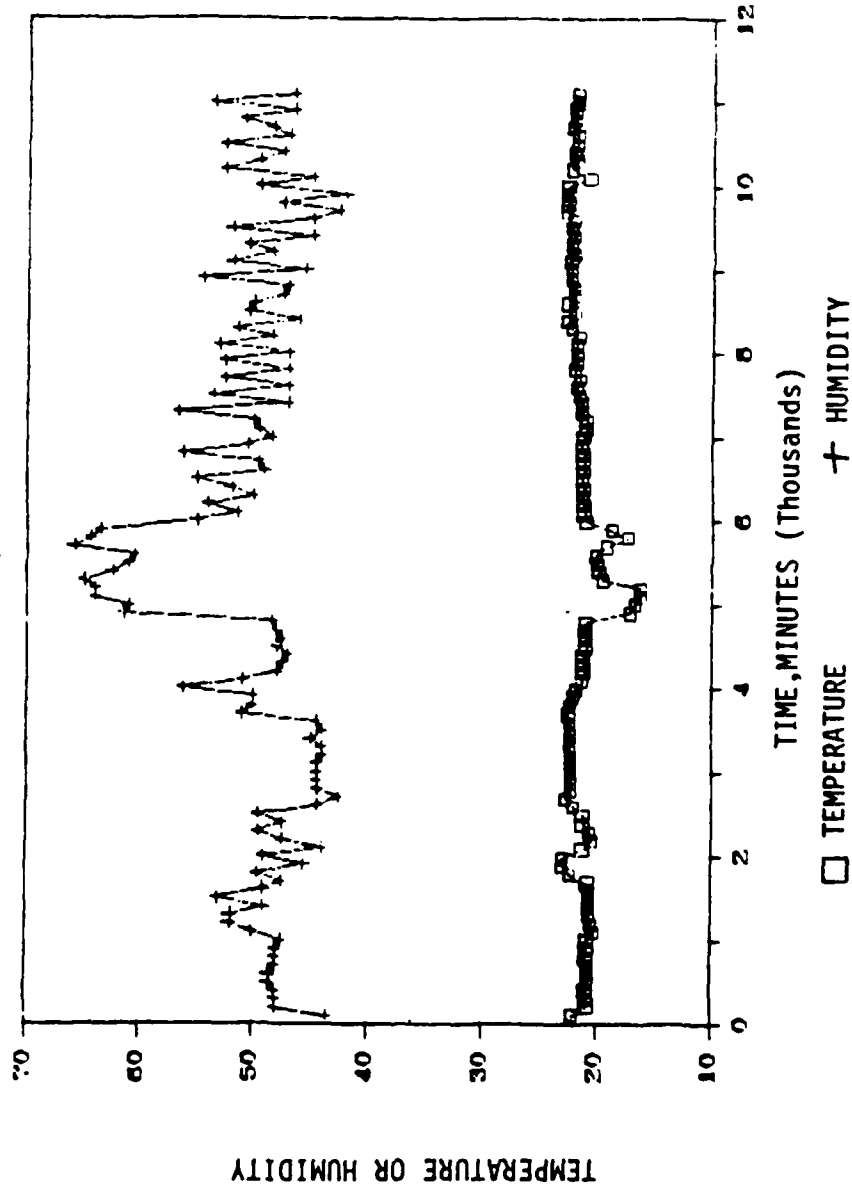
HUMIDITY AND TEMPERATURE VS. TIME  
LCC 118,119 7/85

Figure 4. Temperature and Relative Humidity Versus Time for LCC 118 and 119

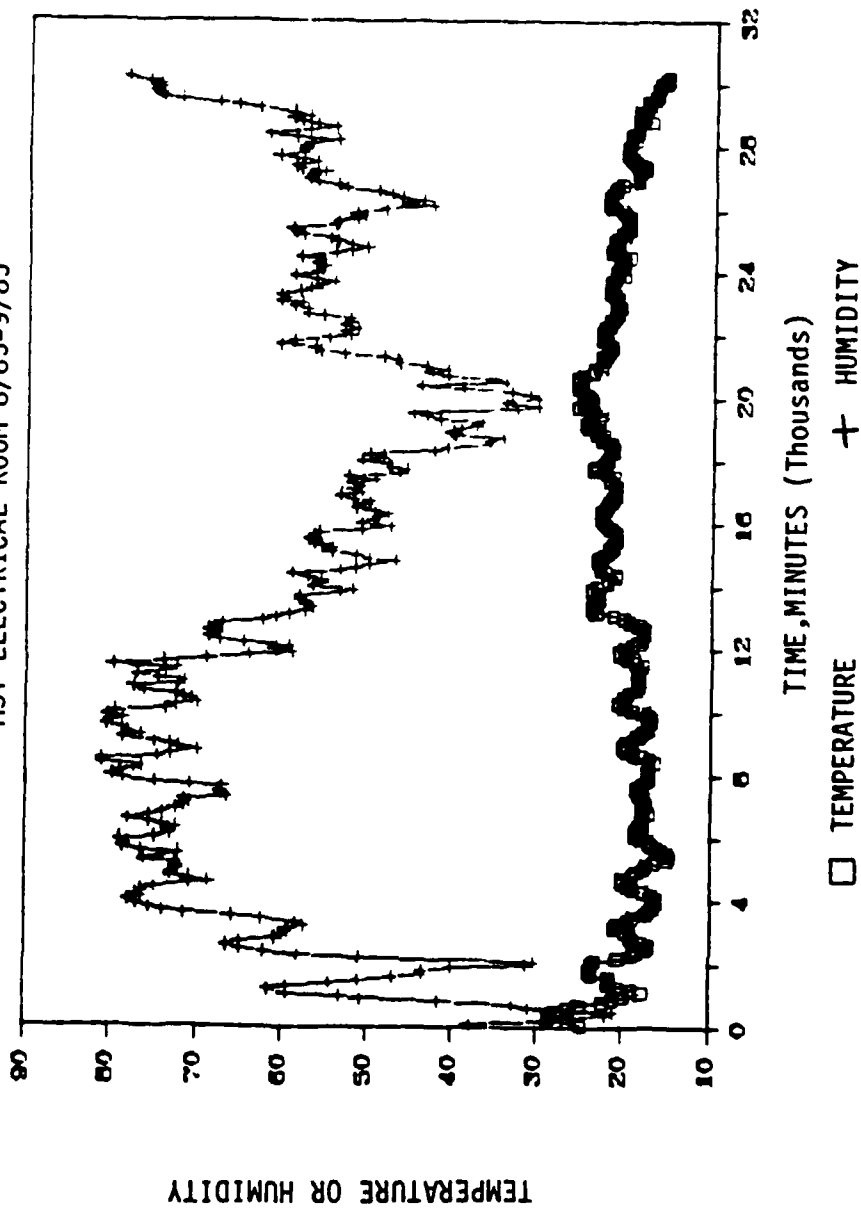
HUMIDITY AND TEMPERATURE VS. TIME  
MST ELECTRICAL ROOM 8/85-9/85

Figure 5. Temperature and Relative Humidity Versus Time for MST Electrical Room

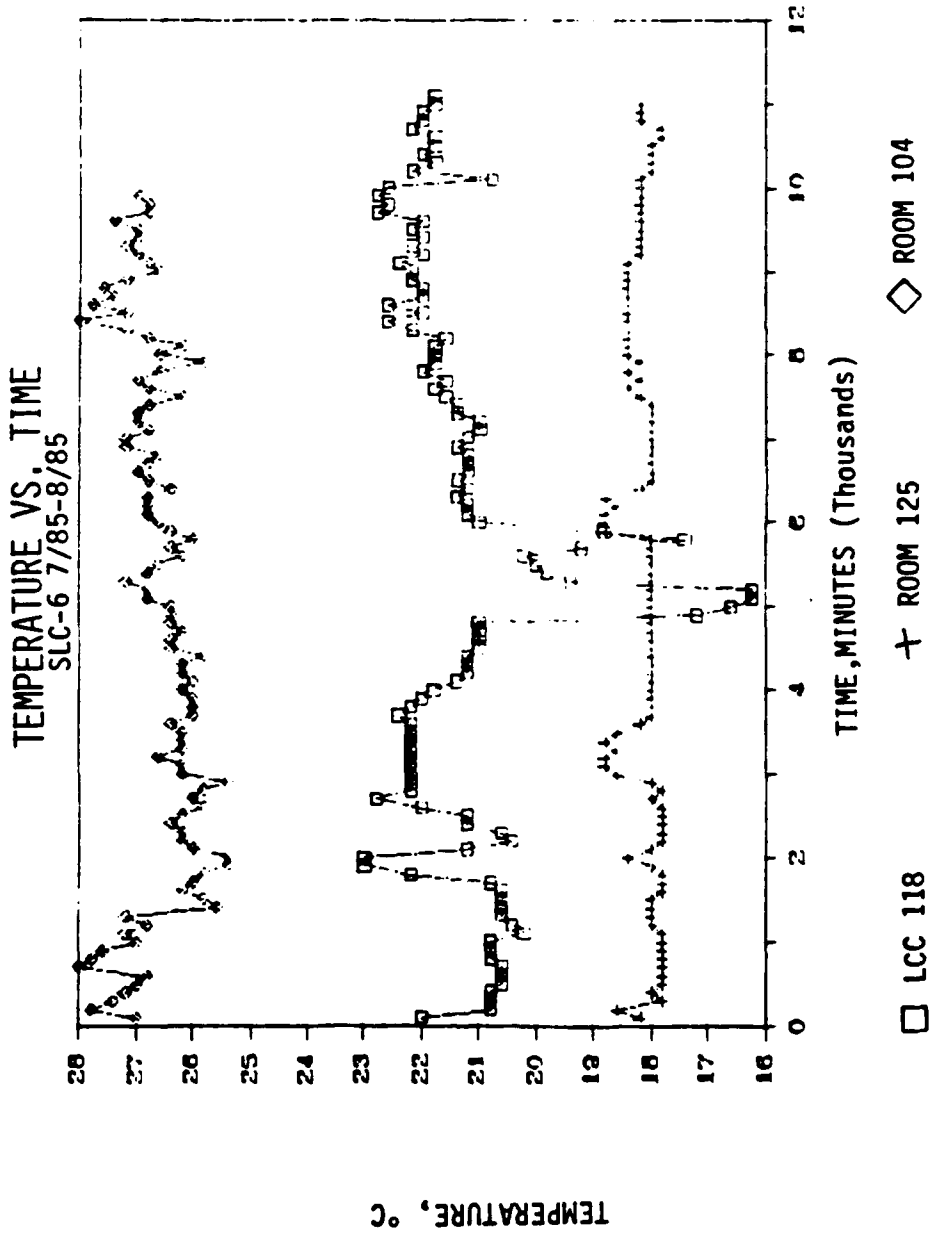
Figure 6. Temperature Versus Time for LCC 118, Room 125 and Room 104 At Shuttle Launch Complex 6

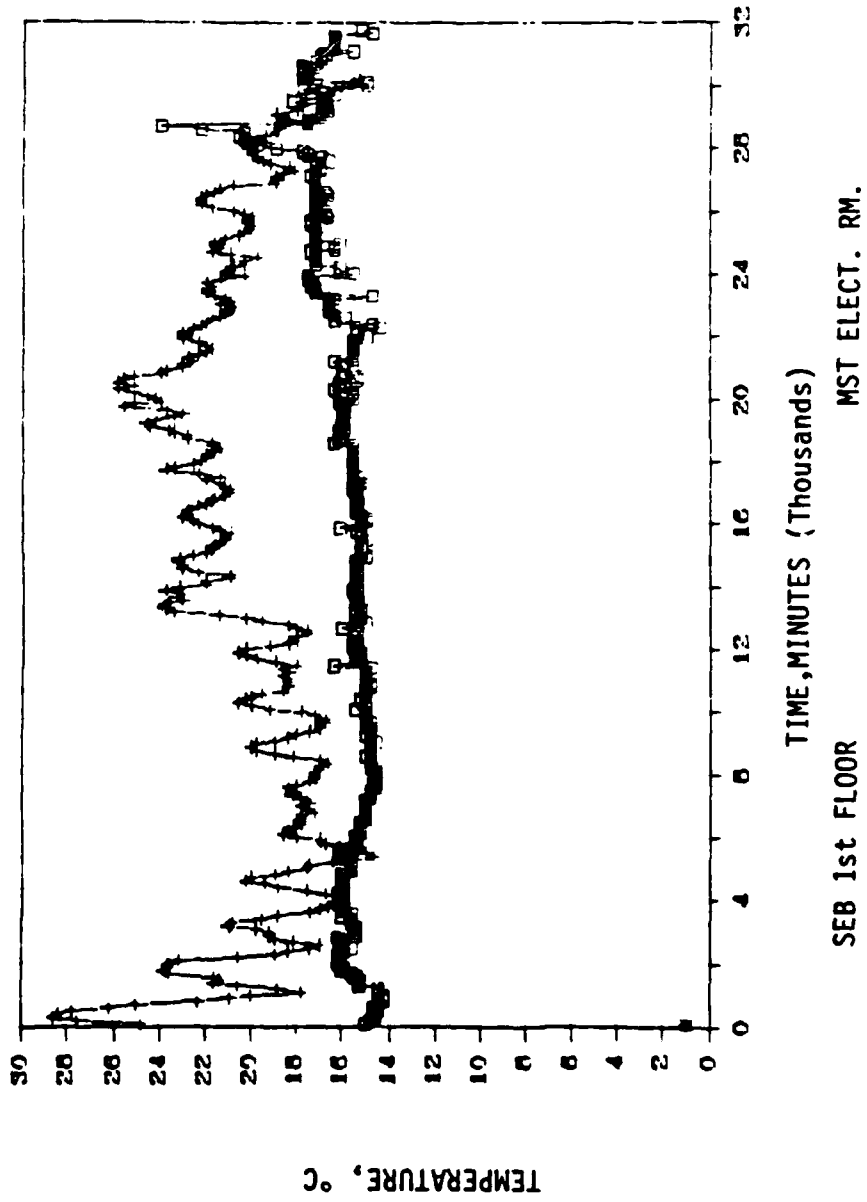
TEMPERATURE VS. TIME  
SLC-6 8/85-9/85

Figure 7. Temperature Versus Time for SEB 1st Floor and MST Electrical Room At Shuttle Launch Complex 6

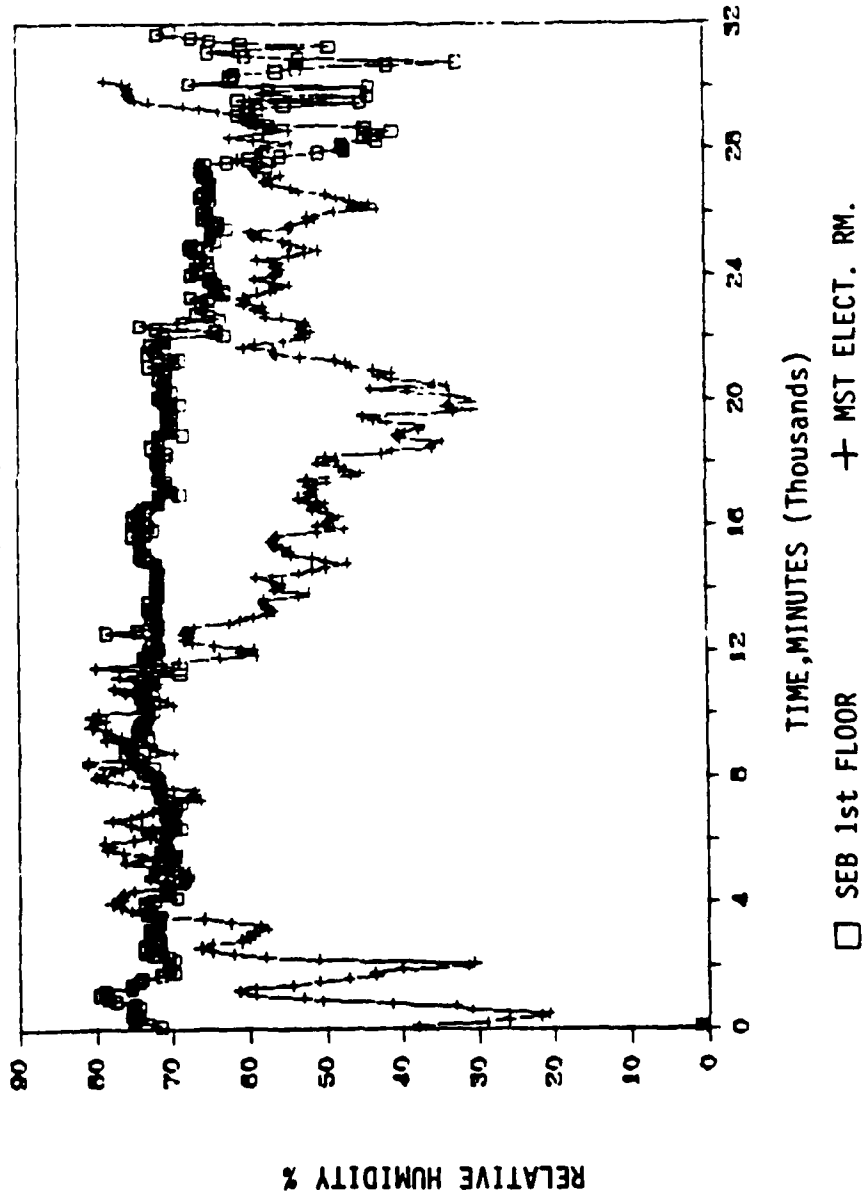
RELATIVE HUMIDITY VS. TIME  
SLC-6 8/85-9/85

Figure 8. Relative Humidity Versus Time for SEB 1st Floor and MST Electrical Room at Shuttle Launch Complex 6

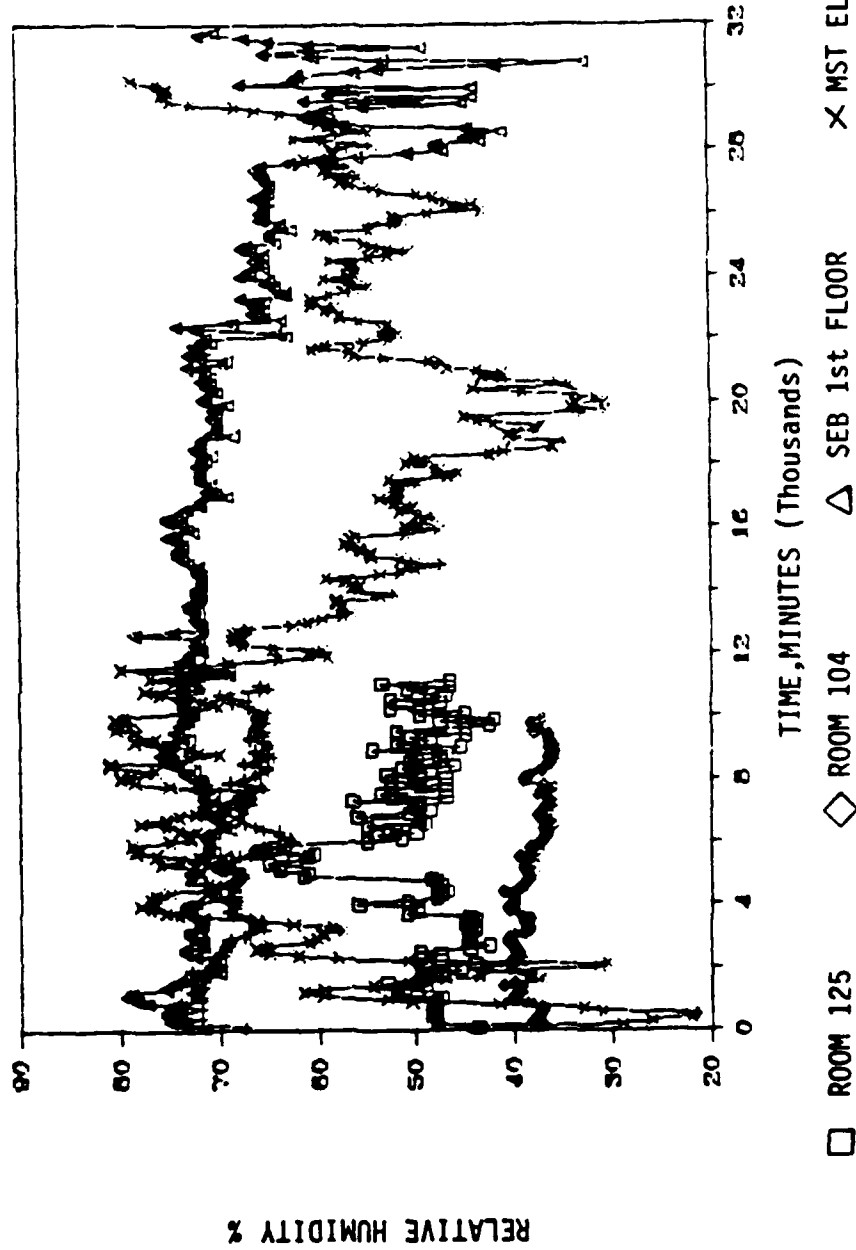
RELATIVE HUMIDITY VS. TIME  
SLC-6 7/85-9/85

Figure 9. Relative Humidity Versus Time for Room 125, Room 104, SEN 1st Floor and MSI Electrical Room at Shuttle Launch Complex 6

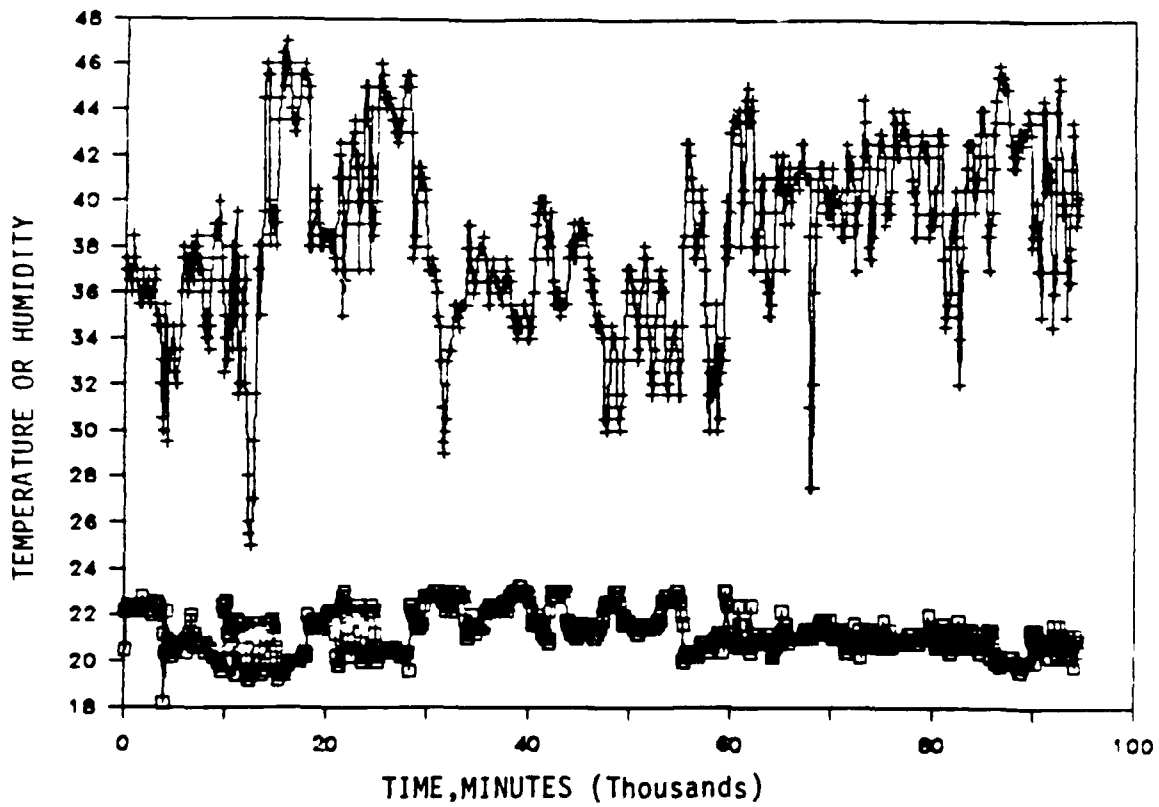
TEMPERATURE AND RELATIVE HUMIDITY  
VANDENBERG SLC-4 3/86-5/86

Figure 10. Temperature and Relative Humidity Versus Time at Vandenberg Shuttle Launch Complex 4

All of the available data for SLC-4 are summarized in Tables 6 and 7 and Figure 10. Additional samples and monitoring equipment had been placed at this facility, but were lost following the Titan mishap. Reference should also be made to Tables 4 and 5 for air pollution and temperature-humidity statistics.
