**Enhanced Preliminary  
Assessment Report:**

**Beverly Army Housing Units  
Beverly, Massachusetts**

September 1989

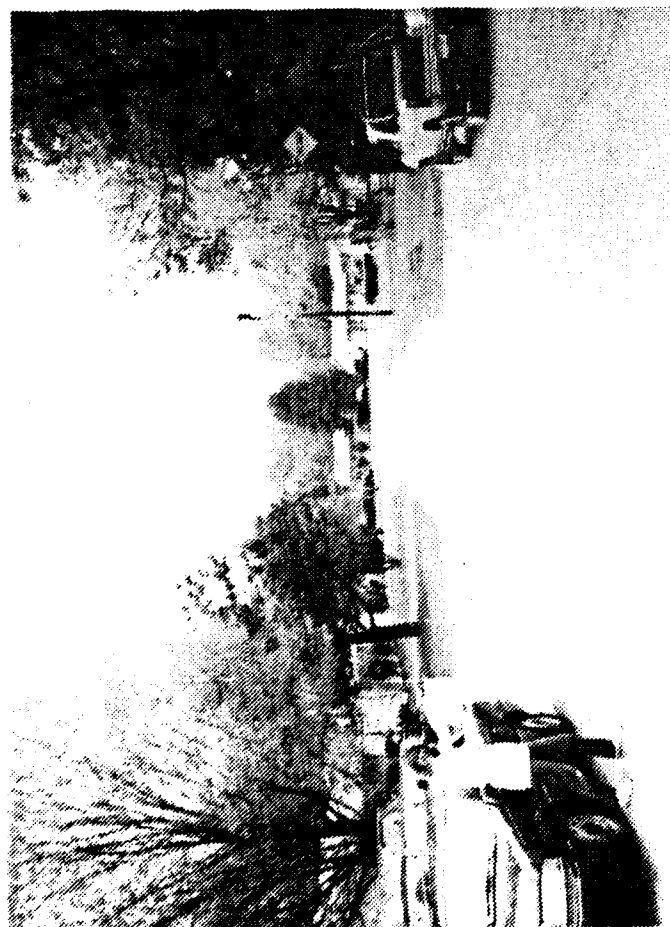
Some of the current above-ground tanks evidenced oil spilled around them, from accidental leakage during the filling procedure. However, the volumes of fuel involved appear to have been very small, and no significant adverse environmental impacts are believed to have resulted.

Lower right-hand photo:  
Wood fence surrounding 275-gallon aboveground heating oil tank at rear of house.
