## **Enhanced Preliminary Assessment Report:**

**Swansea Army Housing Units  
Swansea, Massachusetts**

September 1989

Environmental Research Division  
Argonne National Laboratory  
Argonne, Illinois 60439

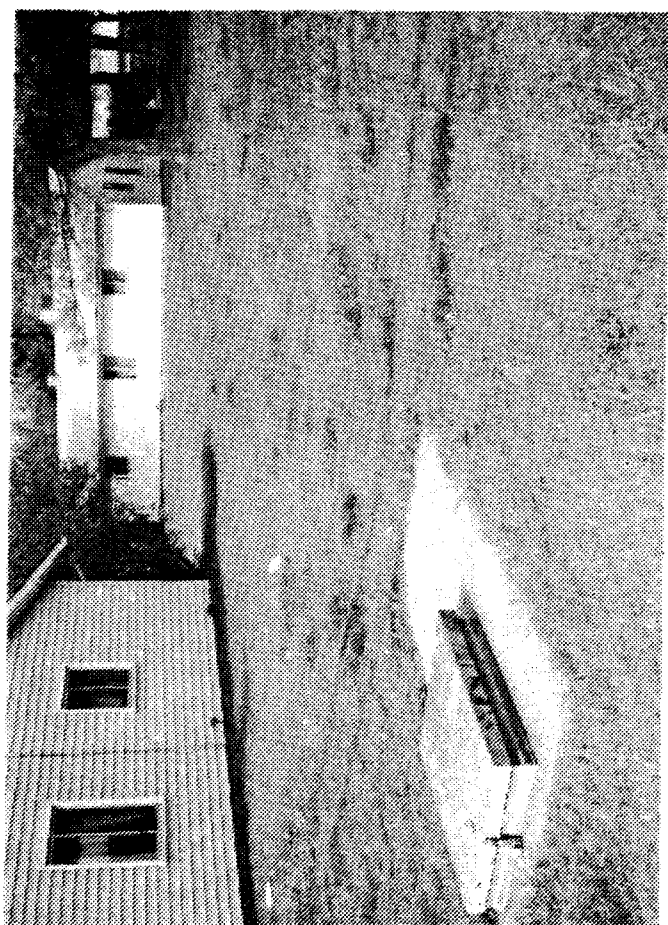
Lower left-hand photo: Private residence to the north of the housing area, reportedly flooded by Army housing septic problems.

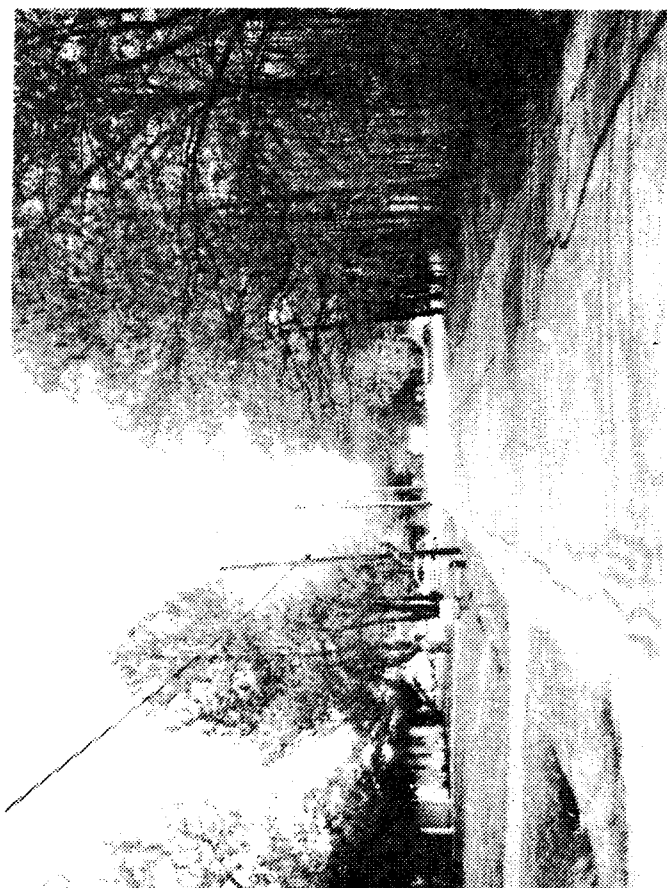
Lower right-hand photo: Fill pipe for an underground storage tank at the rear of a house.

A concern involves the underground heating-oil tanks at each housing unit on the property. Although there is no documentation reporting a failure or suspected leak in any of these tanks, real property records indicate they are more than 30 years old and there is no record of them being covered with cathodic protection or protective coatings when they were installed. Circumstantially, then, each of these tanks may be at or near the end of its effective use. Since no deliberate attempt has been made to characterize the integrity of any of these tanks, their continued use makes the possibility of an environmental release real but the likelihood of this happening unknown. Furthermore, the often saturated condition of the soils at this property can be expected to have aided corrosion of the tanks and associated plumbing.

- Develop and implement a permanent solution to the sewage-treatment problems.
- Remove and replace underground heating-oil tanks at all units on the property, sampling soils in all portions of the tank excavations to identify any possible areas of contamination.

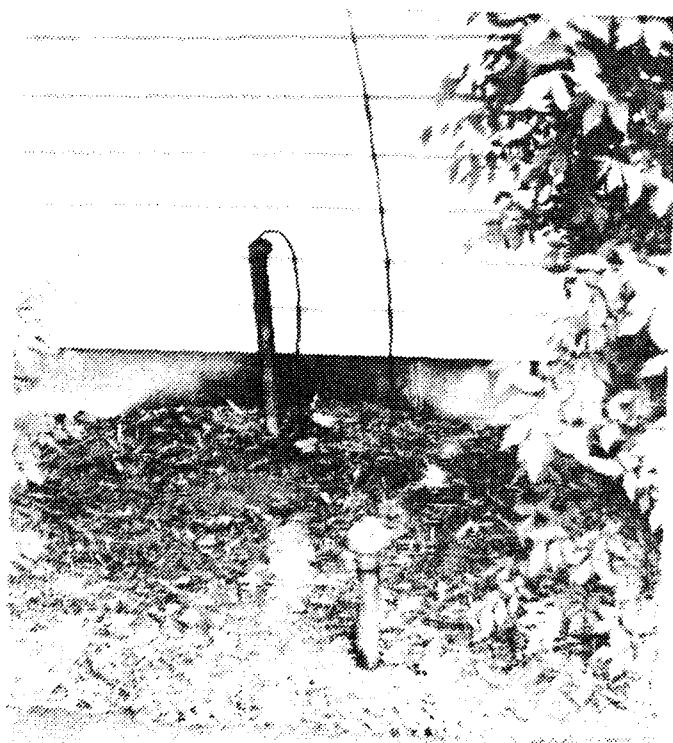
Each unit has a 275-gallon underground fuel tank in front of the house. The fill pipe is located in front of each house, and most areas around the pipe evidenced staining of the soils. Although no documentation was found to indicate failures or suspected leaks in any of these tanks, records manifest that the tanks date to the original construction and are thus more than 30 years old. Circumstantially then, potential environmental risk results from the continued use of these tanks.

Because the original heating-oil tanks are still in place underground at this property, and are assumed to be near or at the end of their expected useful life, it is recommended that all underground tanks be removed and replaced with new tanks. It is also recommended that soil tests be taken in all portions of the tank excavations to identify any contamination that may be present.
