## Enhanced Preliminary Assessment Report:

### Hull Army Housing Units Hull, Massachusetts

September 1989

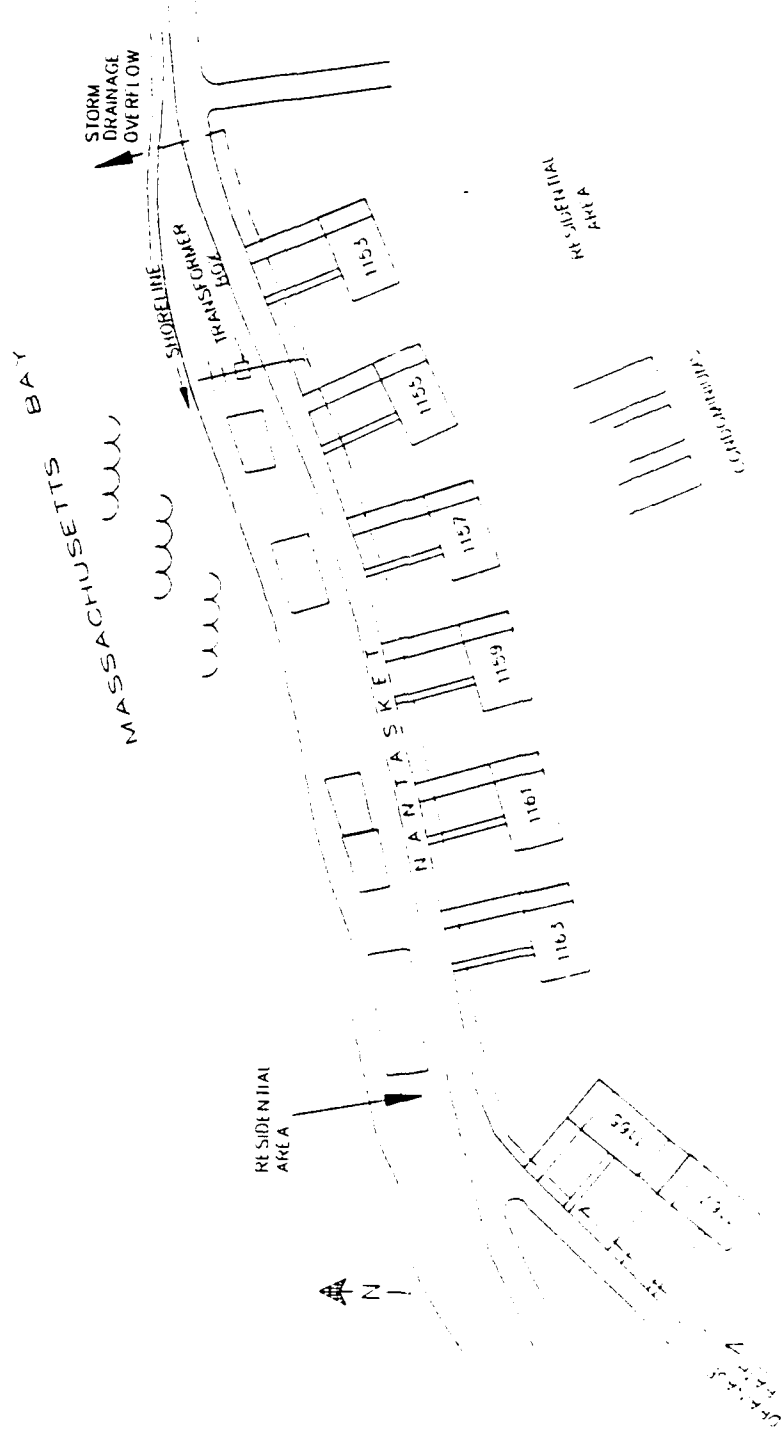
FIGURE 3 Site Plan Map of Hull Army Housing Units

Figure 3 presents the site plan of the housing property.

The Hull family housing facility, built in 1958, consists of eight "capehart" style houses situated along Stony Beach on Nantasket Avenue, in Hull, 0.1 kilometer from Massachusetts Bay.

"Capehart" is the model name assigned to these houses by the builder, National Homes. The capehart style houses include three bedrooms and a family unit, with carport and storage room. The houses are built on concrete slabs with walls of wood frame and asbestos shingle.<sup>3</sup> Water lines and air conditioning ducts are imbedded in the foundation slab.

The facility uses the town sewer system. Storm drains pass through the property behind the houses. Earlier reports indicate abandoned water and sewer lines also cross the rear of the property; there is no additional documentation regarding these lines, however.<sup>3</sup> Maintenance personnel could add no information regarding these lines. The facility receives municipal city power, with all poles, overhead lines, and transformer boxes owned the city of Hull. Locations of nearby municipal or private drinking water wells are not known. Solid wastes (garbage) are collected by a local contractor for disposal off-site.

The property is drained by open ditches and culverts to Massachusetts Bay.

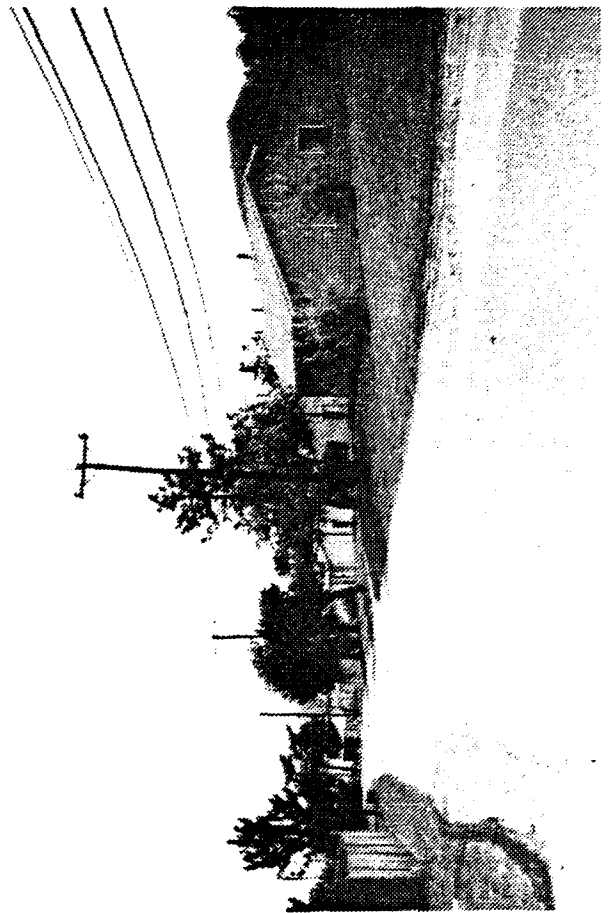
Upper left-hand photo:  
Housing units terraced along Nantasket Ave.

Lower right-hand photo:  
Front view of new siding and window casements.

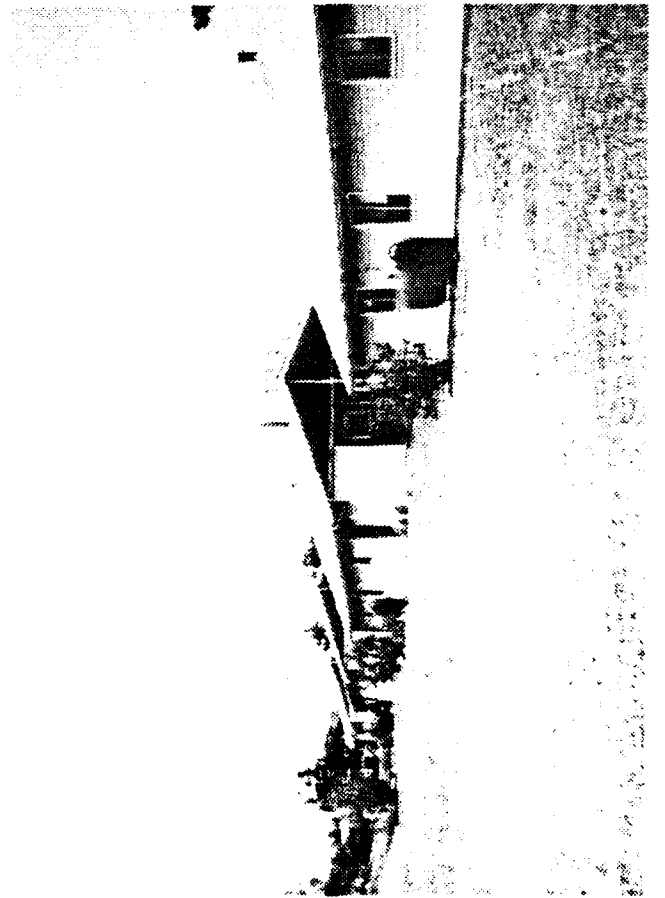
In October 1986, after all underground fuel oil tanks for the housing units had been removed, new 275-gallon above-ground tanks were installed at the rear of each of the houses.<sup>4</sup> There is no record of any prior environmental problem associated with the underground tanks. No leakage has been reported. However, no soil tests were made at the time of tank removals. A local contractor scrapped the old steel underground tanks in July 1986.<sup>5</sup> The Refrigerated Air Co. retains the heating maintenance contract for the Hull housing facility and is responsible for fuel oil deliveries as well.<sup>6</sup>

Lower right-hand photo:  
Rear view of house with 275-gallon aboveground heating oil tank.

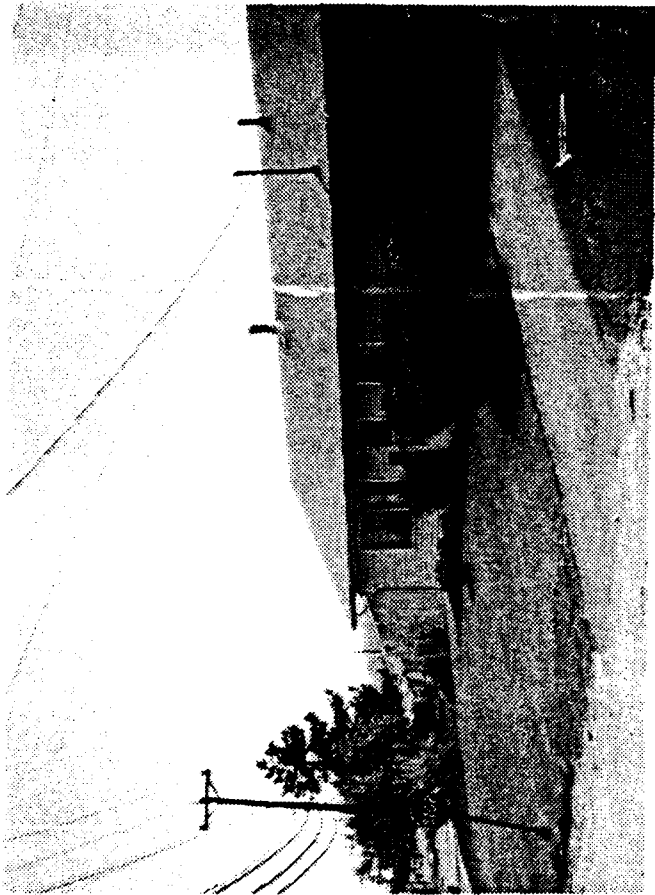
The site investigation revealed that vinyl siding was installed over the original asbestos siding of each house. The date of this action is not documented, but the Fort Devens Area Engineer's Office, Brockton, Mass., confirmed that this happened. It is

assumed that the siding was added for cosmetic reasons and that the original siding was still in good condition and left in place.

Upper right-hand photo:  
Front view of new siding and window casements.

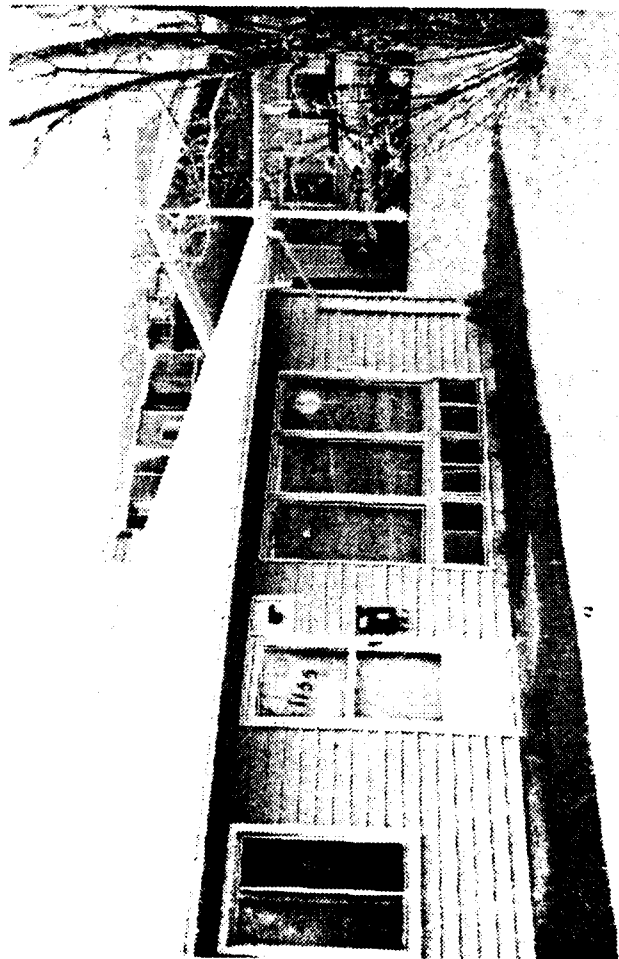
Lower right-hand photo:  
Front view of new siding and window casements.
