## ILS/MLS Comparison Tests at Miami/Tamiami, Florida Airport

July 1989

DOT/FAA/CT-TN89/39

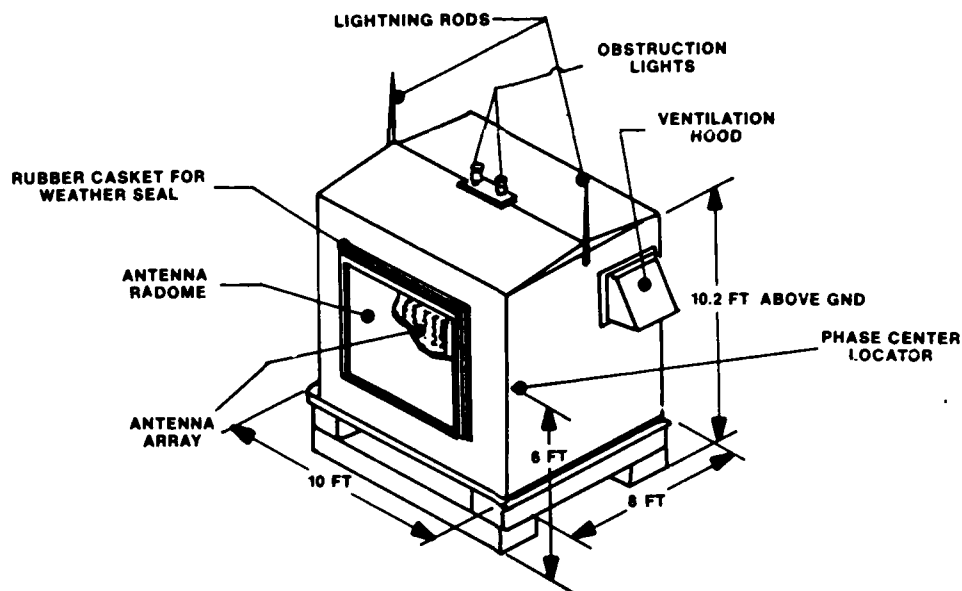
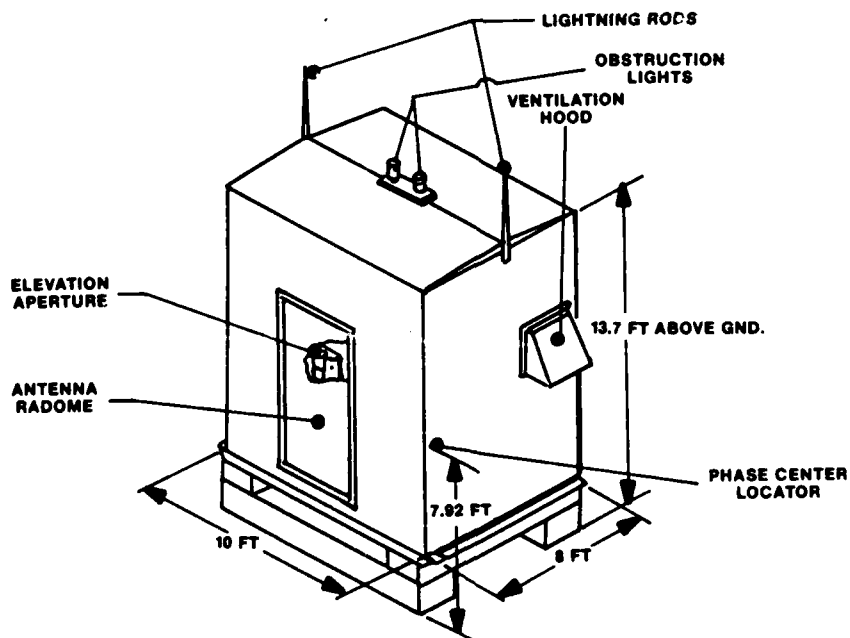
**SHELTERED CONFIGURATION  
AZIMUTH SUBSYSTEM**

**SHELTERED CONFIGURATION  
1.5° ELEVATION SUBSYSTEM**

FIGURE 1. DRAWING OF MLS AZIMUTH AND ELEVATION STATIONS

Tamiami Airport is located approximately 5 miles southwest of Miami and is operated by the Dade County Airport Department. The airport has very flat terrain and is a general aviation airport with very high traffic volume. The ILS, which consists of an 8-element log periodic localizer array and a null reference glide slope array, services runway 9R which is 5,000 feet in length and 150 feet wide. It is a category I commissioned facility. The Federal Aviation Administration (FAA) Technical Center Test Bed MLS, which consists of a Bendix 2° beamwidth azimuth station and a 1.5° beamwidth elevation station, was collocated with the ILS in accordance with the proposed amendments to attachment G to part I of the International Civil Aviation Organization (ICAO) Annex 10 for these tests. Figure 1 is a drawing of the MLS azimuth and elevation stations used in these tests.

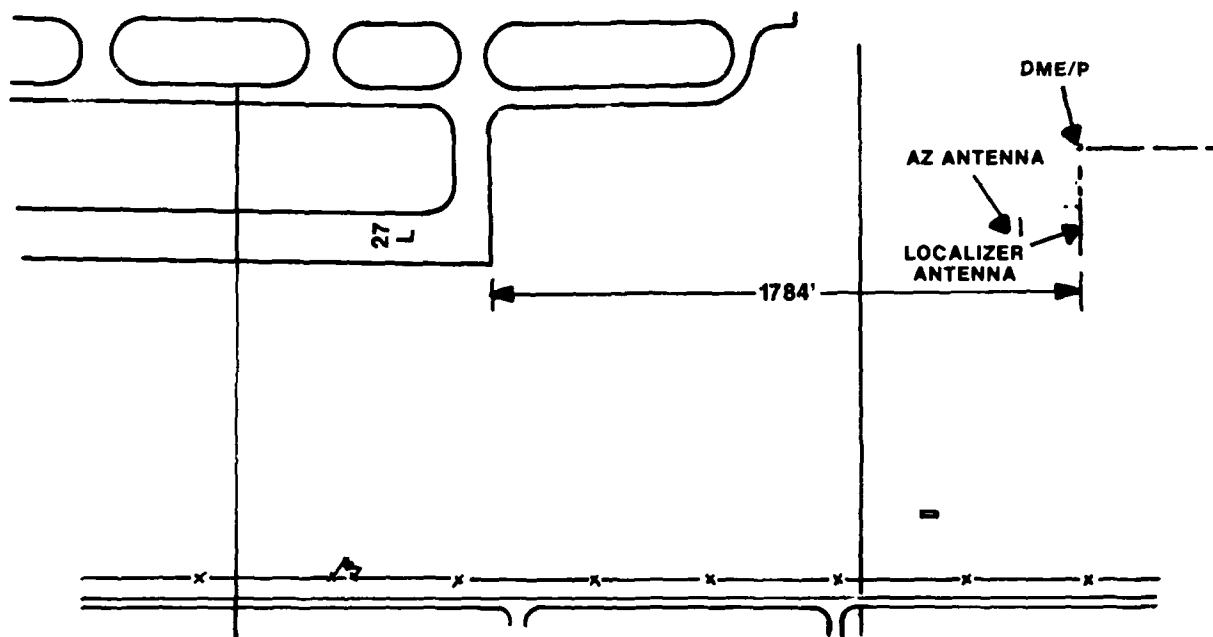
FIGURE 2. LOCALIZER AND AZIMUTH LOCATIONS

The localizer is sited, on the runway centerline extended, 1784 feet beyond the stop end of the runway. The MLS azimuth was installed with the rear of the shelter 200 feet in front of the localizer and was symmetrical about the centerline extended. Figure 2 is a drawing of the localizer and azimuth locations. The glide slope is sited 1025 feet back from threshold and 324 feet to the right (as seen by the pilot on an approach) of runway centerline. The elevation station was installed to place the front of the antenna 906 feet from threshold and 274 feet to the right of centerline. This location was to the runway side of a line from the glide slope antenna to the runway centerline at threshold and provided for coincident threshold crossing heights between the glide slope and elevation systems. Figure 3 shows the locations of the glide slope and elevation antennas.

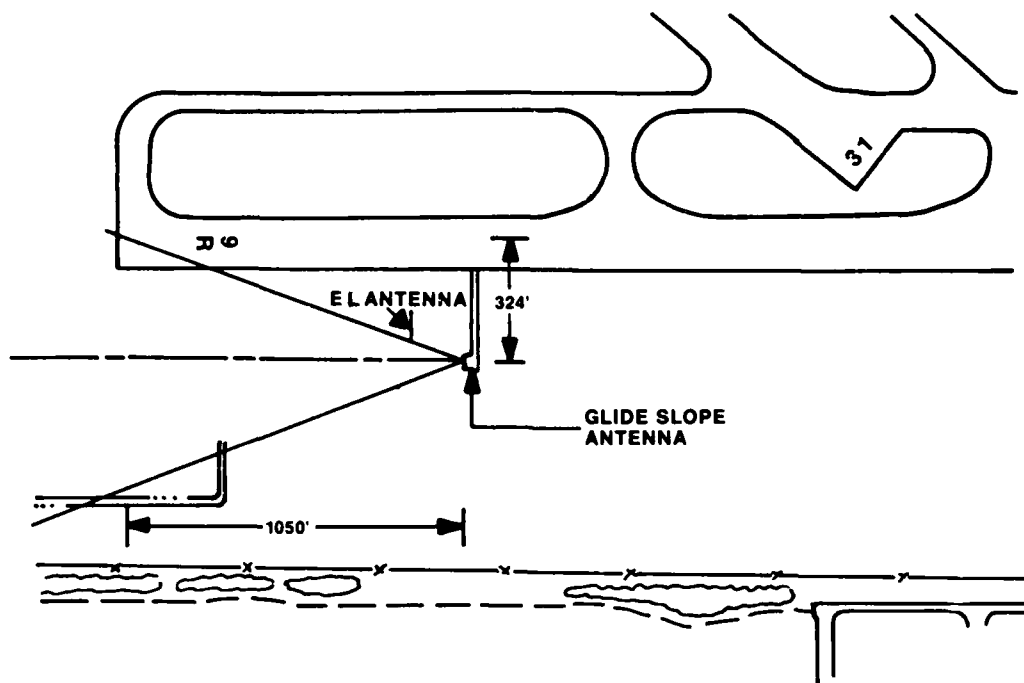
FIGURE 3. GLIDE SLOPE AND ELEVATION LOCATIONS

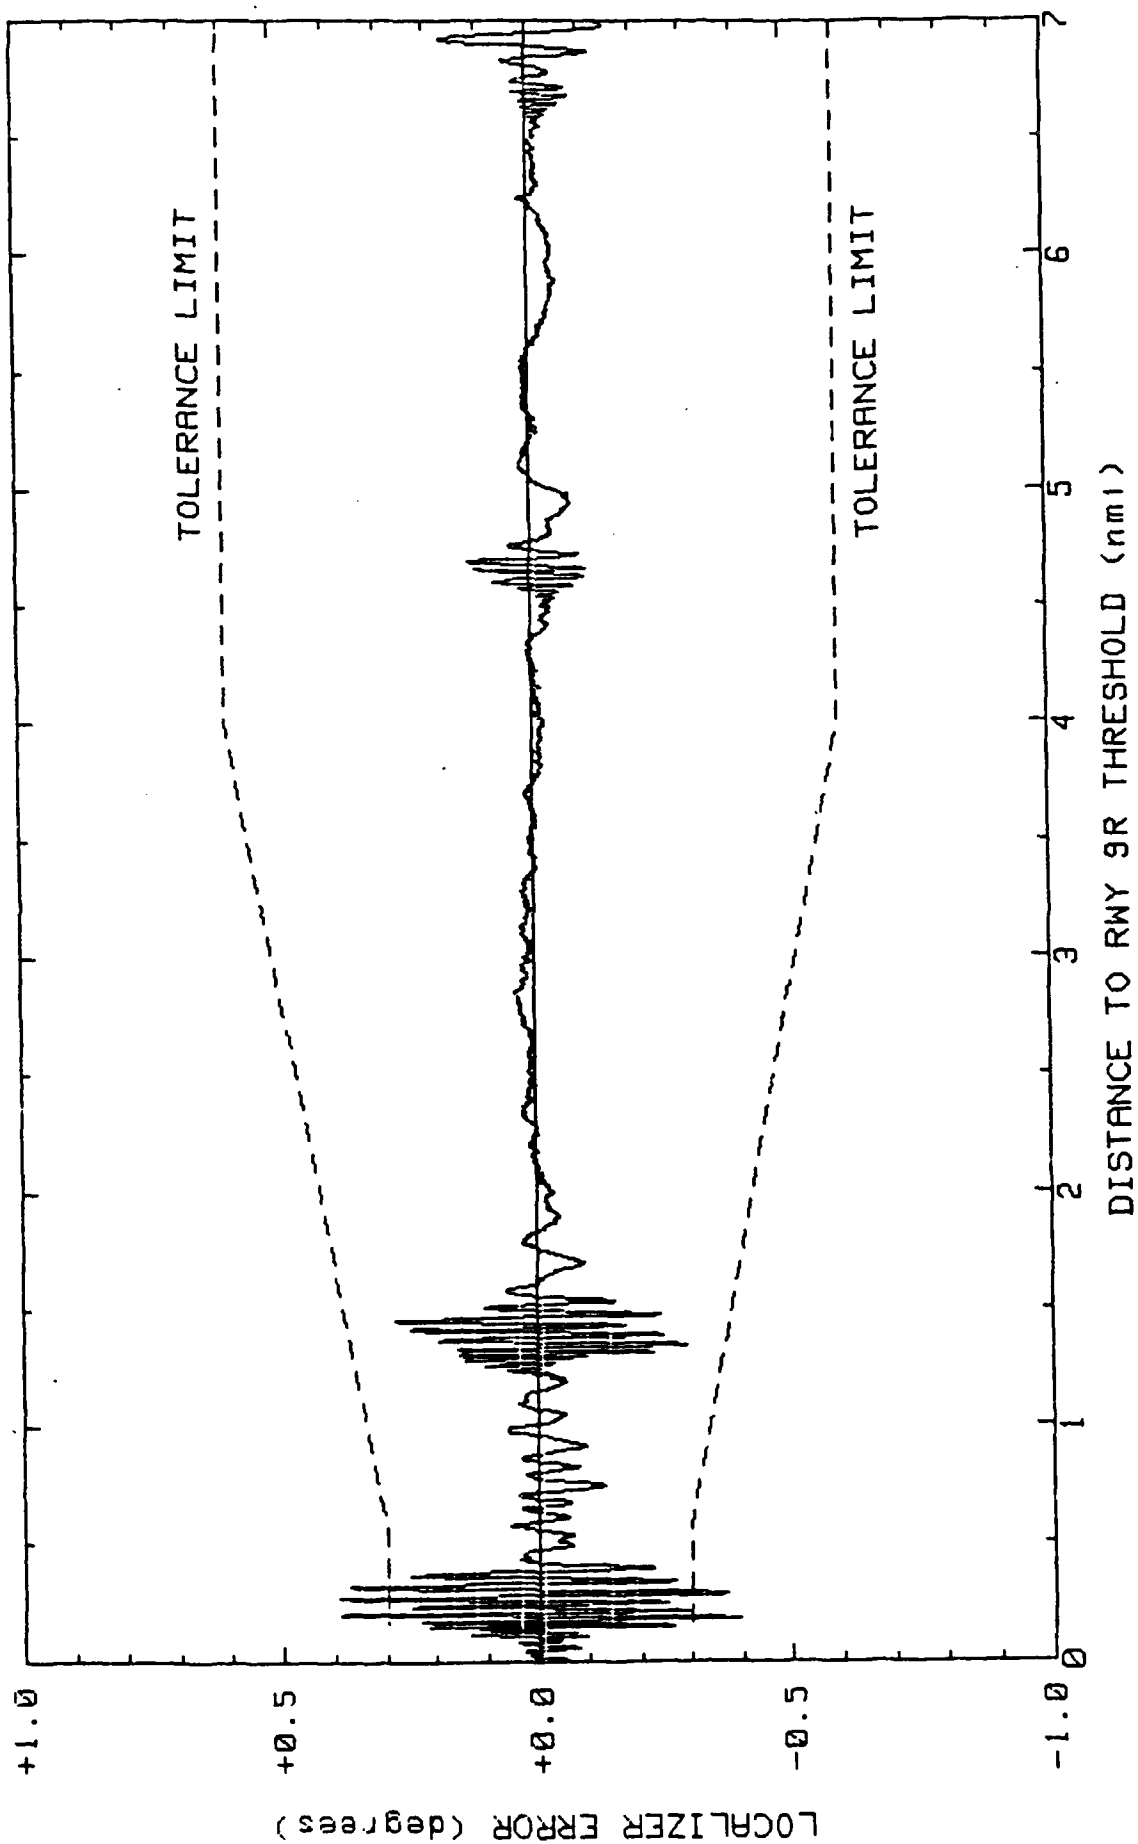
TAMiami, FL RUNWAY 9R LOCALIZER  
MLS AZIMUTH LOCATED 200' IN FRONT OF LOCALIZER

FIGURE 4. LOCALIZER ERROR PLOT FOR A CENTERLINE APPROACH

Figure 4 is a plot of the localizer error for a centerline approach. The error stays within the prescribed error limits, but the rapid high frequency oscillations at 0.5, 1.5, 4.5, and 7.0 miles are caused by other aircraft flying between the localizer and the test aircraft (overflight interference). In addition, there is a lower frequency scalloping effect on the signal from 2 miles to threshold. Figure 5 is a plot of the raw MLS azimuth data for the same approach. It is obvious from the data that the MLS is unaffected by the overflight interference and does not have any scalloping. The tolerance limits on the MLS data are those for the PFE filtered data and are for reference only. Figures 6 (localizer) and 7 (azimuth) are the raw error traces from a second approach with the same trends evident. There is overflight interference on the localizer at 4 and 6 miles and scalloping in the final 2 miles, while the azimuth signal is unaffected by the overflight interference and shows no scalloping.

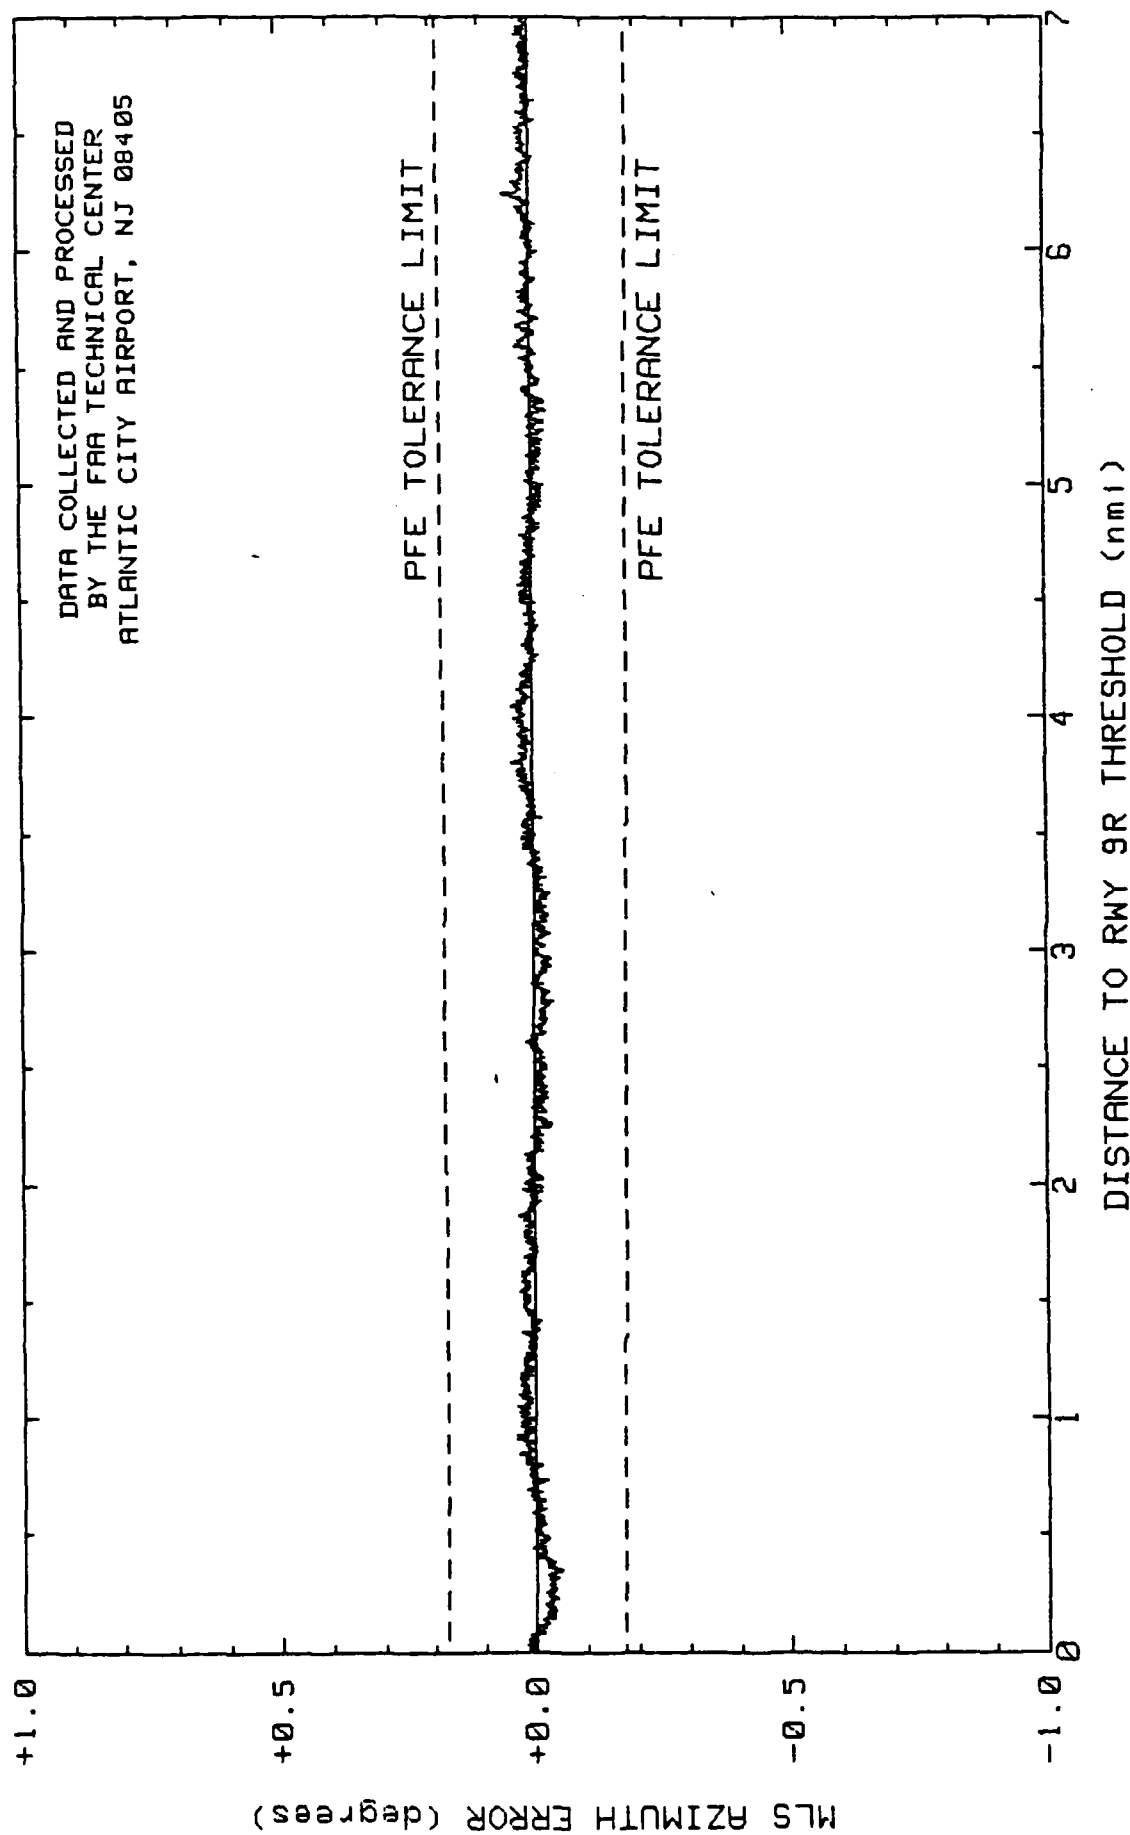
# TAMiami, FL RUNWAY 9R MLS AZIMUTH MLS AZIMUTH LOCATED 200' IN FRONT OF LOCALIZER

FIGURE 5. AZIMUTH RAW ERROR PLOT FOR A CENTERLINE APPROACH

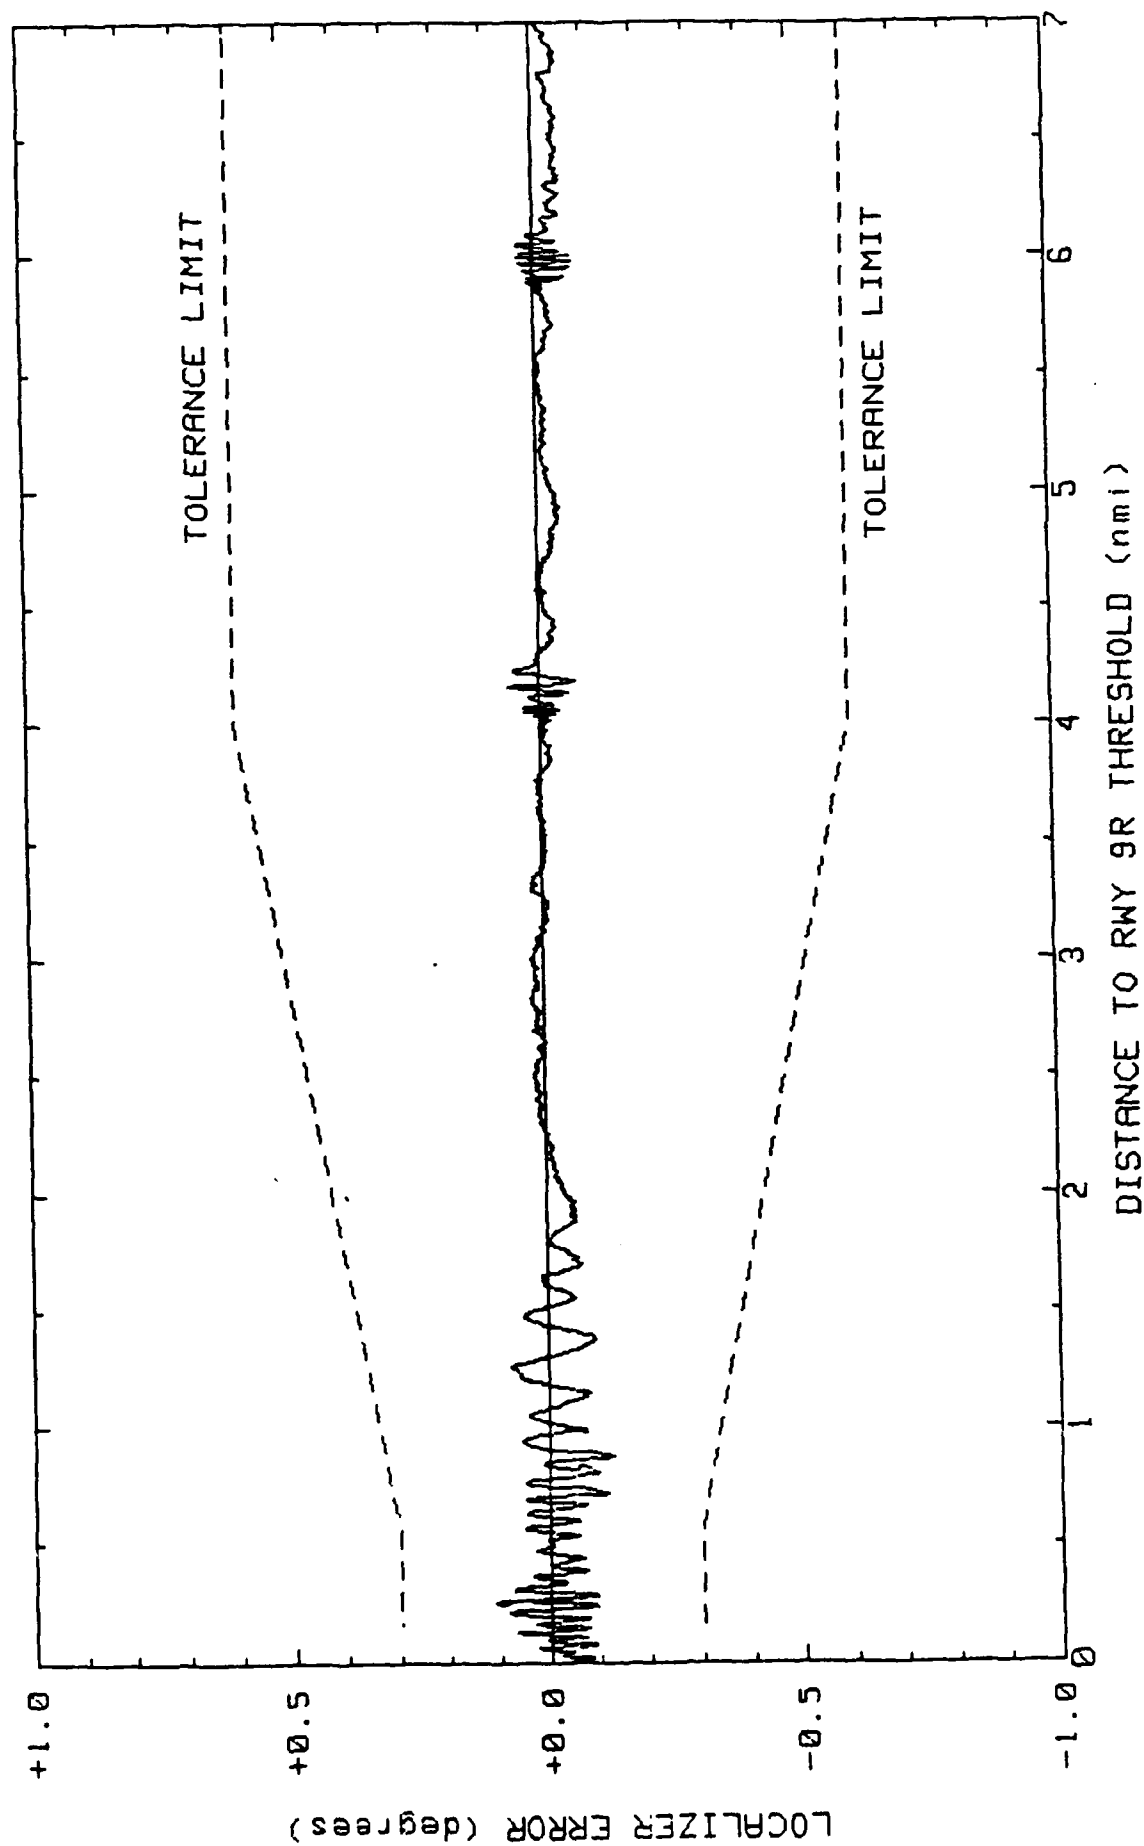
TAMIAI, FL RUNWAY 9R LOCALIZER  
 MLS AZIMUTH LOCATED 200' IN FRONT OF LOCALIZER

FIGURE 6. LOCALIZER ERROR PLOT FOR A SECOND CENTERLINE APPROACH

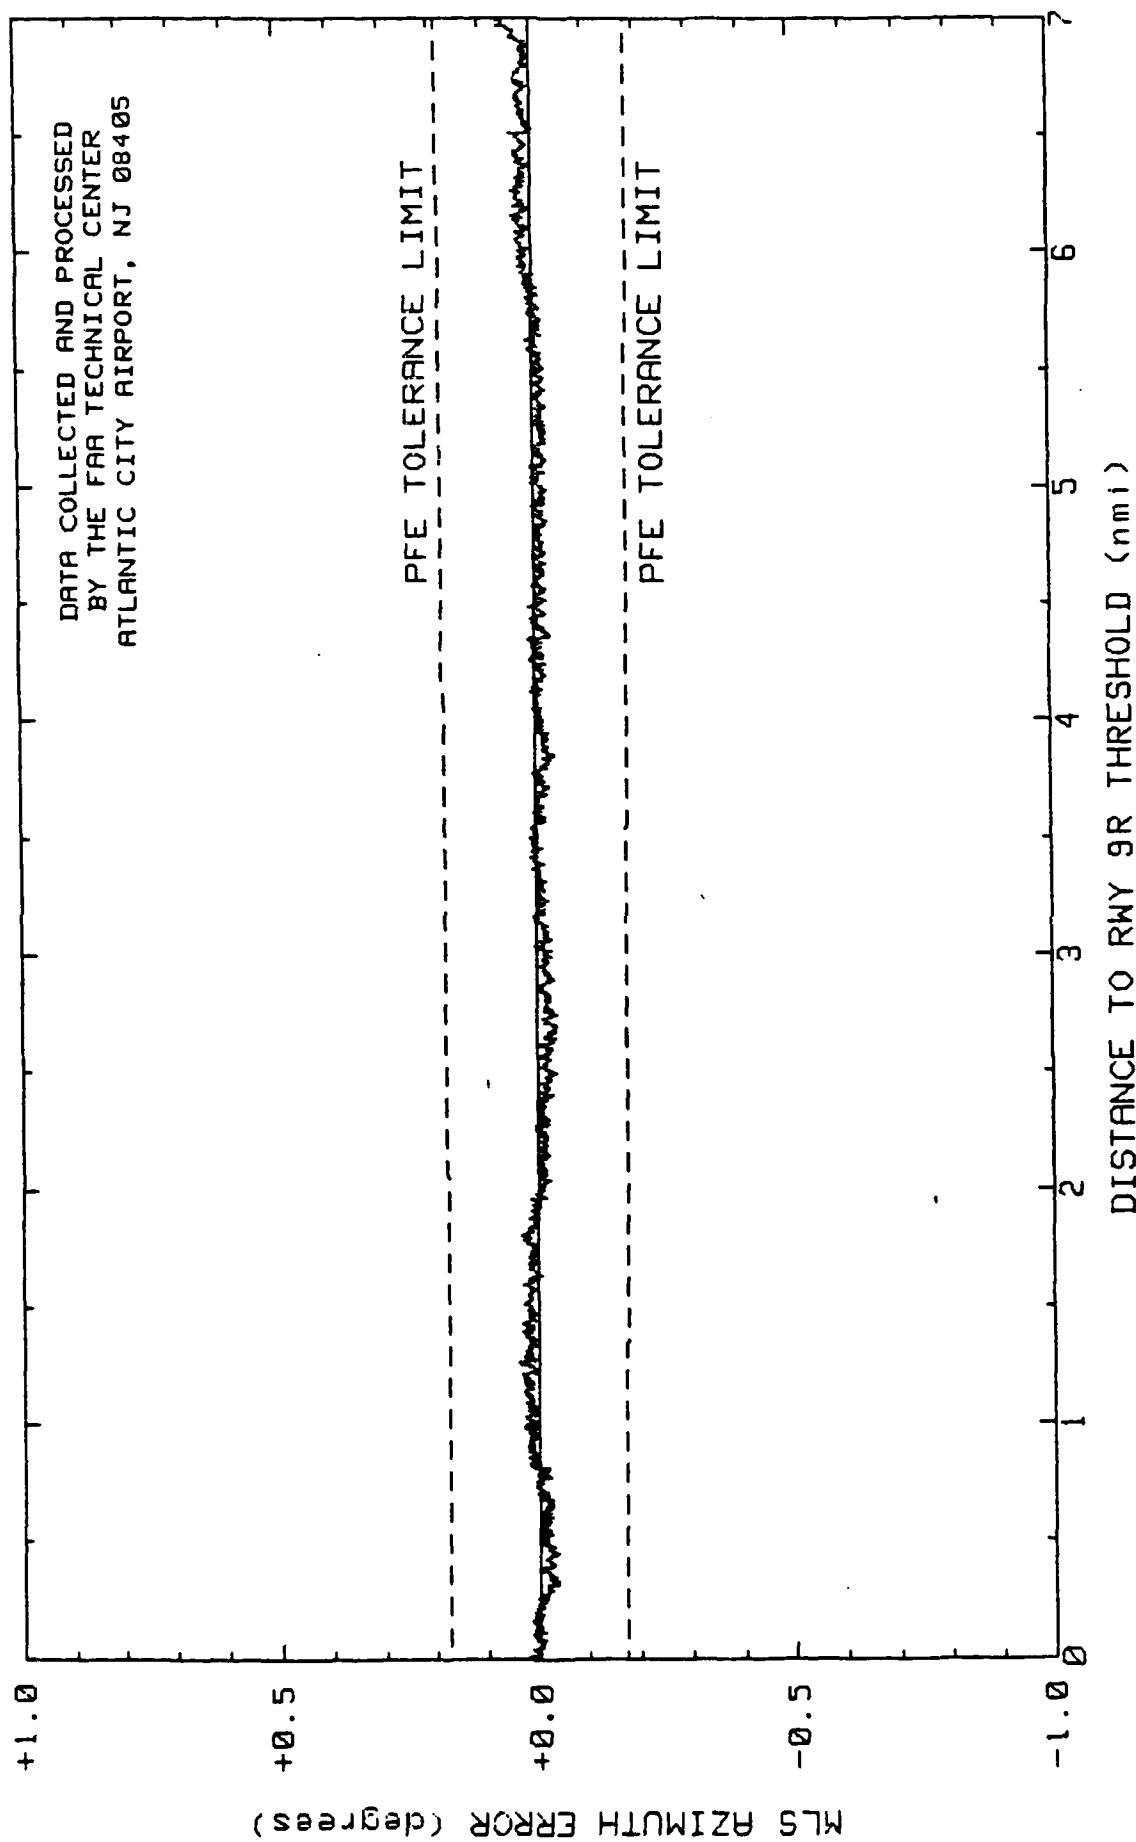
TAMiami, FL RUNWAY 9R MLS AZIMUTH  
MLS AZIMUTH LOCATED 200' IN FRONT OF LOCALIZER

FIGURE 7. AZIMUTH RAW ERROR PLOT FOR A SECOND CENTERLINE APPROACH

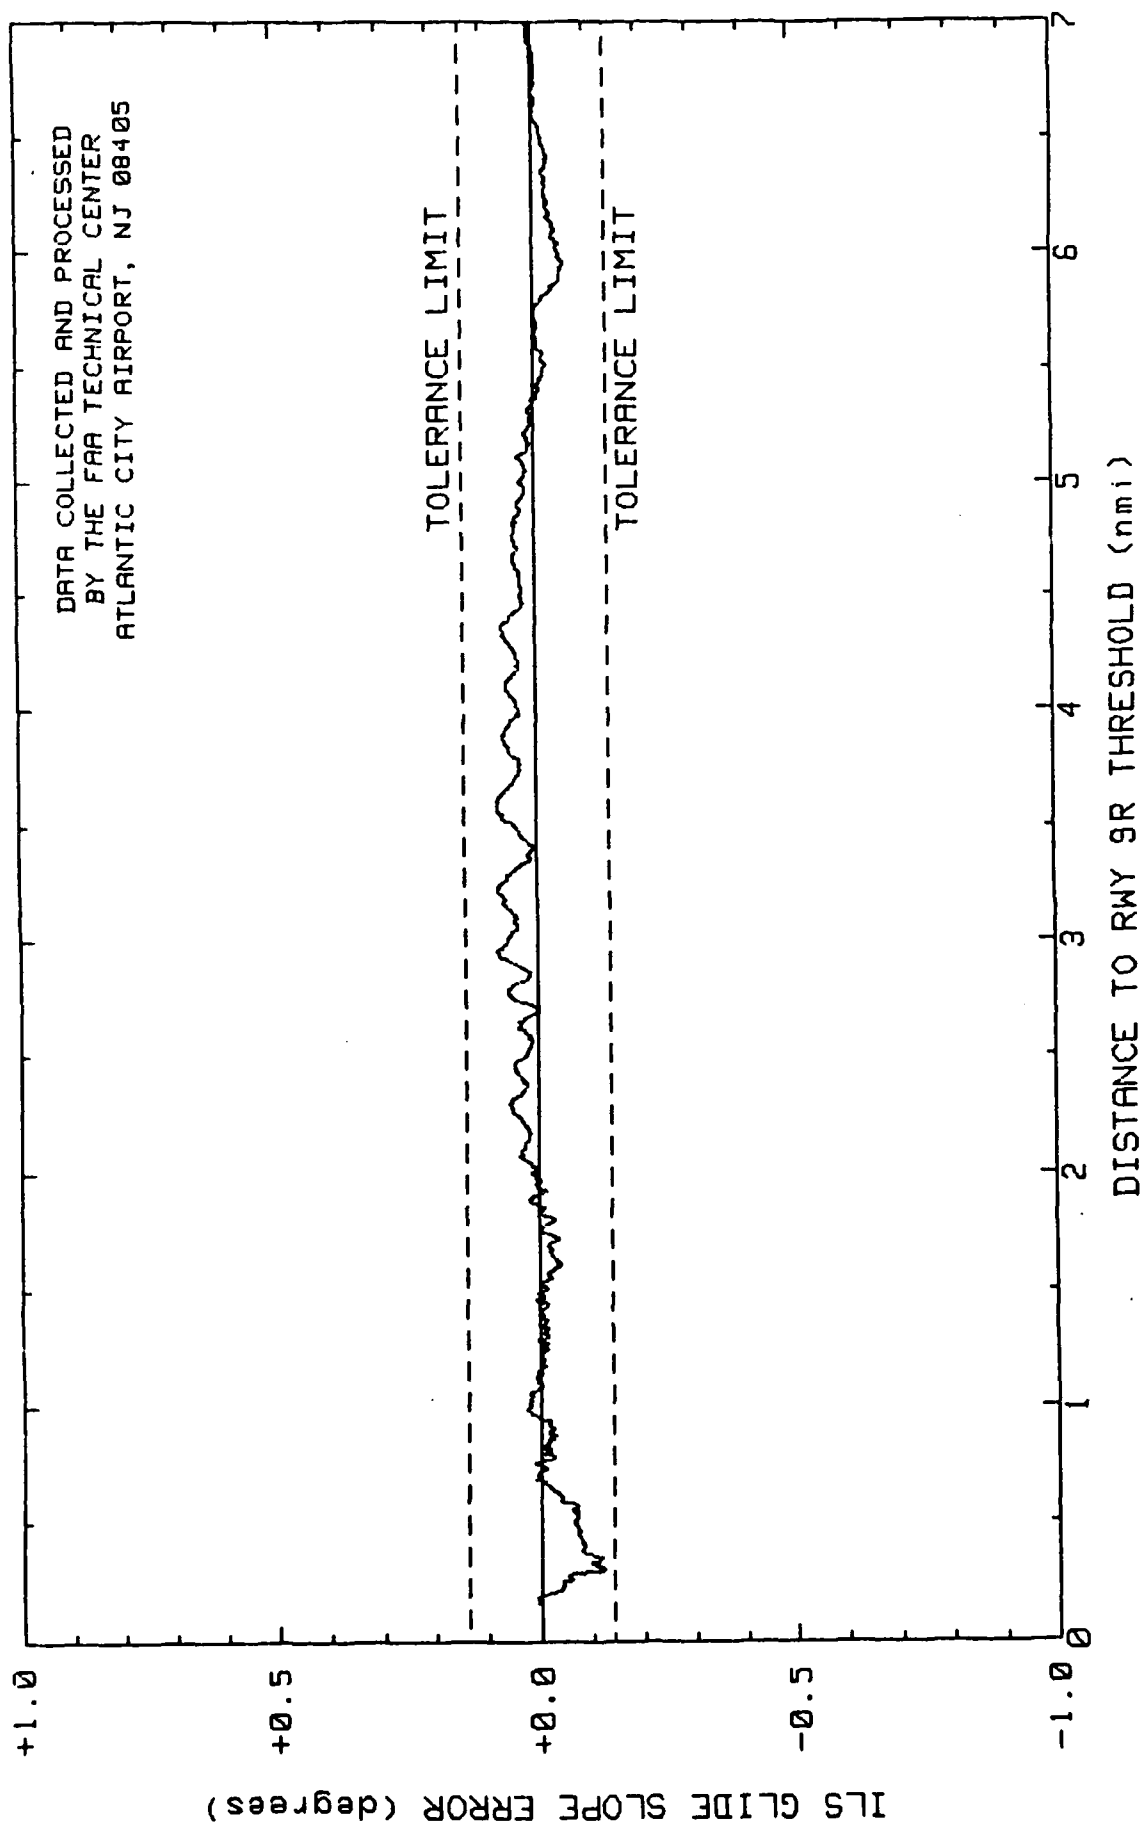
TAMiami, FL RUNWAY 9R ILS GLIDE SLOPE  
MLS ELEVATION LOCATED IN FRONT OF GLIDE SLOPE

FIGURE 8. GLIDE SLOPE ERROR PLOT FOR A CENTERLINE, 3° APPROACH

Figure 8 is the glide slope raw error trace from an approach while figure 9 is the MLS elevation raw error from the same approach. The elevation signal has less scalloping and fewer course bends than the glide slope. Figures 10 (glide slope) and 11 (elevation) are raw error traces from a second approach and show the same trends as the first approach.

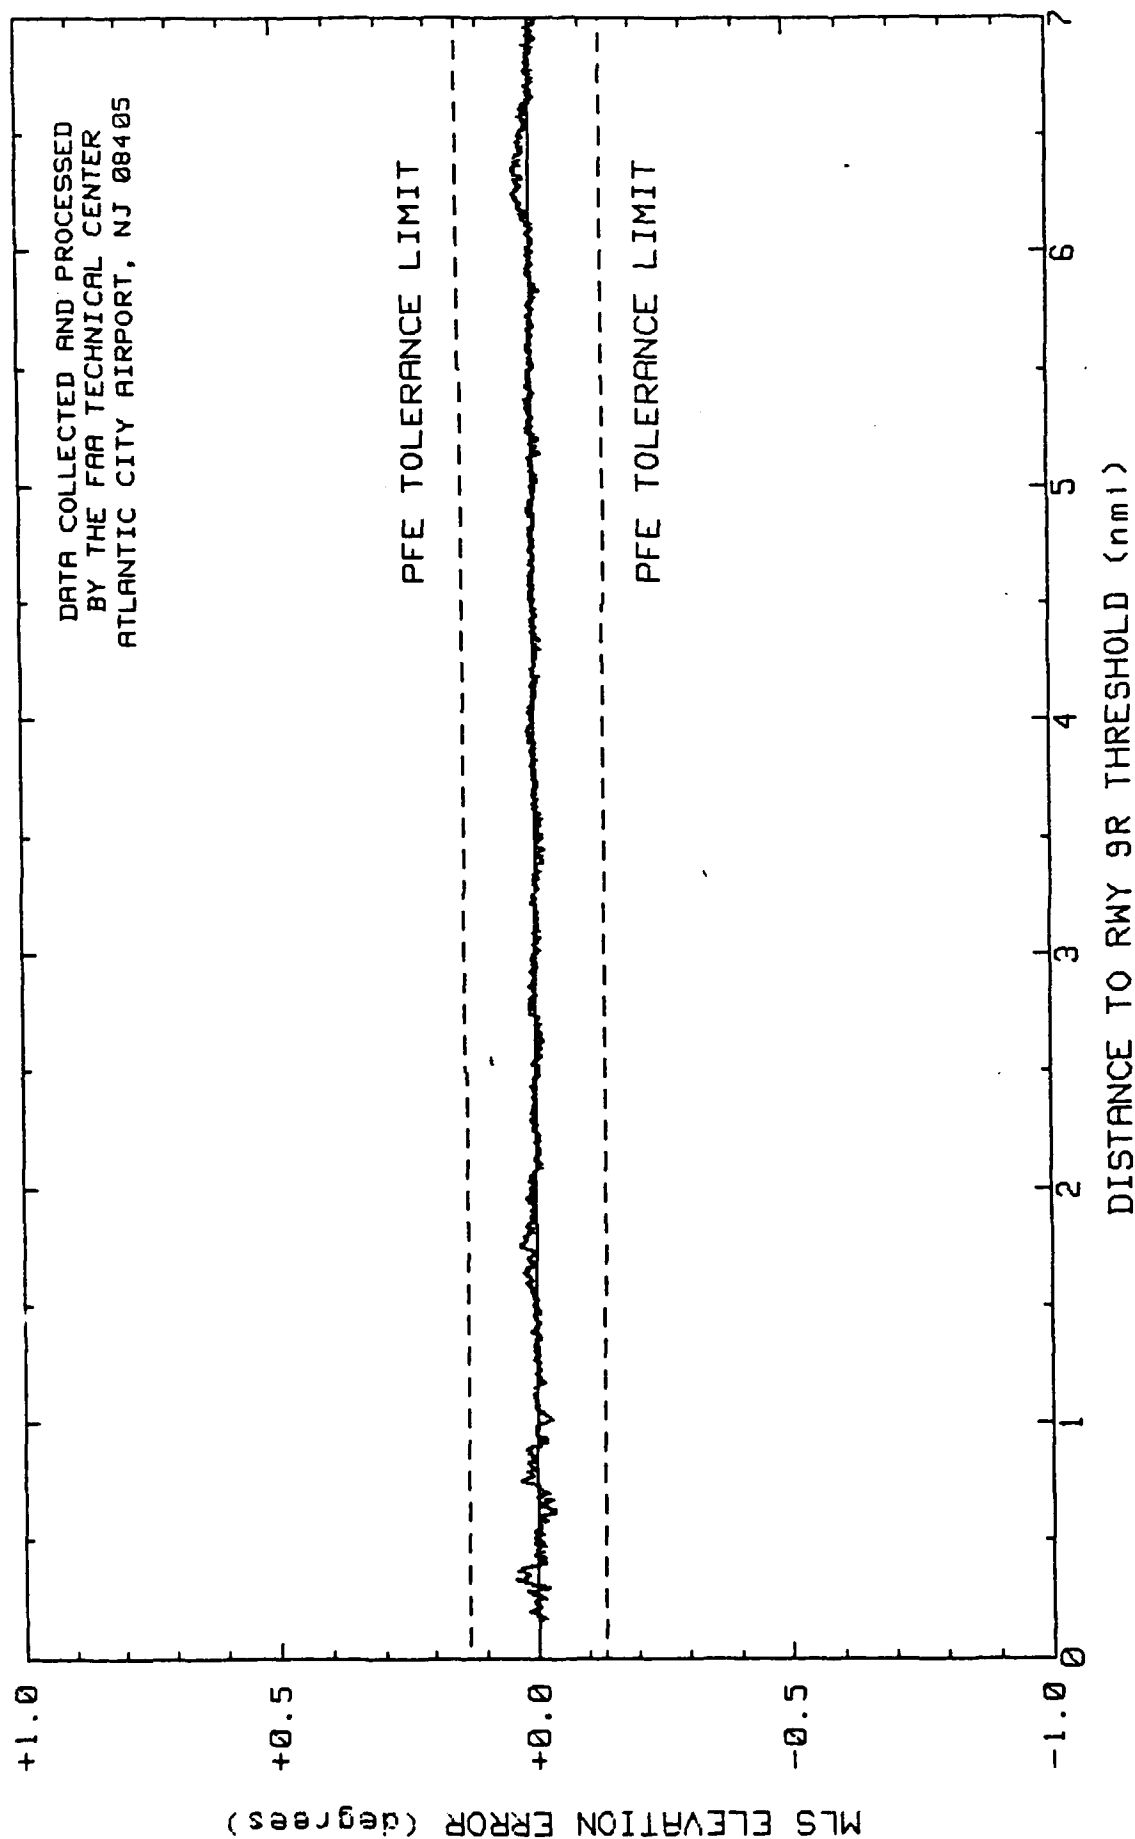
# TAMiami, FL RUNWAY 9R MLS ELEVATION MLS ELEVATION LOCATED IN FRONT OF GLIDE SLOPE

FIGURE 9. ELEVATION RAW ERROR PLOT FOR A CENTERLINE, 3° APPROACH

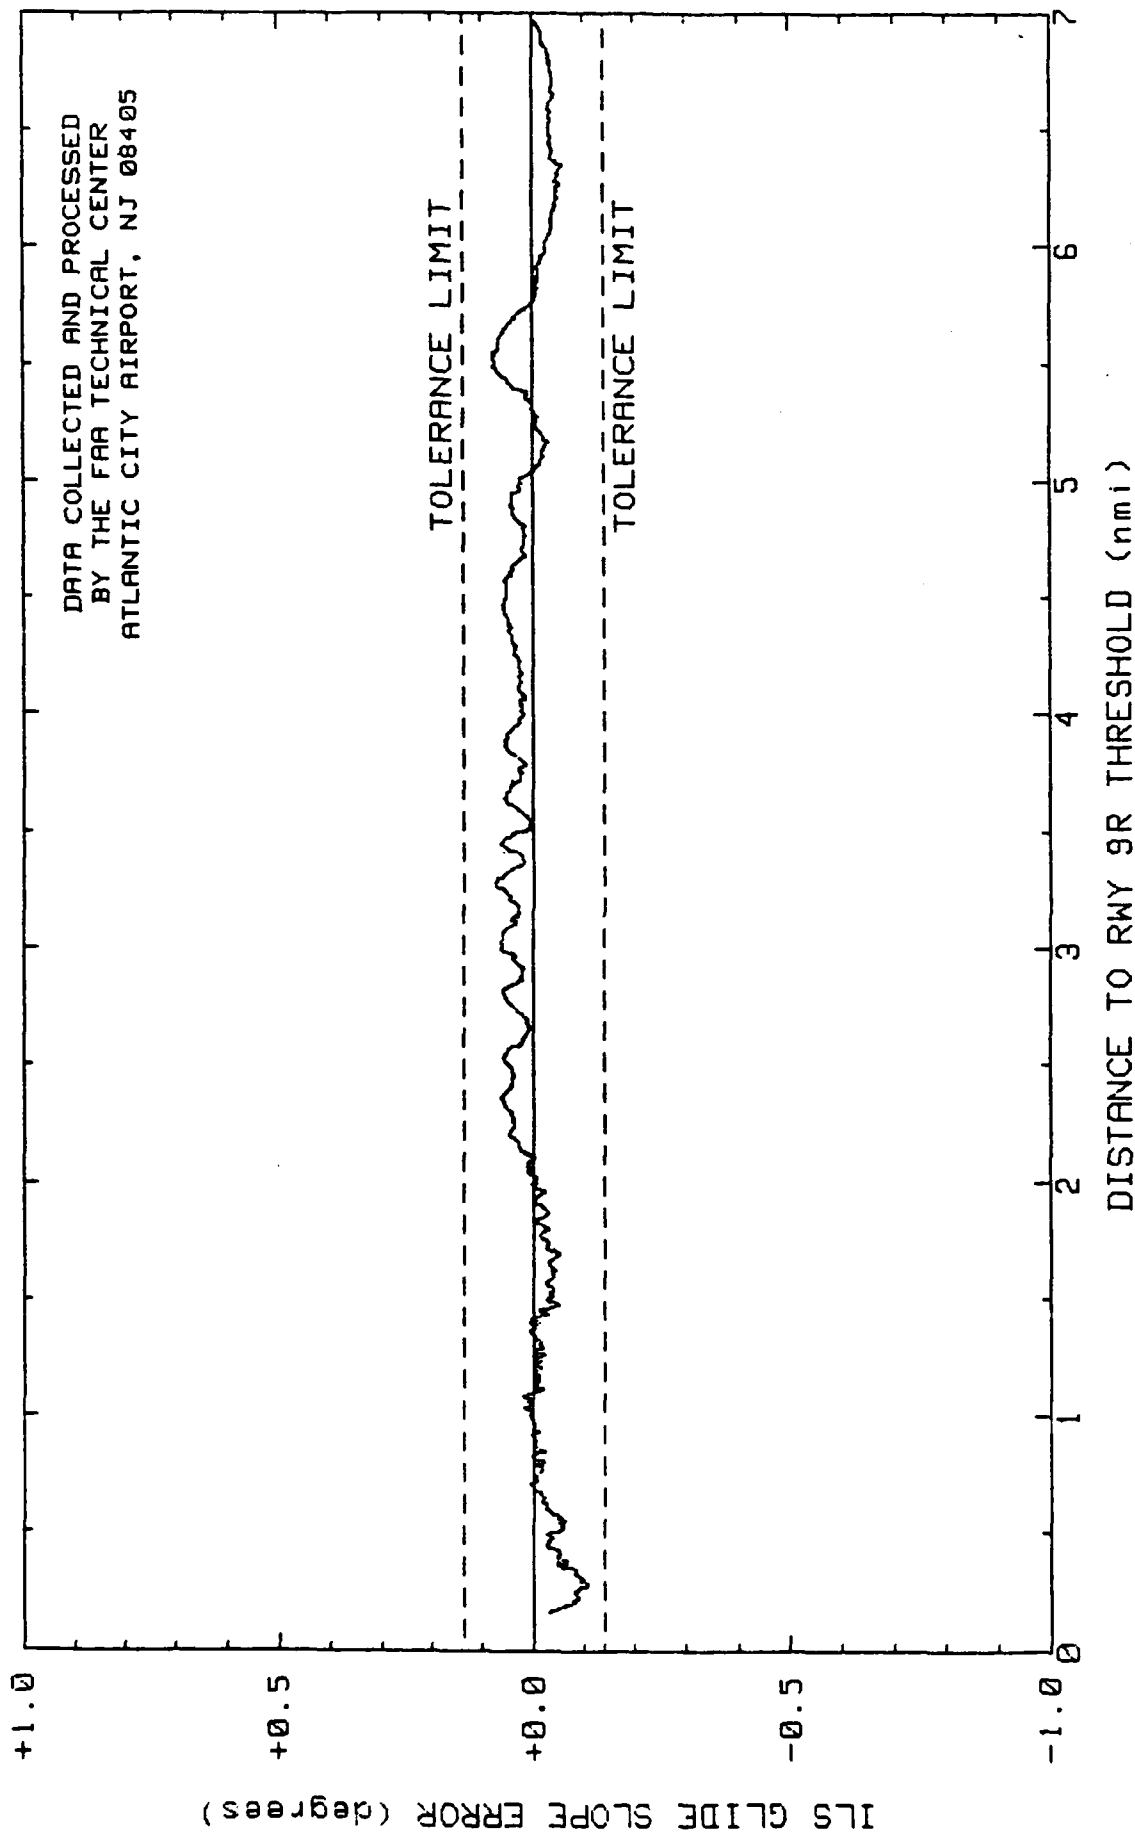
# TAMiami, FL RUNWAY 9R ILS GLIDE SLOPE MLS ELEVATION LOCATED IN FRONT OF GLIDE SLOPE

FIGURE 10. GLIDE SLOPE ERROR PLOT FOR A SECOND CENTERLINE, 3° APPROACH

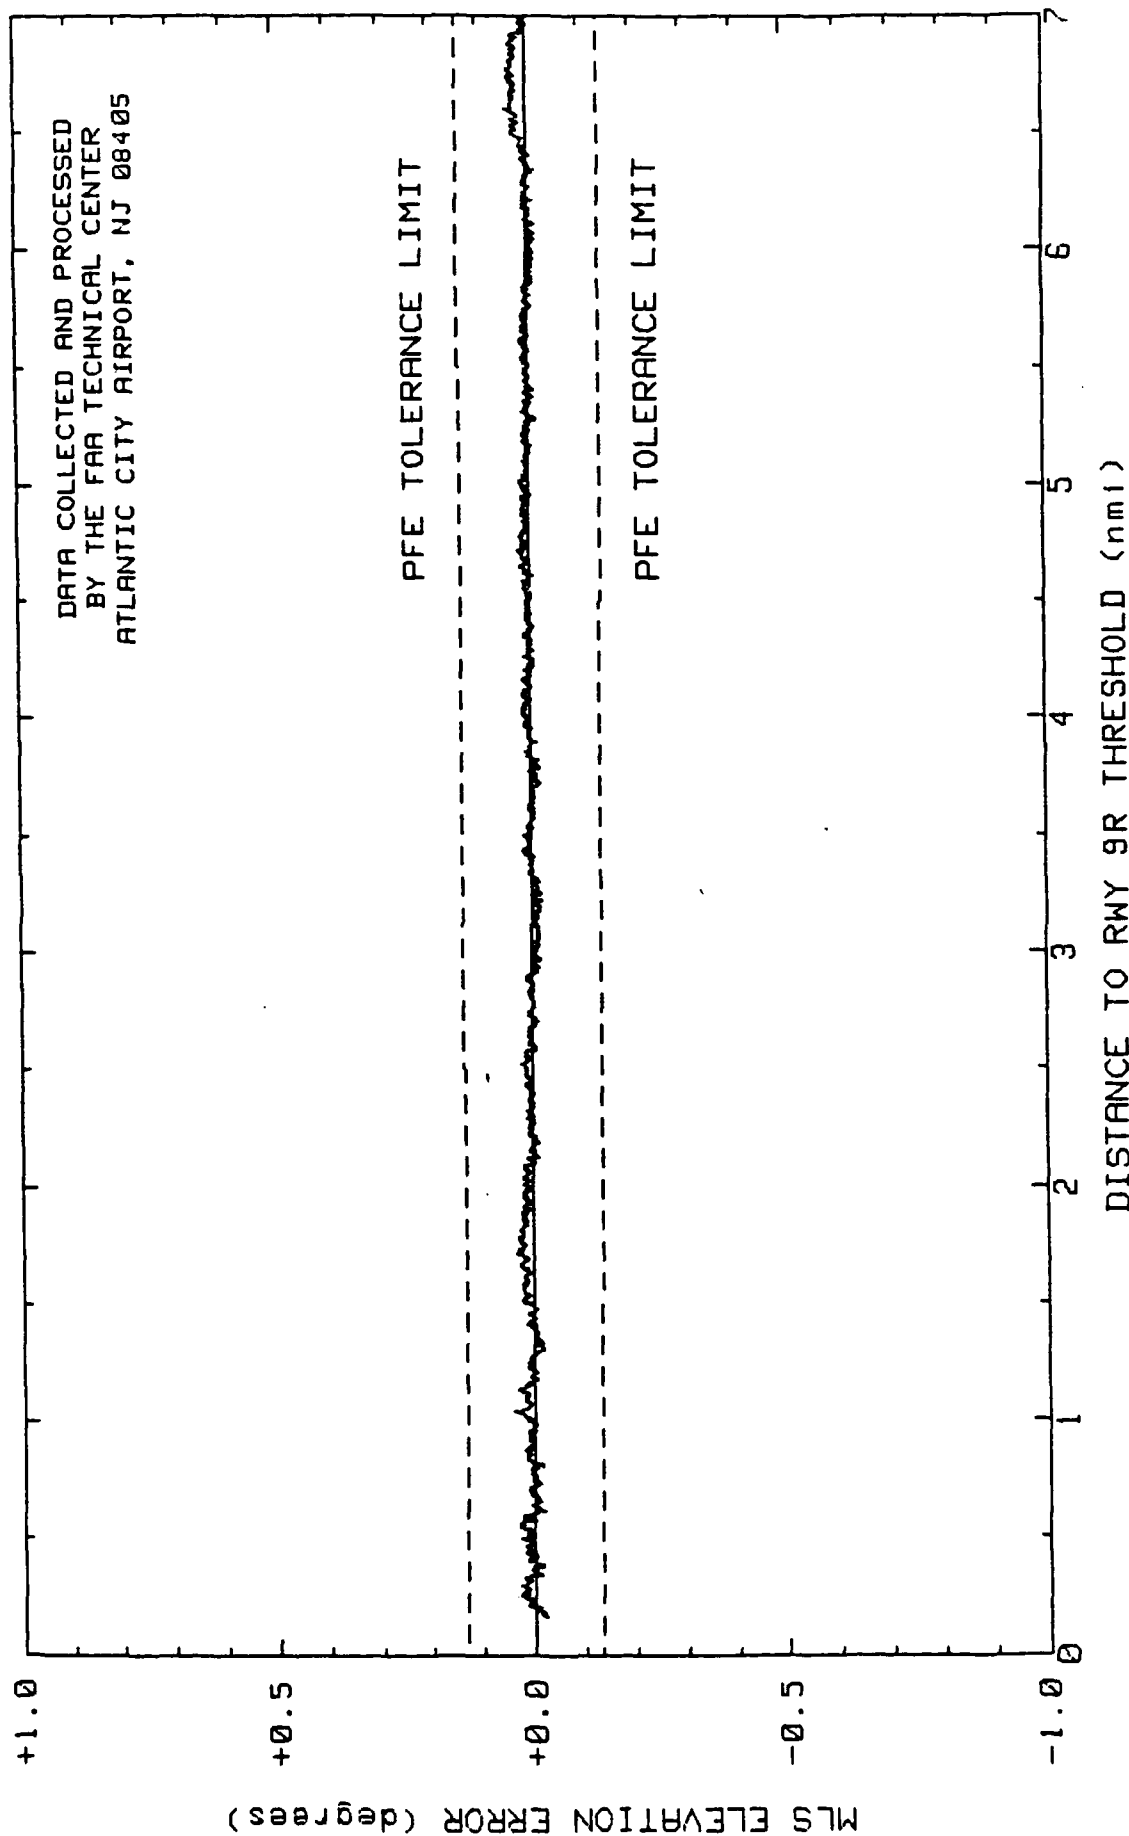
# TAMiami, FL RUNWAY 9R MLS ELEVATION MLS ELEVATION LOCATED IN FRONT OF GLIDE SLOPE

FIGURE 11. ELEVATION RAW ERROR PLOT FOR A SECOND CENTERLINE, 3° APPROACH
