EVT 1-88

TRANSPORTABILITY TESTING OF  
LIGHT ARMORED VEHICLE-LOGISTICS (LAV-L)

| REPORT DOCUMENTATION PAGE | | | | Form Approved<br>OMB No. 0704-0188 | |
|---|---|---|---|---|---|
| 12. PERSONAL AUTHOR(S)<br>J. H. Krohn | | | | | |

U.S. ARMY DEFENSE AMMUNITION CENTER AND SCHOOL  
Evaluation Division  
Savanna, IL 61074-9639

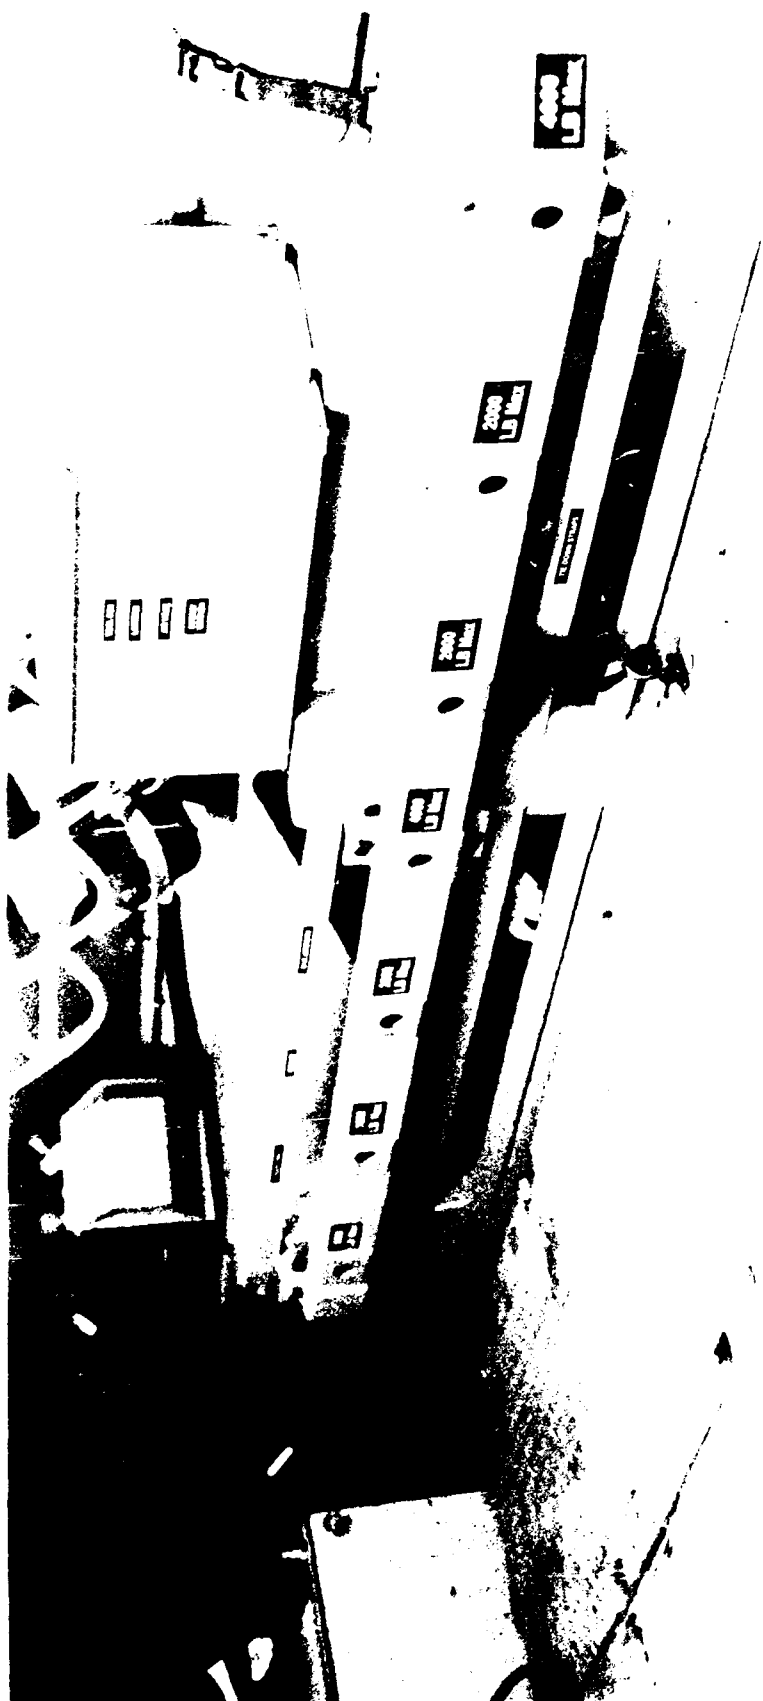
Photo 3. View of the cargo carrying compartment of the LAV-L showing the web strap attachment points on the floor and wall with the ratings of the various points. Note the type of fixture on the ends of the six tiedown straps issued with the LAV-L.

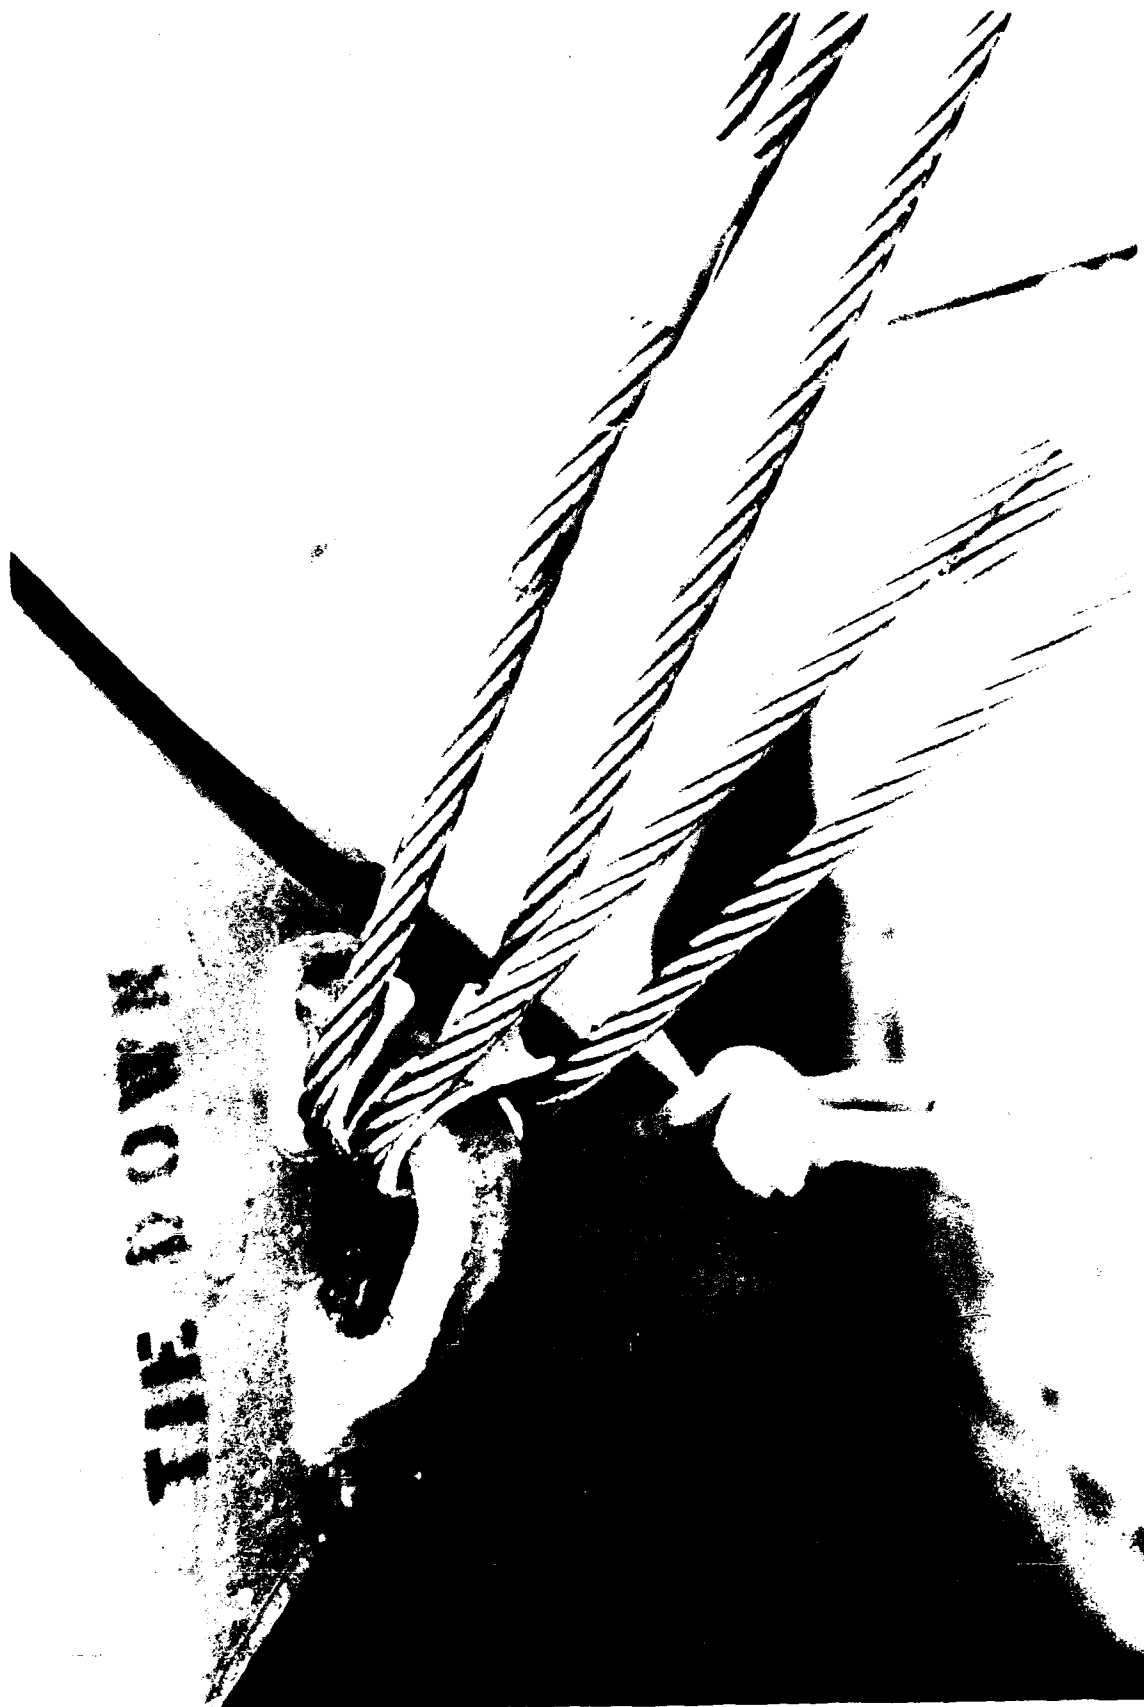
Photo 10. View of LAV-L tiedown provision used in retest. Note the location of the previous test clevis tiedown.

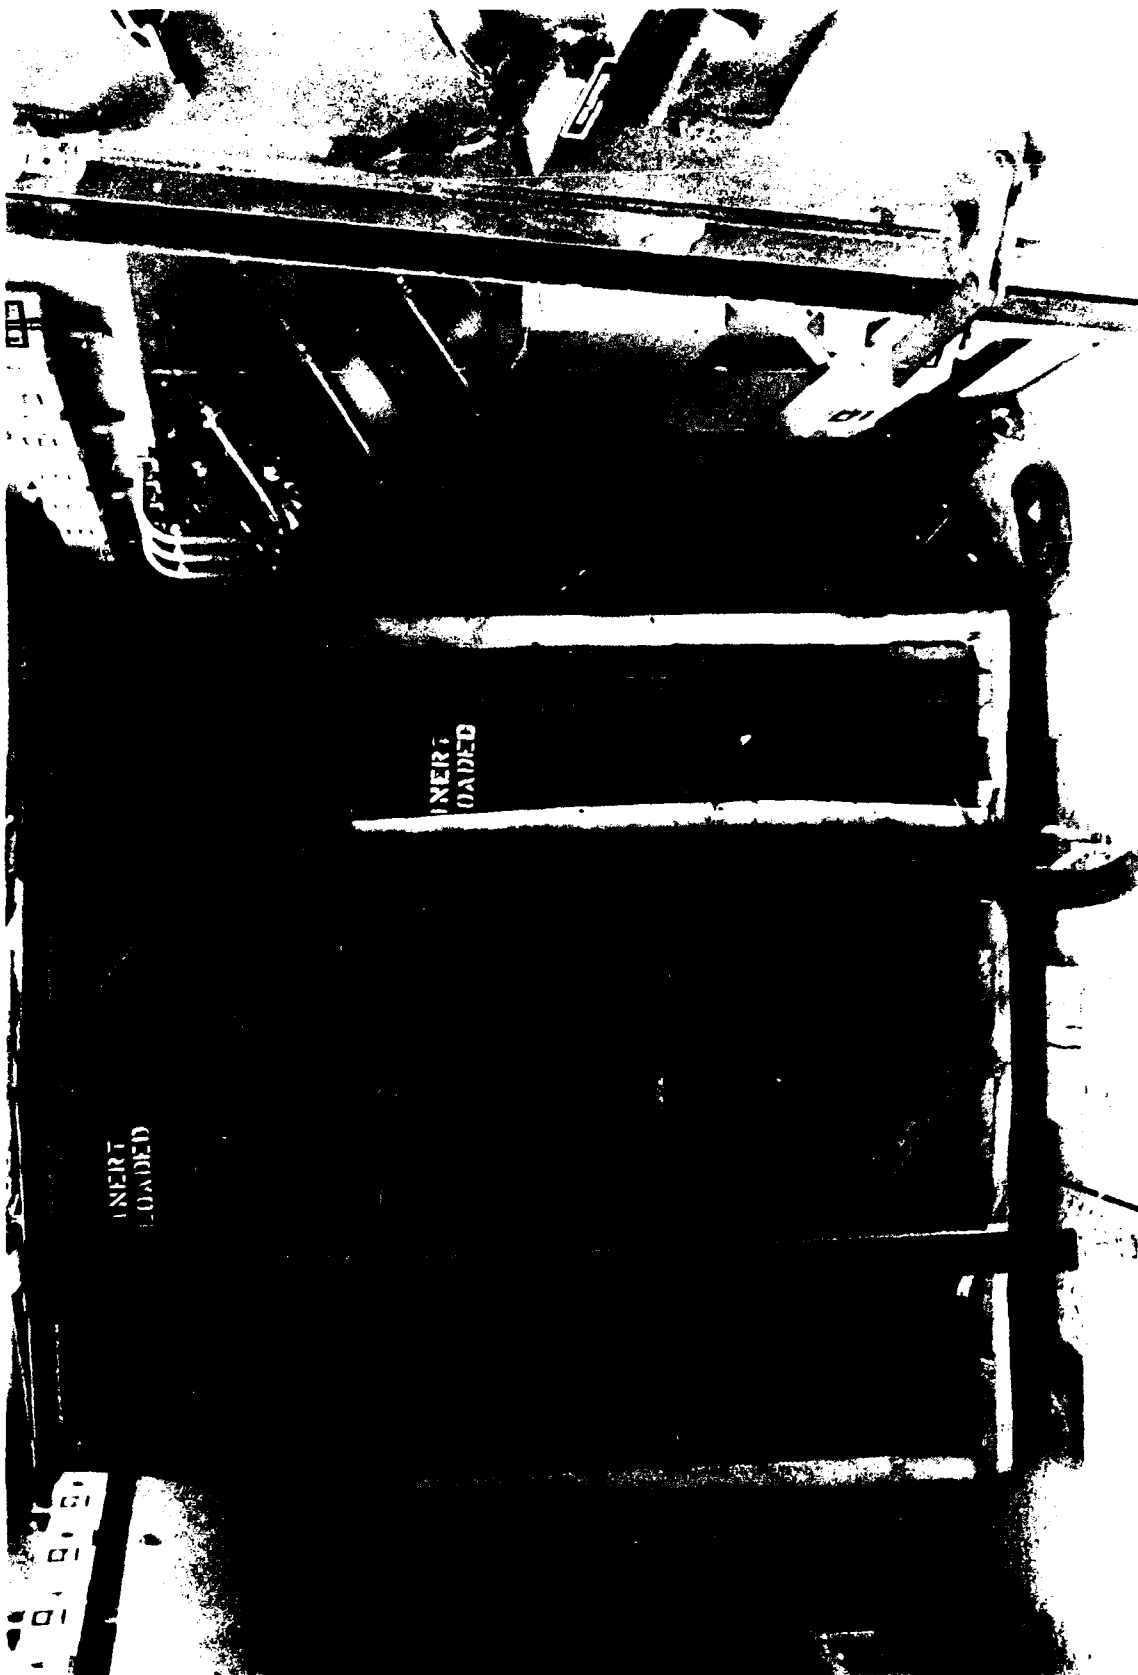
Photo 19. View of the 4,000-pound pallet secured in the cargo area of the LAV-L prior to the rail impact test.
