SUMMARY OF REVEGETATION WORK ON DREDGED MATERIAL SITES

IN THE ST. PAUL DISTRICT, CORPS OF ENGINEERS

Robert Anfang, St. Paul District, Corps of Engineers

May 1989

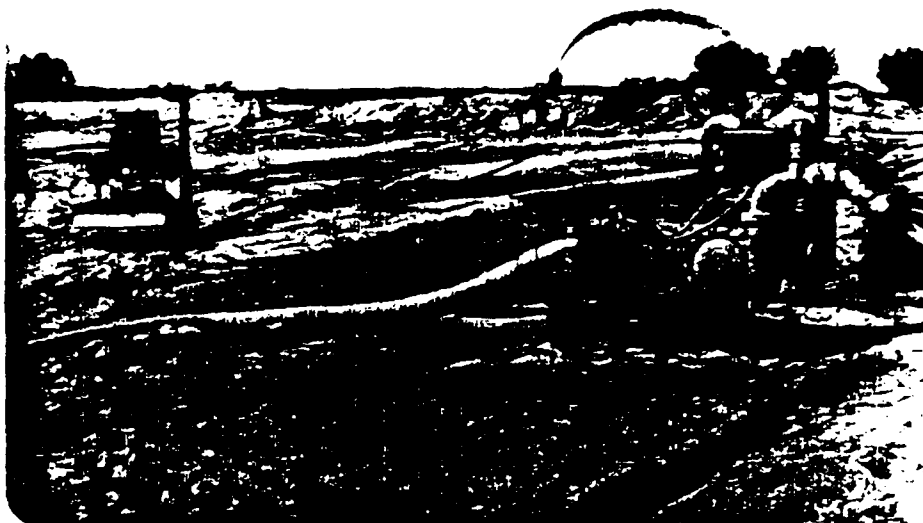
Chopper pump with sprinkler in background.

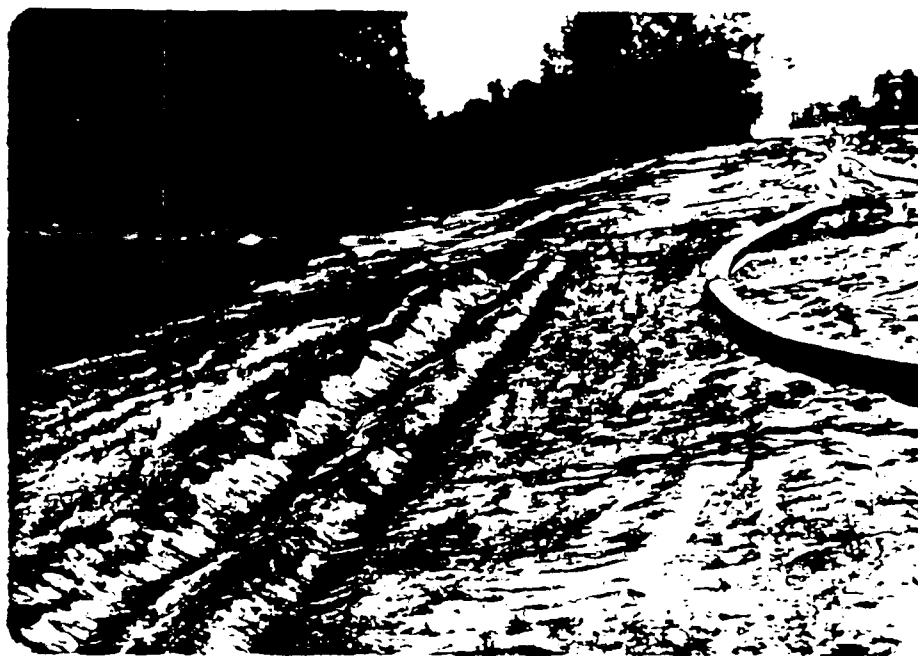
Side slope with and without furoughs created by bulldozer blade.

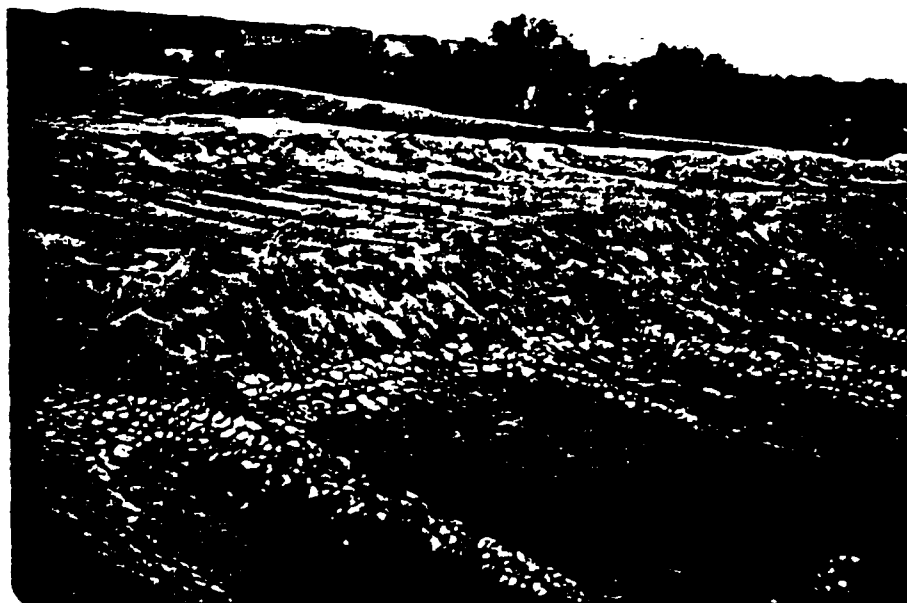
Partially dried organic sediment behind low-head berms.

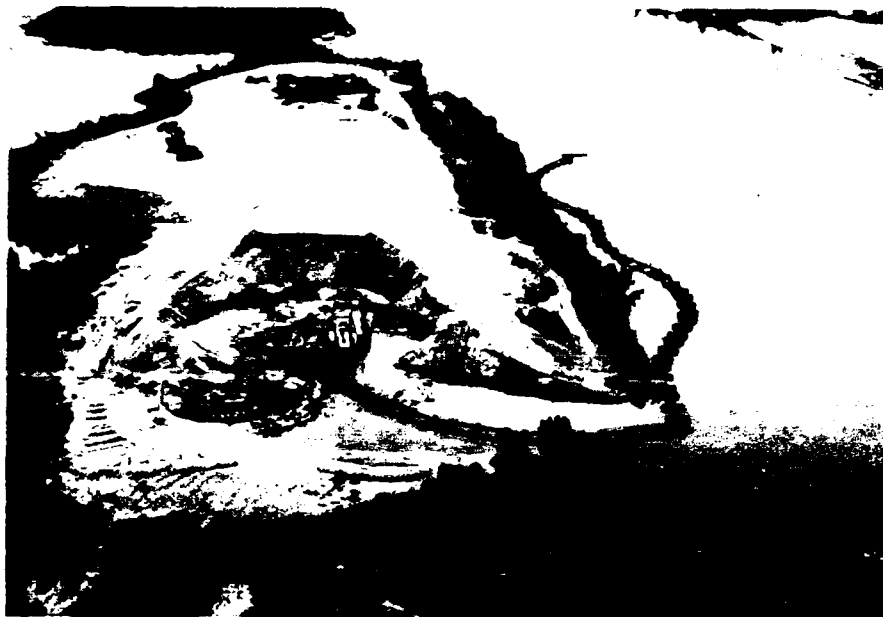
Figure 1. Removing material from Lost Island in 1986 to create islands in Weaver Bottoms. Seeded area on right side slope of island.

During 1986, dredged material was placed in the confined disposal area

at Lost Island, and some of the seeded area was affected by construction equipment. In these areas, the seeded species were destroyed and the successional process was set back to year 1. Winged pigweed and clammyweed were the only species found on these disturbed sites.

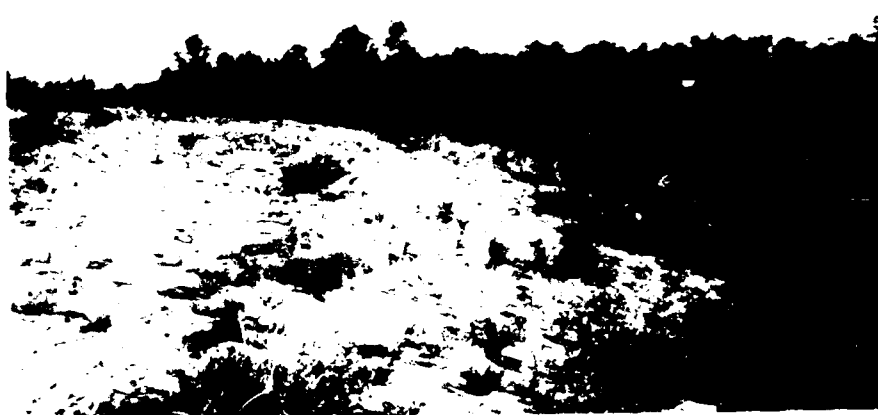
Figure 2. Lost Island control area in 1988. Short grasses and weedy species predominate.

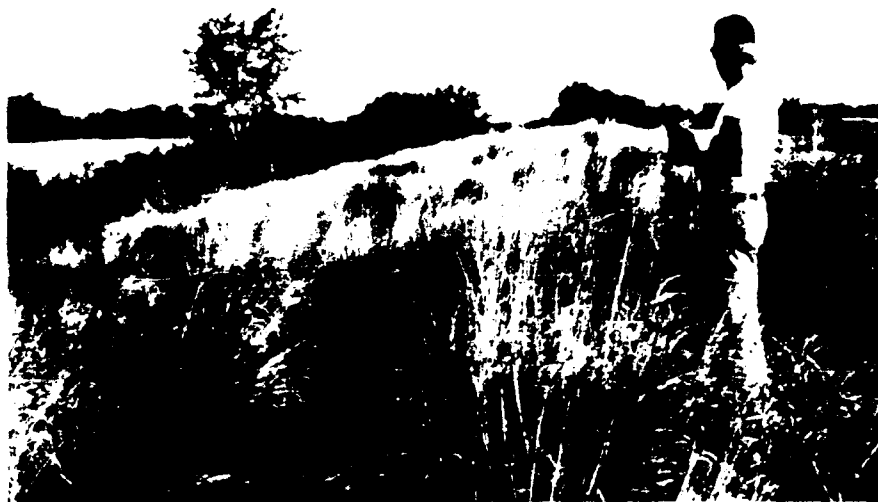
Figure 5. Crosby Island, August 1986. The island is covered with dense vegetation.

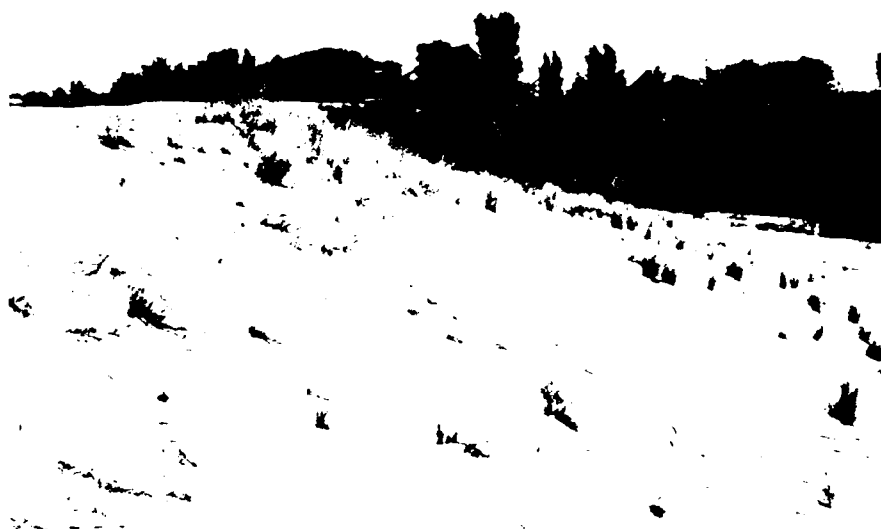
Figure 8. In August of 1993 Canada wild rye was growing on the dredged area at Crosby Island.

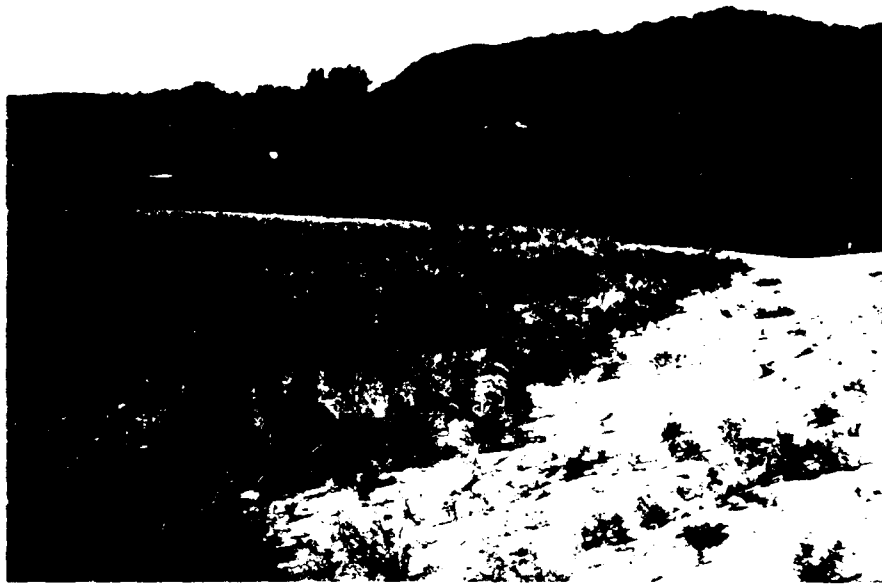
Figure 9. Beachgrass plantings at Crosby Island in August of 1967. Portion of area burned in lower left corner recovered the next year.

On 28 May 1974, Dr. Thomas Claflin of the University of Wisconsin at La Crosse planted American beachgrass (*Amophila brevilegulata*) sprigs on a low flat area near the present confined disposal site. In the 15 years since planting, these plants have expanded vegetatively about 200 feet from the original plantings. The beachgrass has formed a dense, almost monotypic mat. The expansion is entirely vegetative because this is a sterile strain of American beachgrass. In 1985, a small portion of the beachgrass plantings were burned by what appeared to be fireworks. By 1986, the effects of the fire had disappeared. Other species planted by the University included alder and white cedar, both of which are growing well near the water.

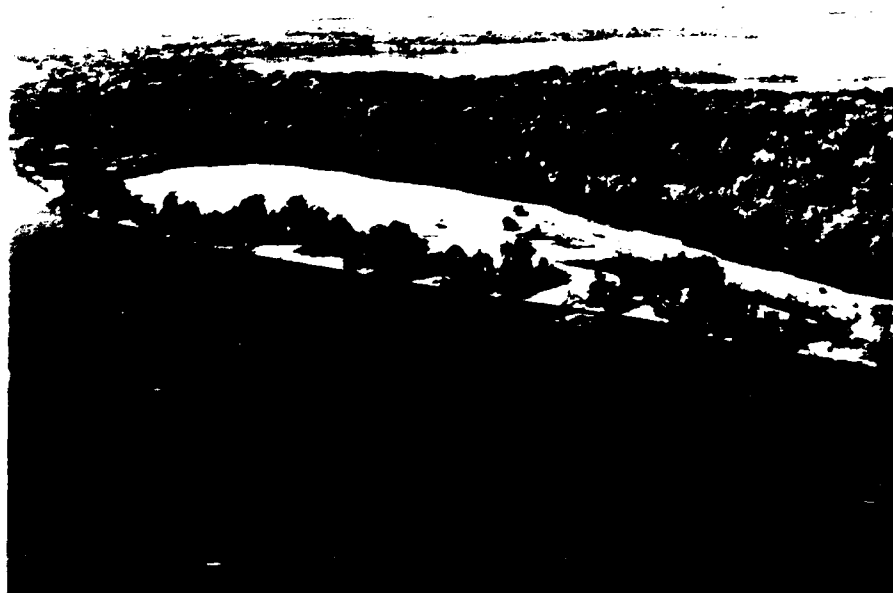
Figure 14. Aerial view of Teepeeota Point in 1986. Fine material was dredged from the open water area in back of the island.

From 8 August to 13 September 1984, fine material was dredged from a backwater area near the island using a Mud Cat and pumped onto the site through an 8-inch pipe. The first method of placement involved cutting holes in the pipe to allow the fine material to escape, but this caused erosion of the side slopes of the disposal site. The next method involved excavating pits and pumping the fine material into them but they soon overflowed and also eroded. The final method used an irrigation sprayer which was dead-headed to a bulldozer and automatically retrieved from up to 600 feet away using a winch. This procedure allowed the fine material to dry slightly and the water to soak away or run off between applications of the fine material. This method appeared to be working and capable of applying an adequate amount of fine material. However, the contract was beginning to expire and it was not possible to apply more than about 1/4 inch of fine material over the area. Overflow from the dredge was pumped into the bottom of the disposal site where it accumulated to a thickness of at least 6 inches. No vegetation seeding was conducted at Teepeeota Point.

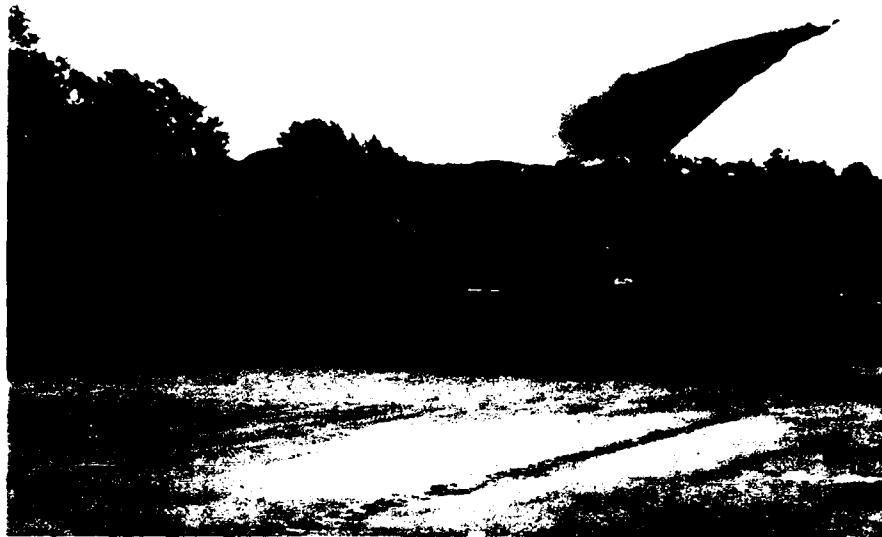
Figure 15. Using an irrigation sprayer to place fine material on Teepeeota Point in August of 1984.

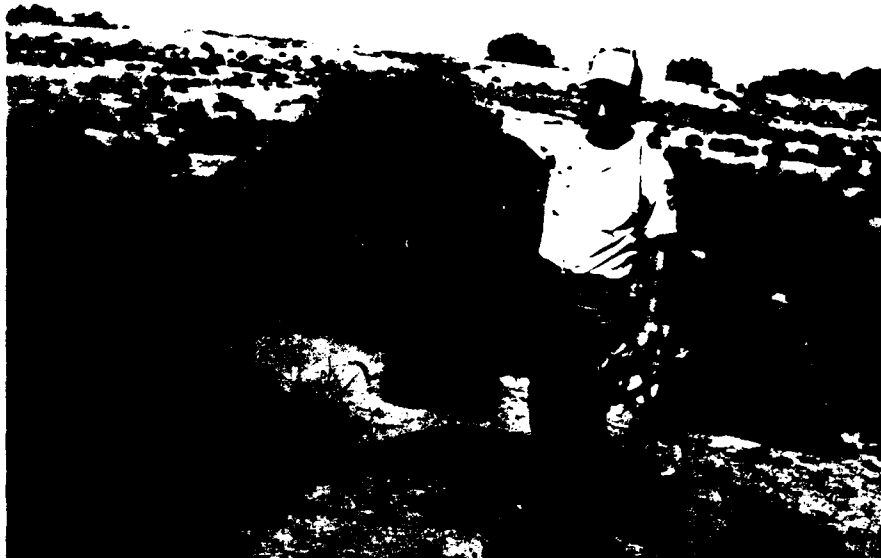
Figure 17. Winged pigweed in the bottom of the disposal area at Teepeeota Point area attained large size.

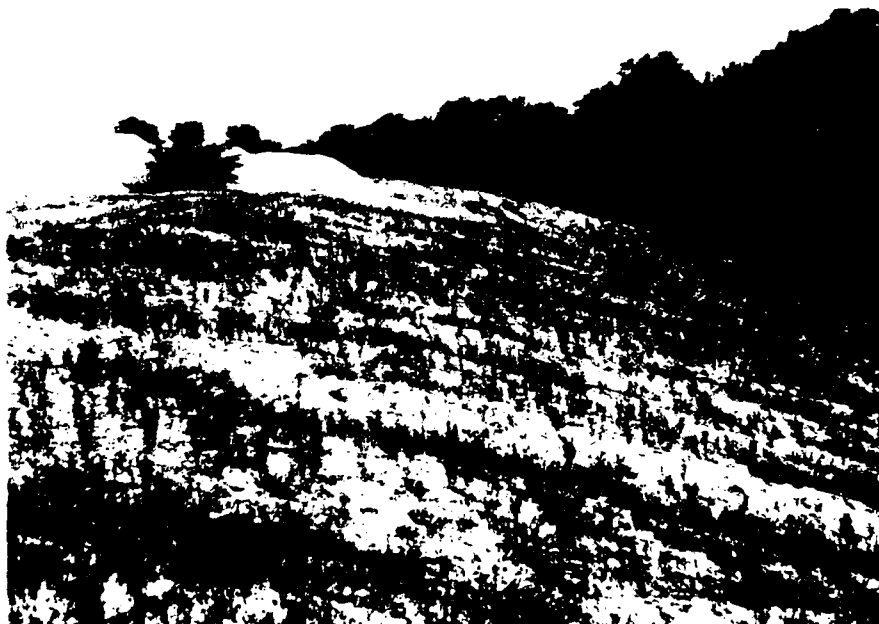
Figure 18. The sprayed area at Teepeeota Point had a cover of 13 percent in August of 1988.

Even though only about 1/4 inch of fine material was placed on the side slopes of the disposal site, it appears that this was enough to produce some benefits for enhancing the growth of vegetation. The main advantage that the fine material adds over the pure sand is that it retains moisture better which contributes to the growth of the vegetation. The treated area and a control site at Teepeeota Point have been monitored yearly since 1985. The percent cover estimates from the monitoring activities are shown in the following table.

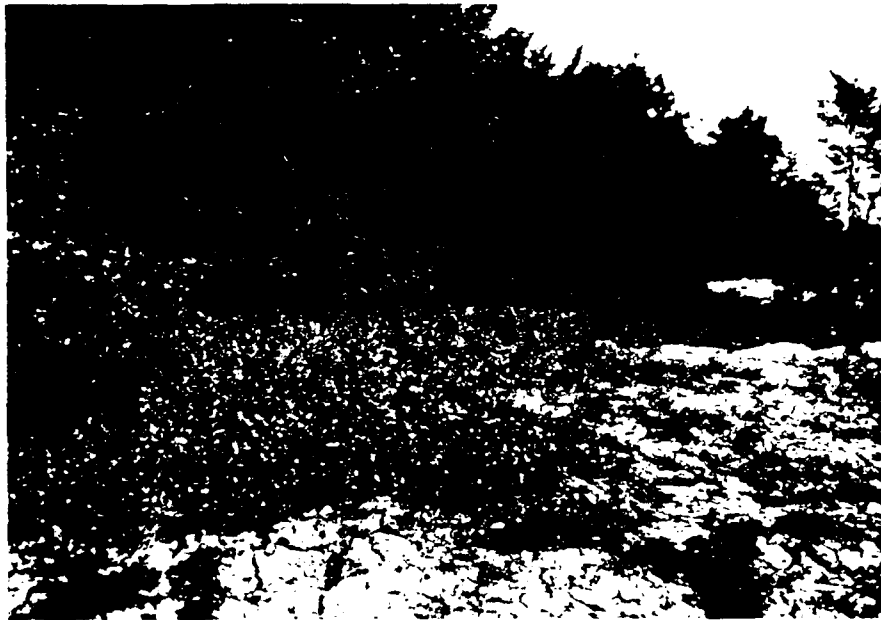
Figure 19. Island 58 in August of 1985 soon after spreading the material. Cottonwood sprouts were already starting to appear.

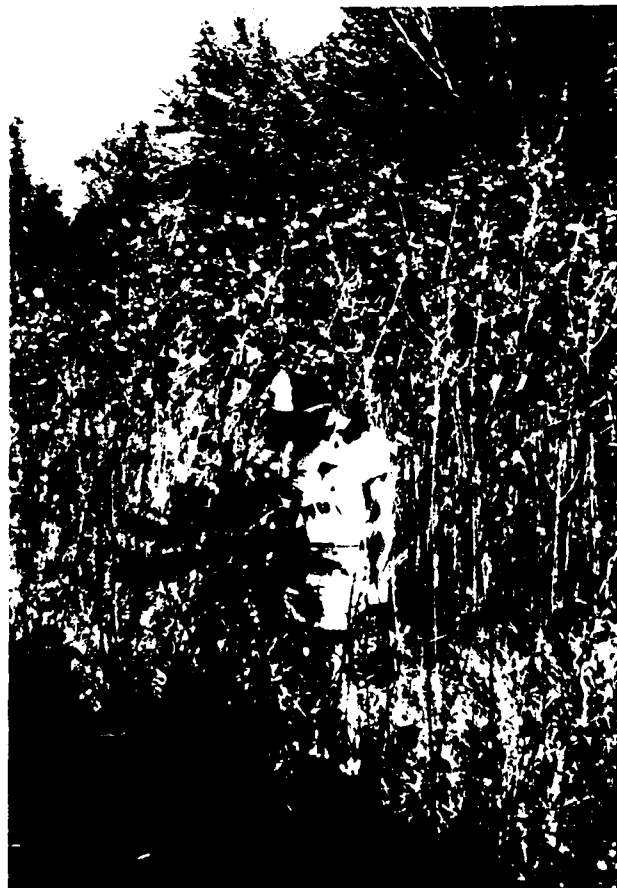
Figure 20. In 1988 the cottonwood at island 58 was over 10 feet tall. Grass species are not common.

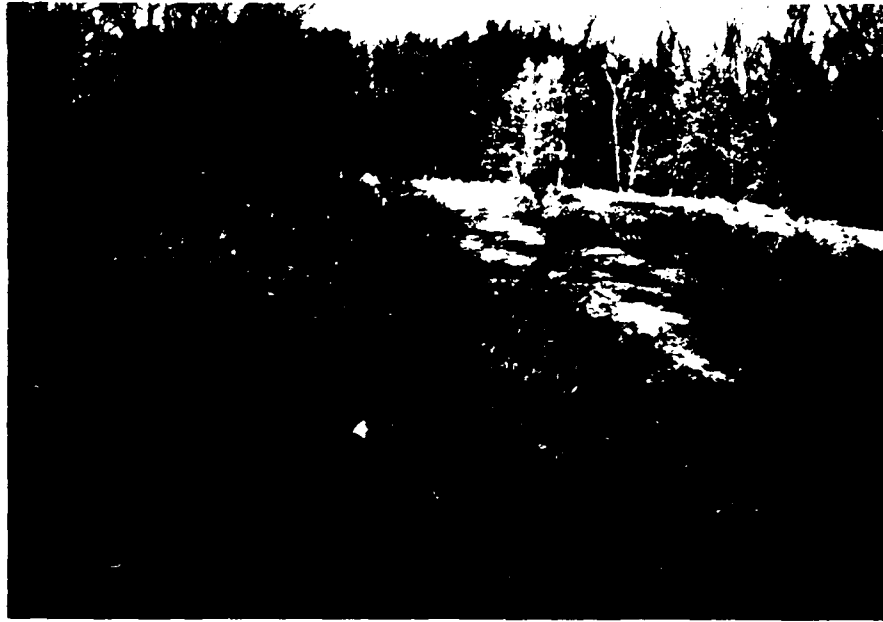
Figure 21. Fine material at Jackson Island was mostly vegetated by weeds and grasses in 1984.

In late May 1984, fine sediment from the auxiliary lock at Lock and Dam No. 9 was placed on a 1-acre site on Jackson Island at river mile 644.5. The sediment contained a high amount of clay and dried to produce a very hard and cracked surface. The area was seeded with the following mixture, but it could not be incorporated into the soil. A bulldozer ran over the area after seeding. Corps and Service employees were used to conduct the seeding operation, which cost approximately \$200 for the seed.

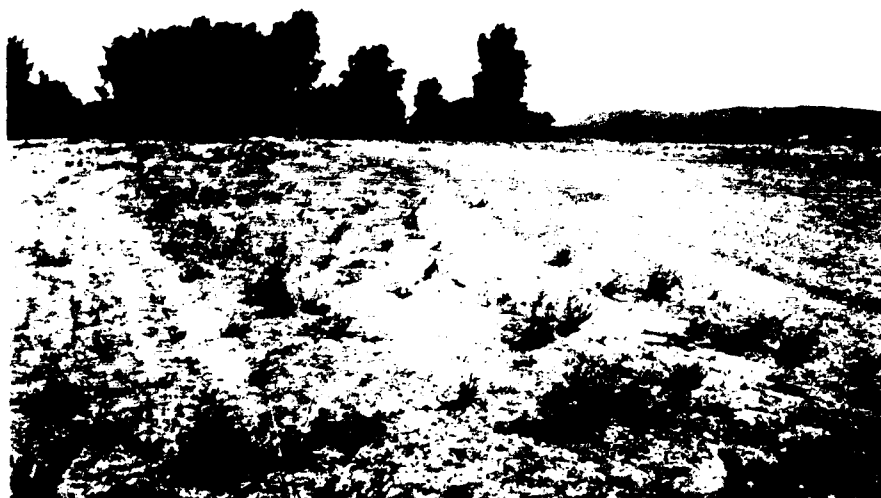
Figure 28. Fine material was not placed on MN 12. Sand dropseed was drill seeded in 1988.

Closure MN 12 was seeded with sand dropseed. Sand dropseed was growing on the site but this could also be natural regrowth. Some winged pigweed was also present. Most of the beachgrass sprigs were brown and do not appear to be very vigorous, but they could come back next year from the roots as was the case at Crosby Island. The beachgrass should have been planted in middle to late May, but this was not possible due to contracting problems. The drought of 1988 could also be the cause of some of the poor condition.

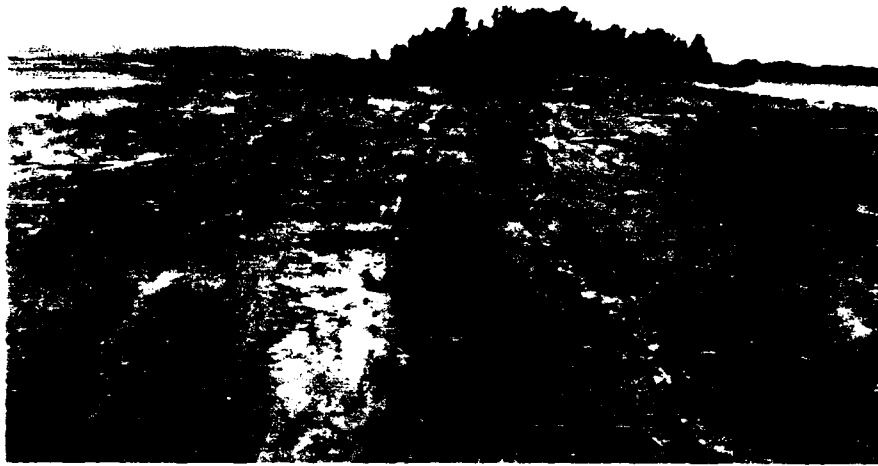
Figure 29. Fine material was placed on MN 13 and drill seeded in 1988.

The wet zone of closure MN 13 was planted with rice cutgrass sprigs. The sprigs are only about 3 inches tall when planted and could not be found during the 1988 sampling. There is some naturally occurring rice cutgrass in the area. Many of the grasses were too immature to identify. Some of the species present in 1988 included:

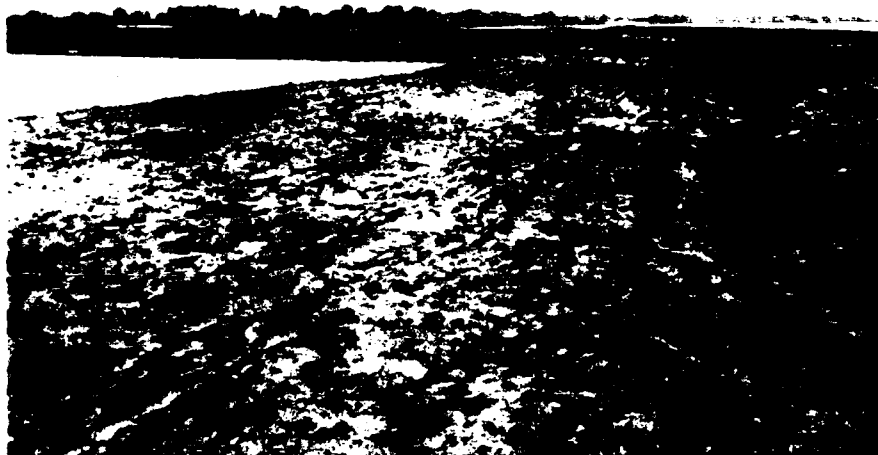
Figure 30. Fine material was spread on Mallard Island in July of 1988. The island was not seeded and is used as a control site.

Both Swan and Mallard Islands had about 6 inches of fine material placed on top of the sand. The fine sediment was incorporated with the sand using a disk or bulldozer. Due to the thickness of the fine material the disk did not mix the fine material with the sand to a great degree and resulted in a silt/clay surface soil (Swan Island). Using a bulldozer with the blade slightly tilted and making several passes over the surface resulted in better incorporation and a coarser soil texture, which may result in better soil aeration and growing conditions (Mallard Island and the side channel closures). Mallard Island was used as a control and did not receive any further treatment. The incorporation of fine material on Mallard Island was completed in July 1988. Swan Island was drill seeded with the following species, and the side slopes were mulched with 1 ton/acre of hay and anchored using a disk.
