Enhanced Preliminary Assessment Report:

Orange Army Housing Units Orange, Connecticut

October 1989

Environmental Research Division
Argonne National Laboratory
Argonne, Illinois 60439

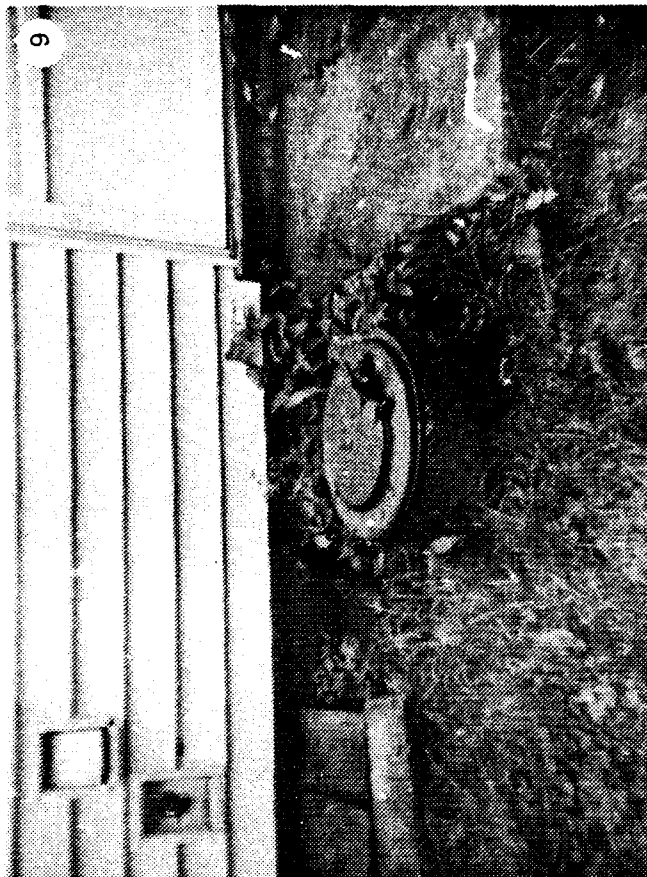
Potential risk to health might also attach to the collection of rainwater in the storage-tank containment box if the water is allowed to stagnate. On the other hand, if the occupant of a housing unit opens the containment-box drainage tap to release rainwater but forgets to close it, the effectiveness of the trough in containing an oil leak would be compromised should a tank rupture occur.

7. A closer view of the fuel-oil storage tank in photograph 6; the end seam of the tank shows considerable rusting.
8. The drainage tap of the concrete containment box; oil leaks from the tank would not be contained were this tap to be left in the open position.

A second potential environmental impact derives from the continued use of the inadequately protected above-ground fuel-oil storage tanks and their associated concrete containment boxes. The integrity of these relatively new storage tanks should be confirmed, and following treatment for existing rust, protective coatings should be applied to the exteriors of the tanks. With respect to containment-box drainage taps, a method should be devised to ensure that they do not remain in the open position for extended periods of time.

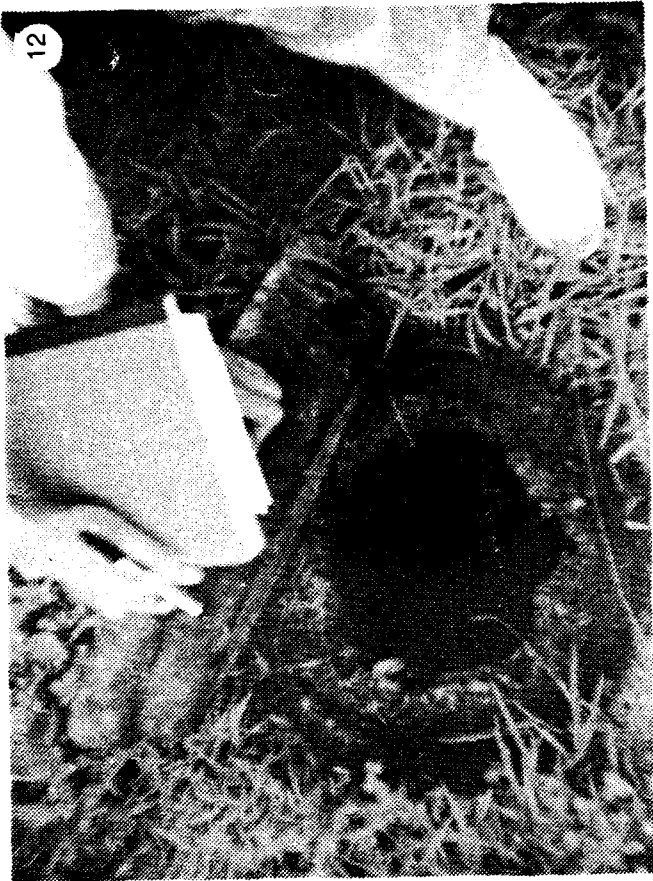
According to the Area Facilities Engineer in Windsor Locks, the septic systems are no longer adequate to service the units and do not meet existing State of Connecticut standards. Furthermore, the groundwater table is high, lying just below the surface, and contributes to and exacerbates septic system problems. The unit at 345 Sybil Street is now closed to occupancy because of backup of sewage caused by a leaching-trench plugging problem that persisted despite repeated attempts to correct it.

11. The round concrete cover of a septic system holding tank in the rear of unit #345, Sybil Street; this unit is no longer occupied because attempts to correct septic system problems were unsuccessful.

The 20 putatively substandard waste-disposal systems represent a continuing potential for environmental impact and a possible impediment to the expeditious excessing of this property. It is therefore recommended that a determination be made of the adequacy of the waste-disposal systems and that whatever modifications deemed necessary to meet State of Connecticut standards be made.
