Enhanced Preliminary Assessment Report:

Plainville Army Housing Units Plainville, Connecticut

October 1989

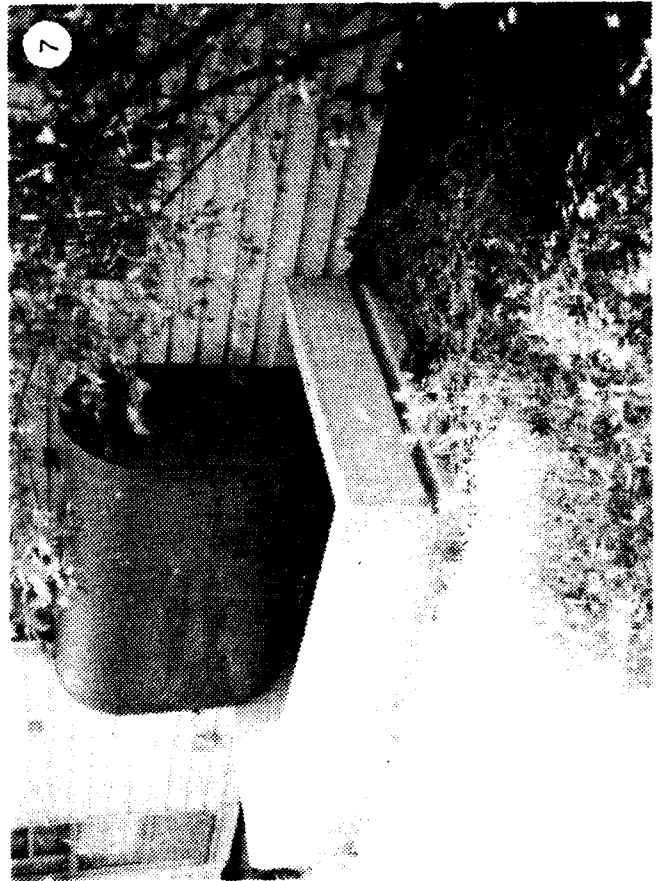
IDENTIFICATIONS OF PHOTOGRAPHS

The above-ground tanks have only a primer paint to cover them, and a make-shift shelter attached to the house a few feet above the tanks. This does not offer adequate protection to the tanks against adverse weather conditions. Areas of rust and corrosion were observed on some of the tanks.

It is common practice for the residents of the housing area to leave the spigots open which drain the cement troughs around the above-ground tanks. This is to allow the rainwater which collects in these tanks to drain away. Residents store garbage cans, lawn chairs, and miscellaneous supplies in this trough area. If these spigots are left open routinely, the effectiveness of the cement troughs as spill-containment devices would be compromised. No such incident has occurred, however.

1. A general view of one section of the housing area; a fire hydrant and grated cover of the storm sewer system (lower center) can be seen.
2. Front view of a Capehart house.
3. Side view of another housing unit with a detached garage.
4. Another housing unit, *this one with an attached garage (top right)*.
5. A playground, with houses on two sides.
6. Above-ground fuel-oil storage tank, concrete containment box, and protective canopy over the tank, at the rear of a housing unit.
7. A close-up view of the oil-storage tank; drain tap for the concrete box is located just above the ground on concrete slab at right; if drain tap is left in the open position, any oil leak would not be contained inside the box, but instead would spill to the surrounding ground.

One potential environmental impact derives from the continued use of the inadequately protected above-ground fuel-oil storage tanks and their associated concrete containment boxes. The integrity of these relatively new storage tanks should be confirmed, and, following treatment for existing rust, protective coatings should be applied to the exteriors of the tanks. With respect to containment-box drainage taps, a method should be devised to ensure that they do not remain in the open position for extended periods of time.
