## Enhanced Preliminary Assessment Report:

### Spring Valley Army Housing Units Ramapo, New York

November 1989

Environmental Research Division  
Argonne National Laboratory  
Argonne, Illinois 60439

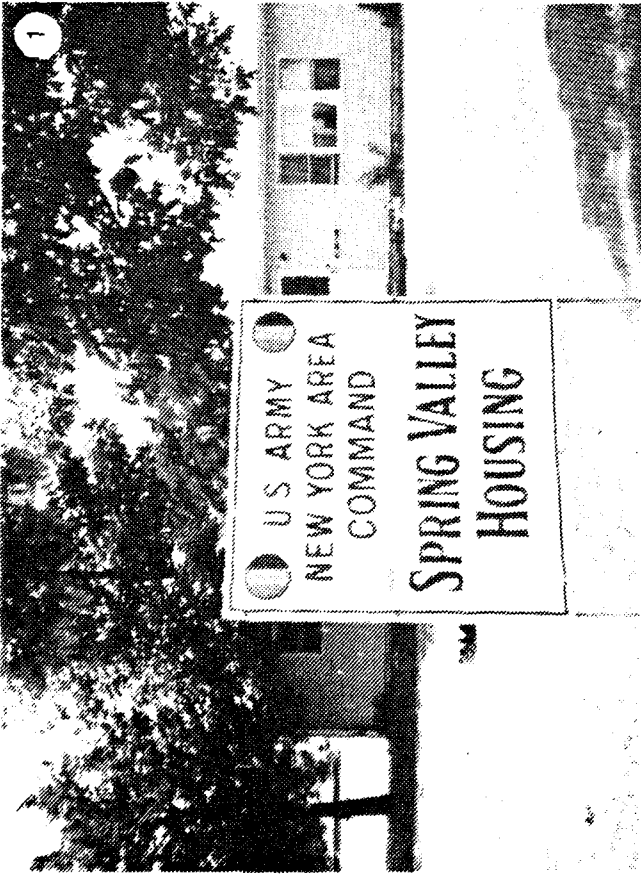
1

1. Sign at entrance to Spring Valley housing area.
2. Locked pumphouse (Bldg. 213), near housing area entrance at Grand View Ave.
3. Transformers adjacent to pumphouse and near housing area entrance.

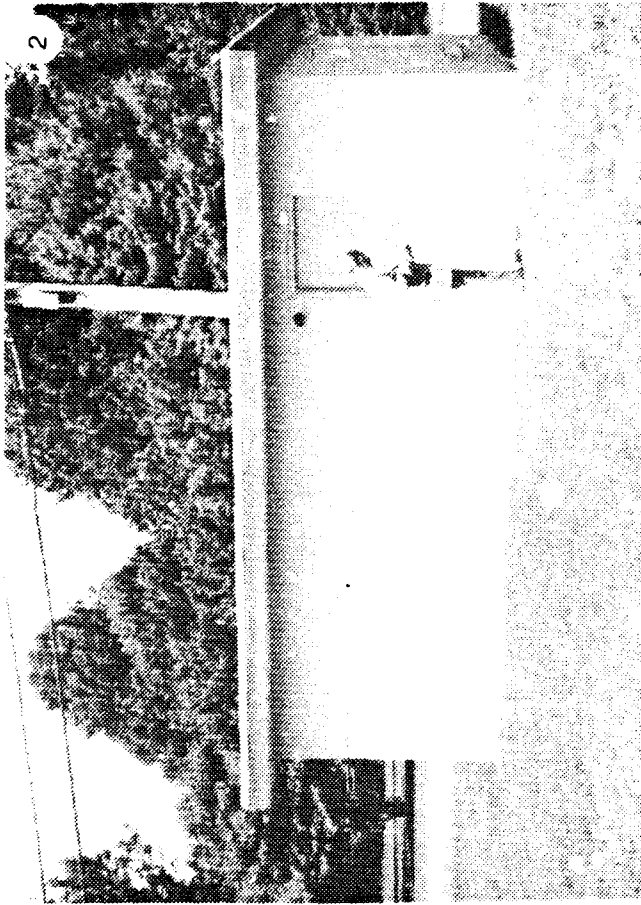
2

Building 213, a small, windowless, locked structure near the entrance to the housing facility off Grandview Avenue, houses the water meter for the property. According to Fort Hamilton personnel, it also contains a water storage tank and pump, installed at the time of Nike site operations to provide water in case the local utility source was interrupted. Though never used for that purpose, the pump is maintained to prevent freezing of the water lines connected to the tank.<sup>2</sup>

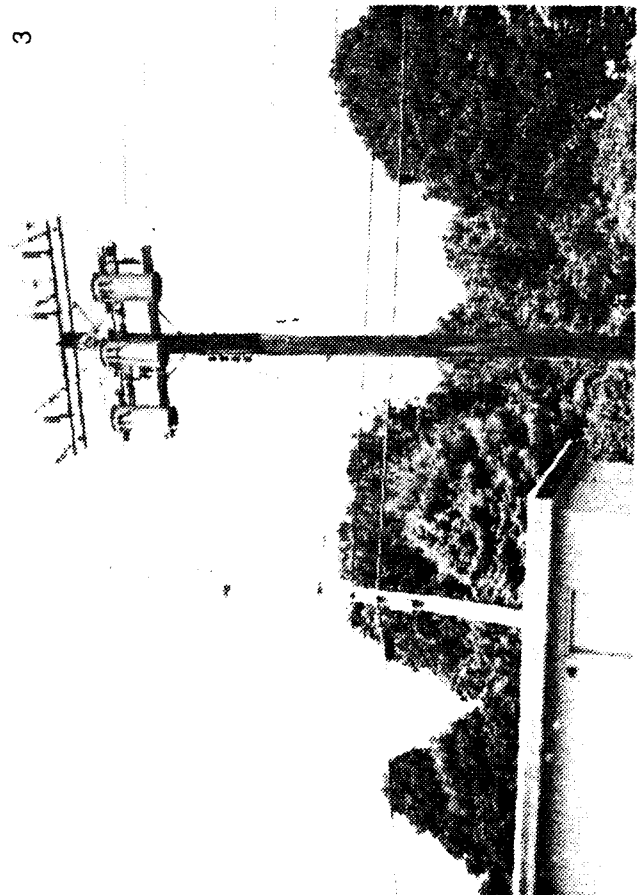
3

Six Army-owned transformers are located at two locations within the housing area; three are on one pole near the Grandview Avenue entrance to the facility, and three others are on a pole among the housing units. It was unknown whether or not the transformers have been tested for the presence of PCBs. Manufacture date of the transformers is unknown, although a site figure dated 1968 showed the transformer positions.<sup>8</sup> None of the poles holding transformers were labeled with PCB identification tags. There was no sign of oil leakage around the transformers or poles.<sup>2</sup>

There is no documentation that the six on-site electrical transformers have been tested for PCBs. However, there were no indications of spills or leaks from any of these transformers.
