## Enhanced Preliminary Assessment Report:

Irwin Army Housing Units  
Irwin, Pennsylvania

October 1989

Environmental Research Division  
Argonne National Laboratory  
Argonne, Illinois 60439

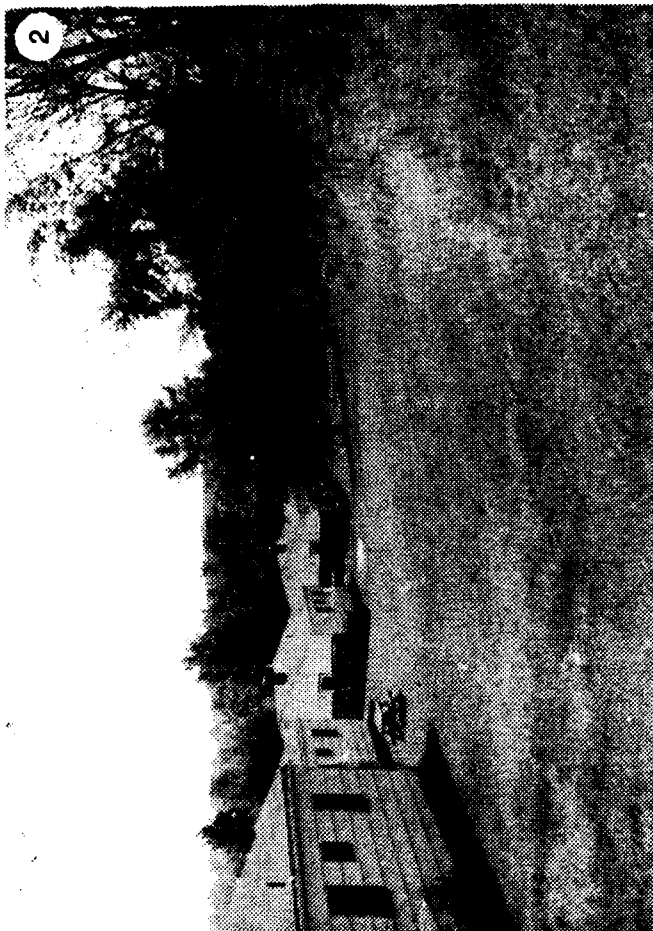
1. A view of the housing area.
2. Grounds at the rear of the housing units.
3. Playground at the housing area.
4. Electrical transformer mounted near the top of the utility pole; the transformers are the responsibility of the Plainville Power Company.
5. A side view of a housing unit; in the foreground are a gas pipeline marker and a storm drain; the housing area uses natural gas for fuel, thus requiring no oil-storage tanks.
6. The opening of a storm drain.
7. The sewage-treatment system, with separators located behind the fenced gate.
8. The trickle rock-bed of the sewage-treatment system.
