Enhanced Preliminary Assessment Report:

Manchester Army Housing Units
Manchester, Connecticut

October 1989

Environmental Research Division
Argonne National Laboratory
Argonne, Illinois 60439

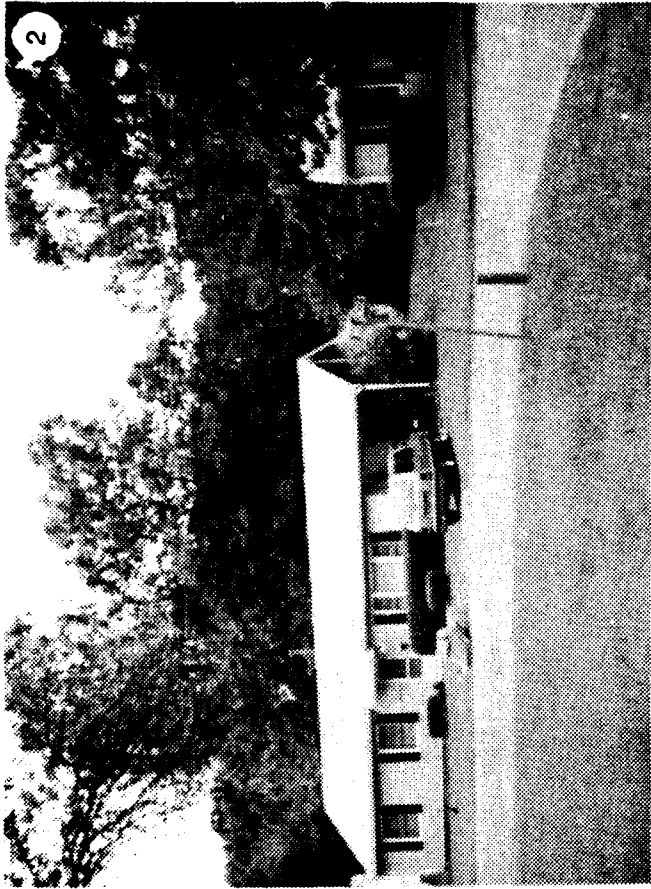
IDENTIFICATIONS OF PHOTOGRAPHS

1. A view from southern section of Nike Circle, looking downhill and northwest; housing units at left are #69 (foreground), #61, and #55.
2. Housing unit #118, with an attached carport; of the 32 units at this site, 13 have carports.
3. A view to the south on Nike Circle from the front of unit #118; a playground (not in photograph) is located in the wooded area at left.
4. An electrical transformer atop a utility pole in front of unit #17; transformers on this property are maintained by the federal government.
5. Housing units #29 (left) and #27 (right) at the northern section of Nike Circle; the small structure between these two houses is the septic-system lift station; unit #37 (not shown), at left of unit #29, had sewer system backup problems.
