In-Line Wear Monitor

November 1989

Final Report for Period July 1988-April 1989

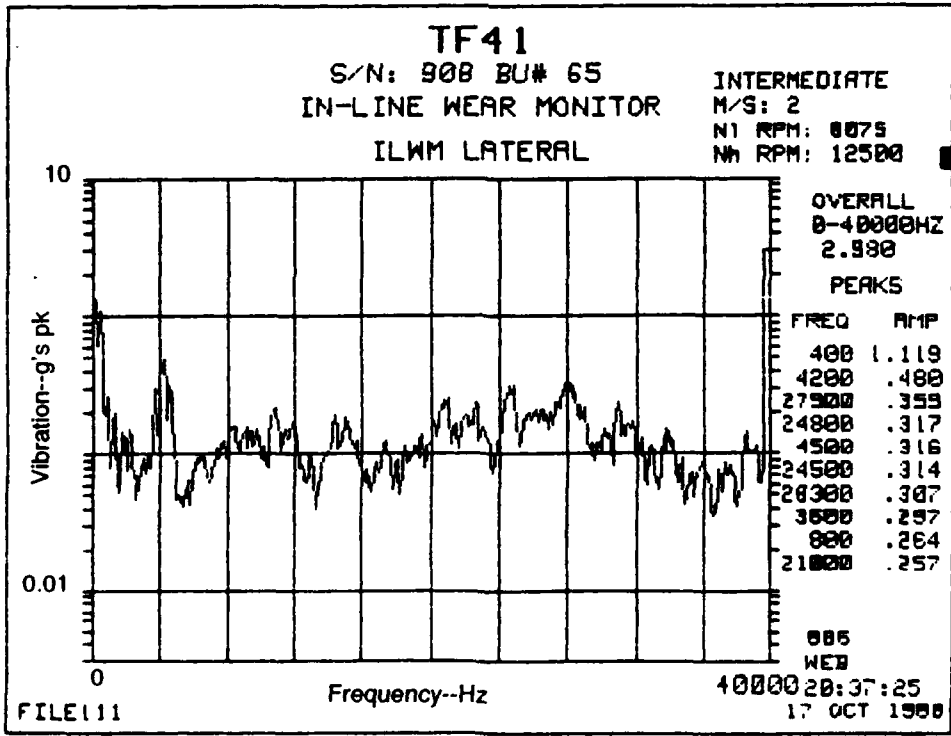
Figure 11. Vibration profiles at intermediate power - vertical and lateral axes.

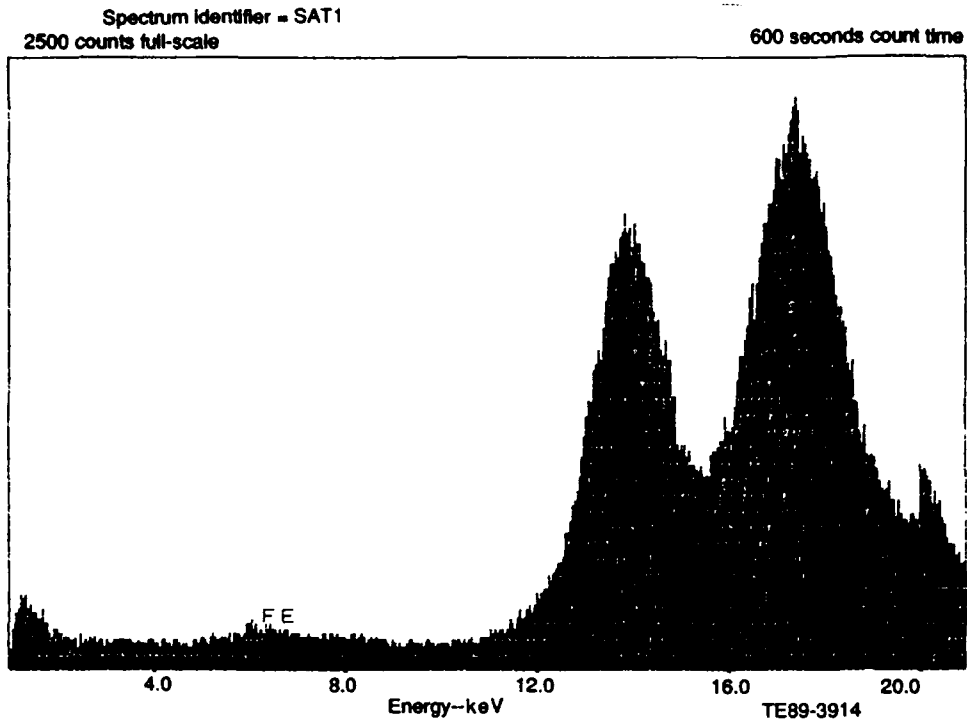
Figure 15. PGT System III spectrum for 60-100 percent engine power.

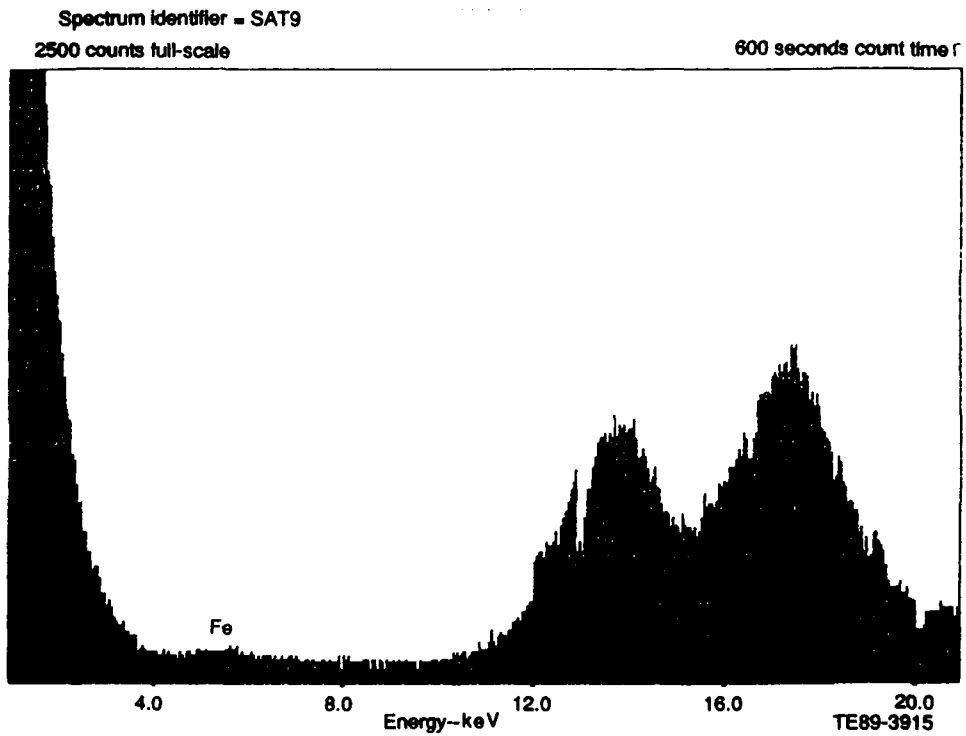
Figure 16. PGT System III spectrum for full engine power.
