NRL HYBRID RELIABILITY

**PHYSICS OF FAILURE
INITIAL STUDY**

**FINAL REPORT FOR
PERIOD 1 OCTOBER 1986 TO 30 SEPTEMBER 1988**

NRL HYBRID RELIABILITY PHYSICS OF FAILURE INITIAL STUDY

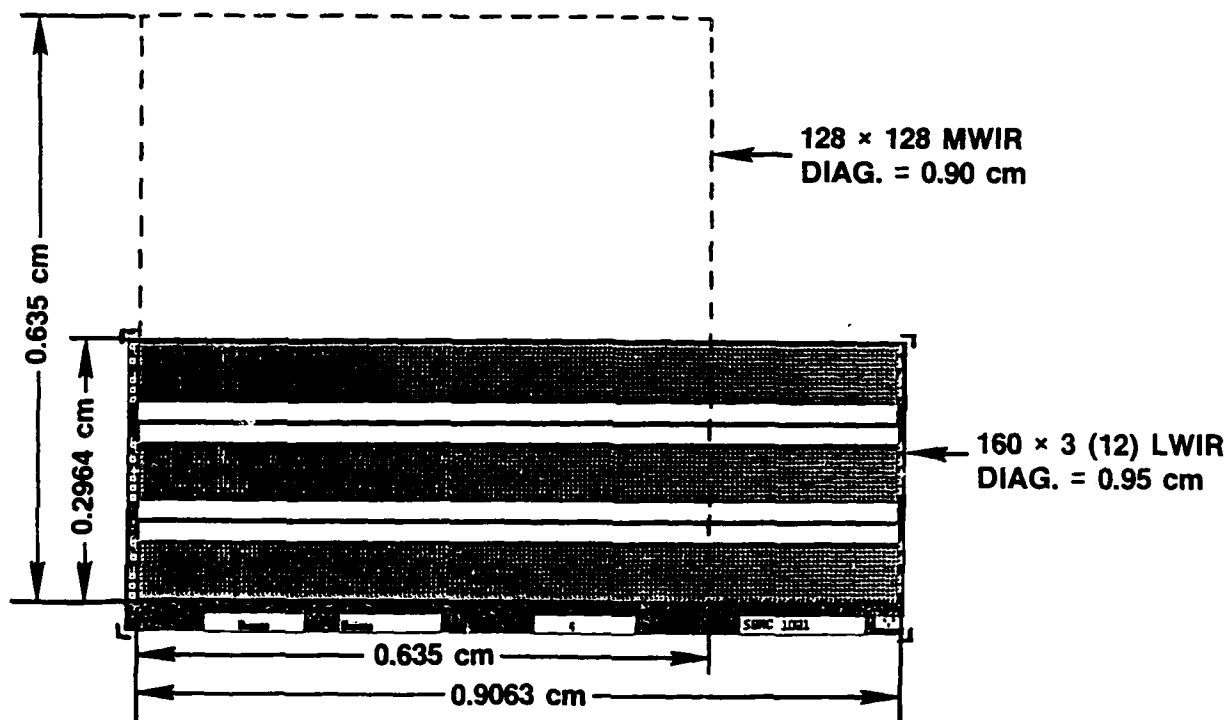
Figure 2-1. 160×3 (12) LWIR HgCdTe Array Is Structurally Similar in Length of Its Maximum Dimension (Diagonal) to 128×128 Array

The objective of this task was to obtain some initial data on the failure modes associated with PV HgCdTe hybrid arrays. As a vehicle for this testing a 160×3 (12) LWIR HgCdTe array hybridized to a Si readout was used. This hybrid is structurally similar in the length of its maximum dimension (diagonal) to a 128×128 array, as shown in Figure 2-1.

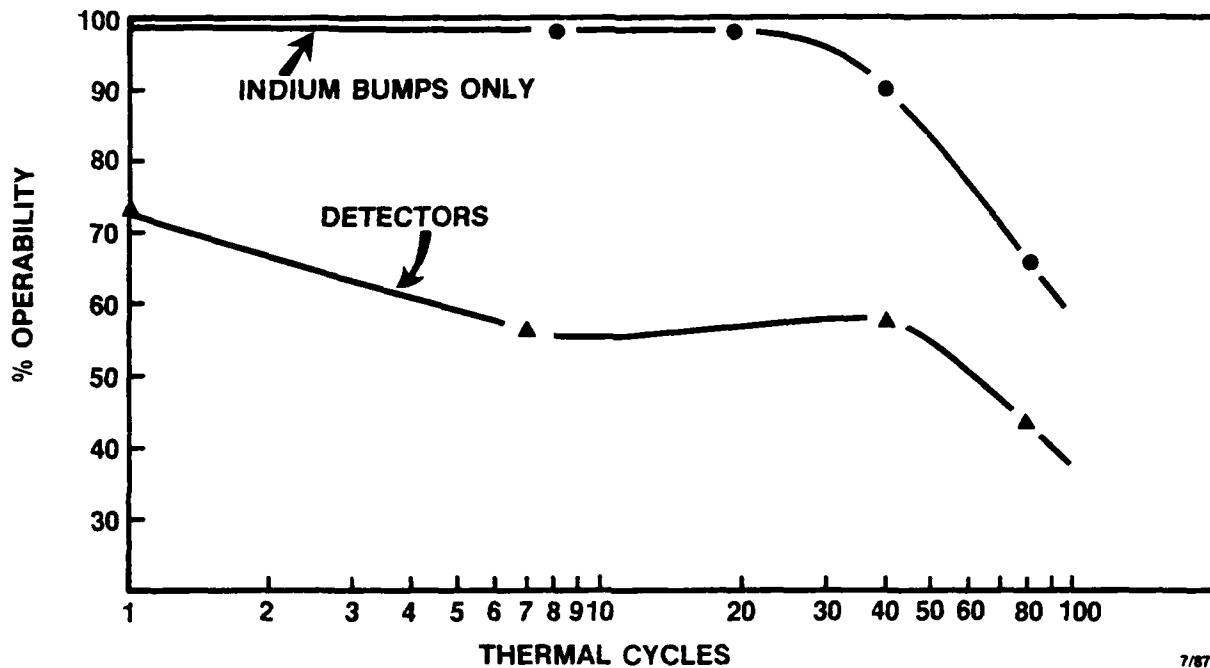
Figure 2-2 shows a plot of percent operability versus number of cumulative thermal cycles. One curve shows indium bump interconnect operability and the other curve shows detector response operability. Figure 2-2 shows that the interconnects began to fail at approximately 40 cumulative thermal cycles. Detector operability was initially 73% and degraded to 60% after 7 cycles; further degradation with thermal cycling was associated with interconnect reliability.

Figure 2-2. Percent Operability for Indium Bump Interconnects and Detector IR Response versus Cumulative Thermal Cycles (Assembly 5089)

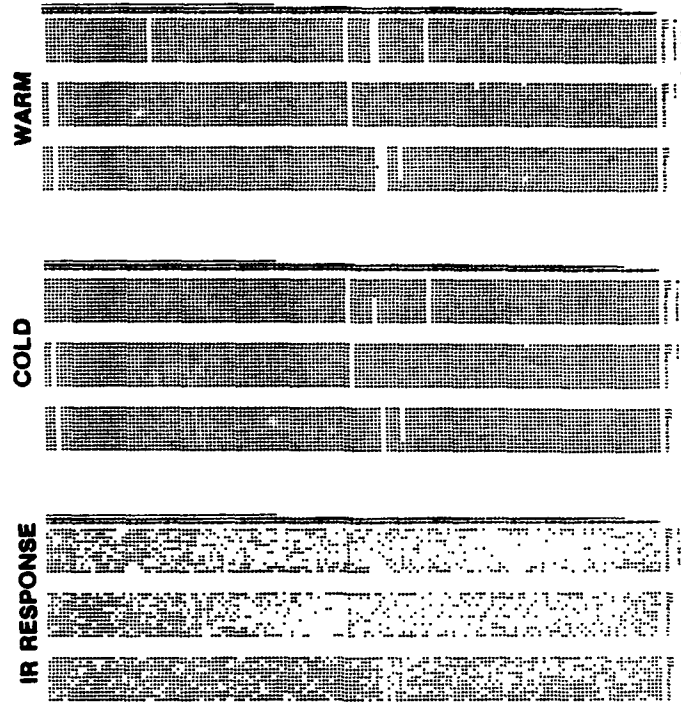
Figure 2-3. Gray-scale Map Showing Operability of Indium Bump Interconnects (Warm and Cold) and Detector IR Response after 7 Cumulative Thermal Cycles (Assembly 5089)

A more detailed look at these results is shown in Figures 2-3, 2-4, and 2-5, which show a gray scale map of indium interconnect operability at 300K and 77K and detector IR response at 77K, after 7, 40, and 81 cumulative cycles, respectively. Figure 2-3 shows that the interconnect reliability is good, but that the IR detector response operability is degraded. Figures 2-4 and 2-5 show that the indium bump interconnects are degrading with thermal cycling and the detector response is degraded only as a result of this interconnect loss. Scanning electron microscopy was used to analyze these degradation mechanisms and is discussed in the next section.

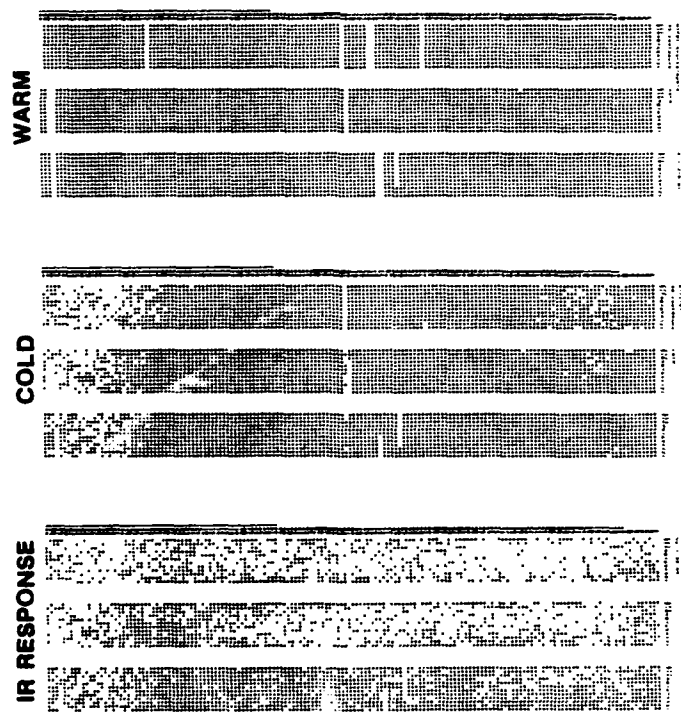
Figure 2-4. Gray-scale Map Showing Operability of Indium Bump Interconnects (Warm and Cold) and Detector IR Response after 40 Cumulative Thermal Cycles (Assembly 5089)

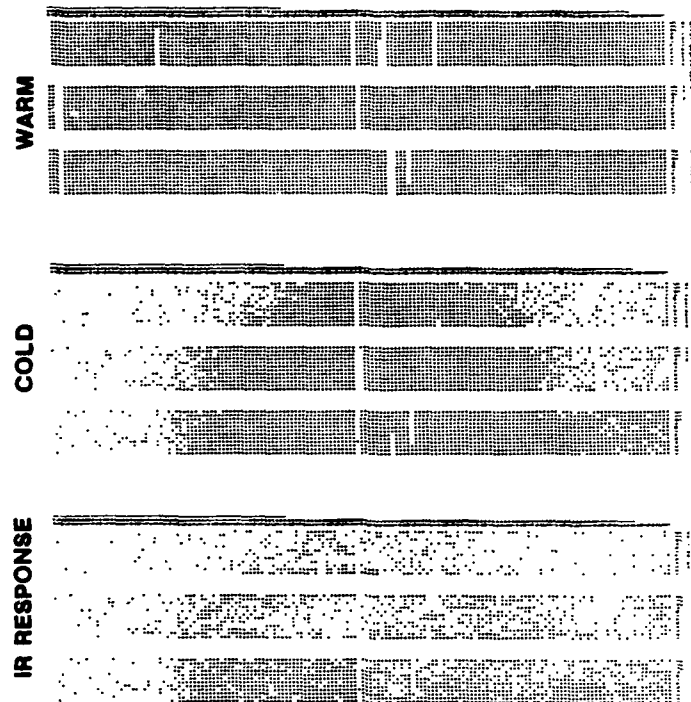
Figure 2-5. Gray-scale Map Showing Operability of Indium Bump Interconnects (Warm and Cold) and Detector IR Response after 81 Cumulative Thermal Cycles (Assembly 5089)

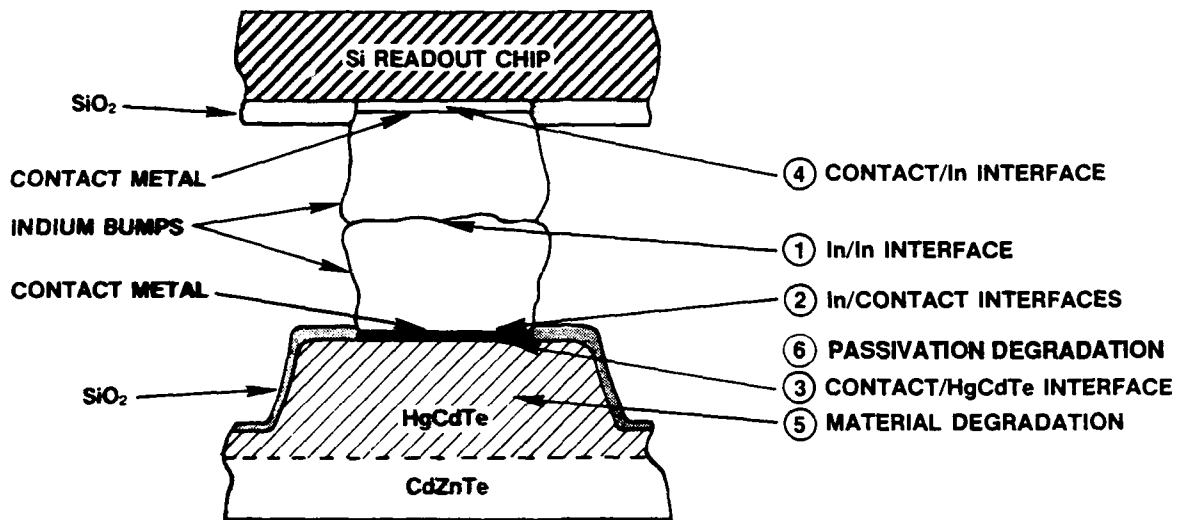
Figure 2-6 is a schematic of a cross-section of an individual pixel in a hybrid array and shows possible failure mechanisms induced by thermal cycling. The following failure mechanisms can occur:

Figure 2-6. Schematic of Cross Section of Individual Pixel on Hybrid Array Showing Possible Failure Mechanisms Induced by Thermal Cycling

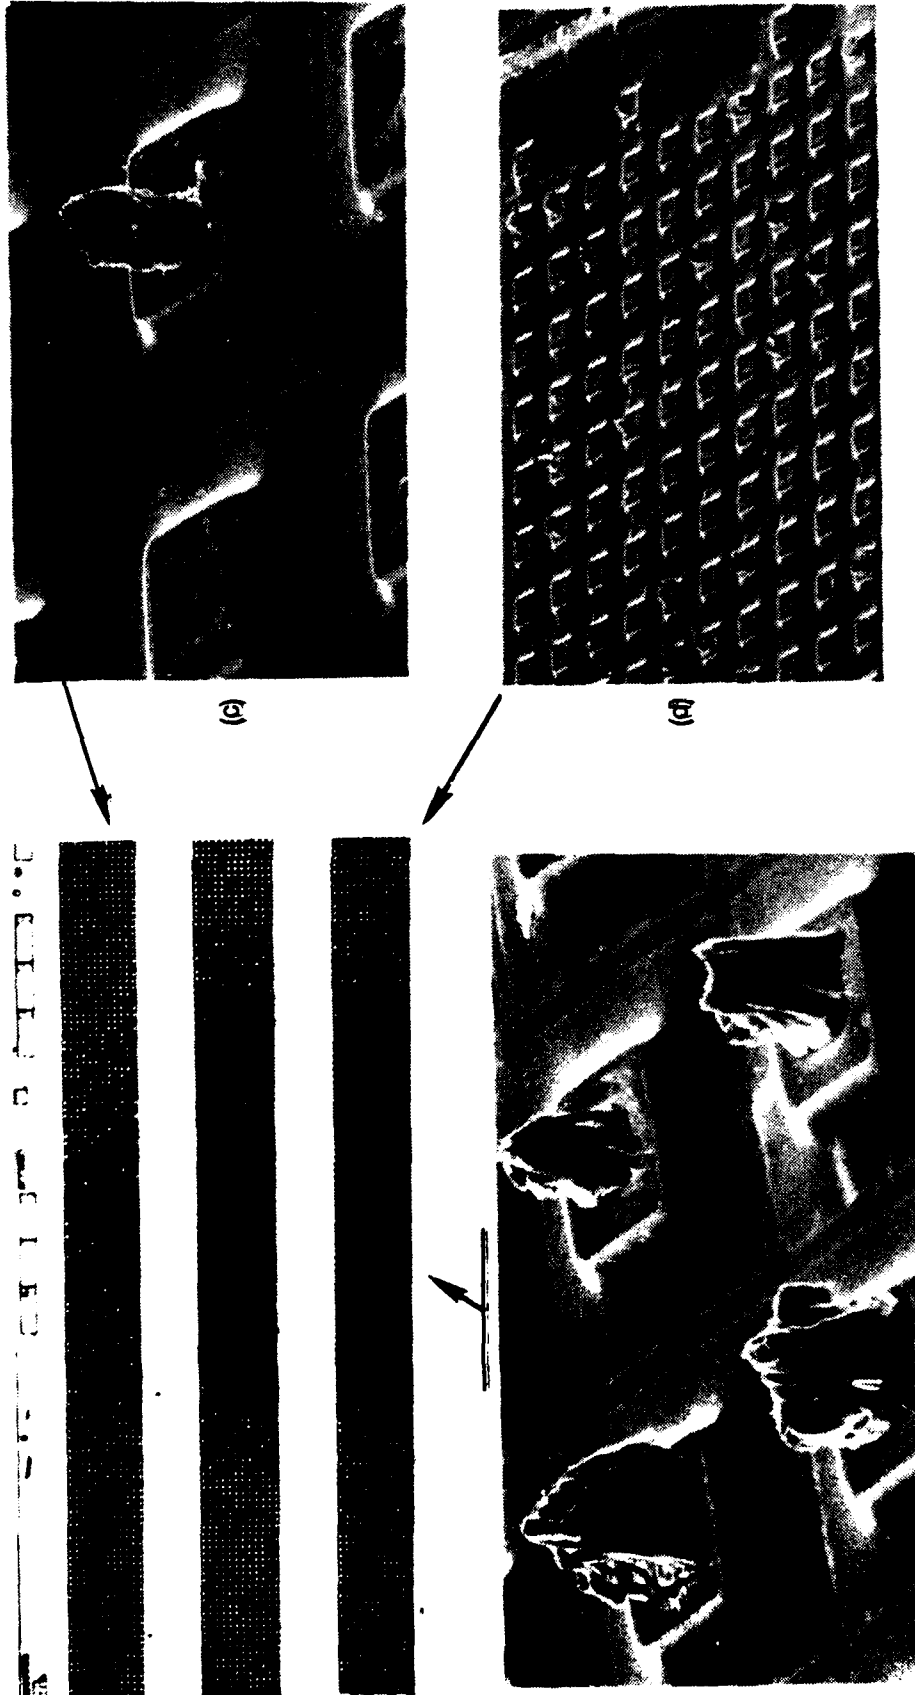
Figure 2-7a shows the gray scale map of interconnect failure of the 160 × 3 (12) LWIR HgCdTe hybrid array (Assembly 5089) after 81 cumulative thermal cycles; Figures 2-7b, c, and d are SEM micrographs of the array after it was pulled apart for analysis. Figure 2-7b shows an SEM micrograph of several pixels in the central region of the hybrid which showed good interconnect operability. The indium bumps showed good cold welding characteristics in this region, as evidenced by their elongated shape after pulling the array apart. Figures 2-7b and c show micrographs of pixels in the exterior region of the array which exhibited poor interconnect operability upon thermal cycling. These figures show that the dominant failure mechanism was contact delamination at the contact metal/HgCdTe interface. This was probably due to surface contamination sometime prior to the metallization step and is not an inherent process limitation.

Figure 2-7. (a) Gray-scale Map Showing Operability of Indium Bump Interconnects after 81 Cumulative Thermal Cycles (Assembly 5089). (b) SEM Micrograph of Pixels (after pulling apart hybrid) of Good Interconnects in Interior of Array Showing Good Indium Bump Cold-welding Characteristics. (c) SEM Micrograph Showing Interconnect Delamination at Contact Metal/HgCdTe Interface. (d) SEM Micrograph of Many Pixels Showing Interconnect Delamination.

These failures were apparently due to unwanted surface contamination during the processing of this device and are not inherent limitations to hybrid detector arrays. These problems have been eliminated in the process and did not affect further experiments discussed in the next sections.

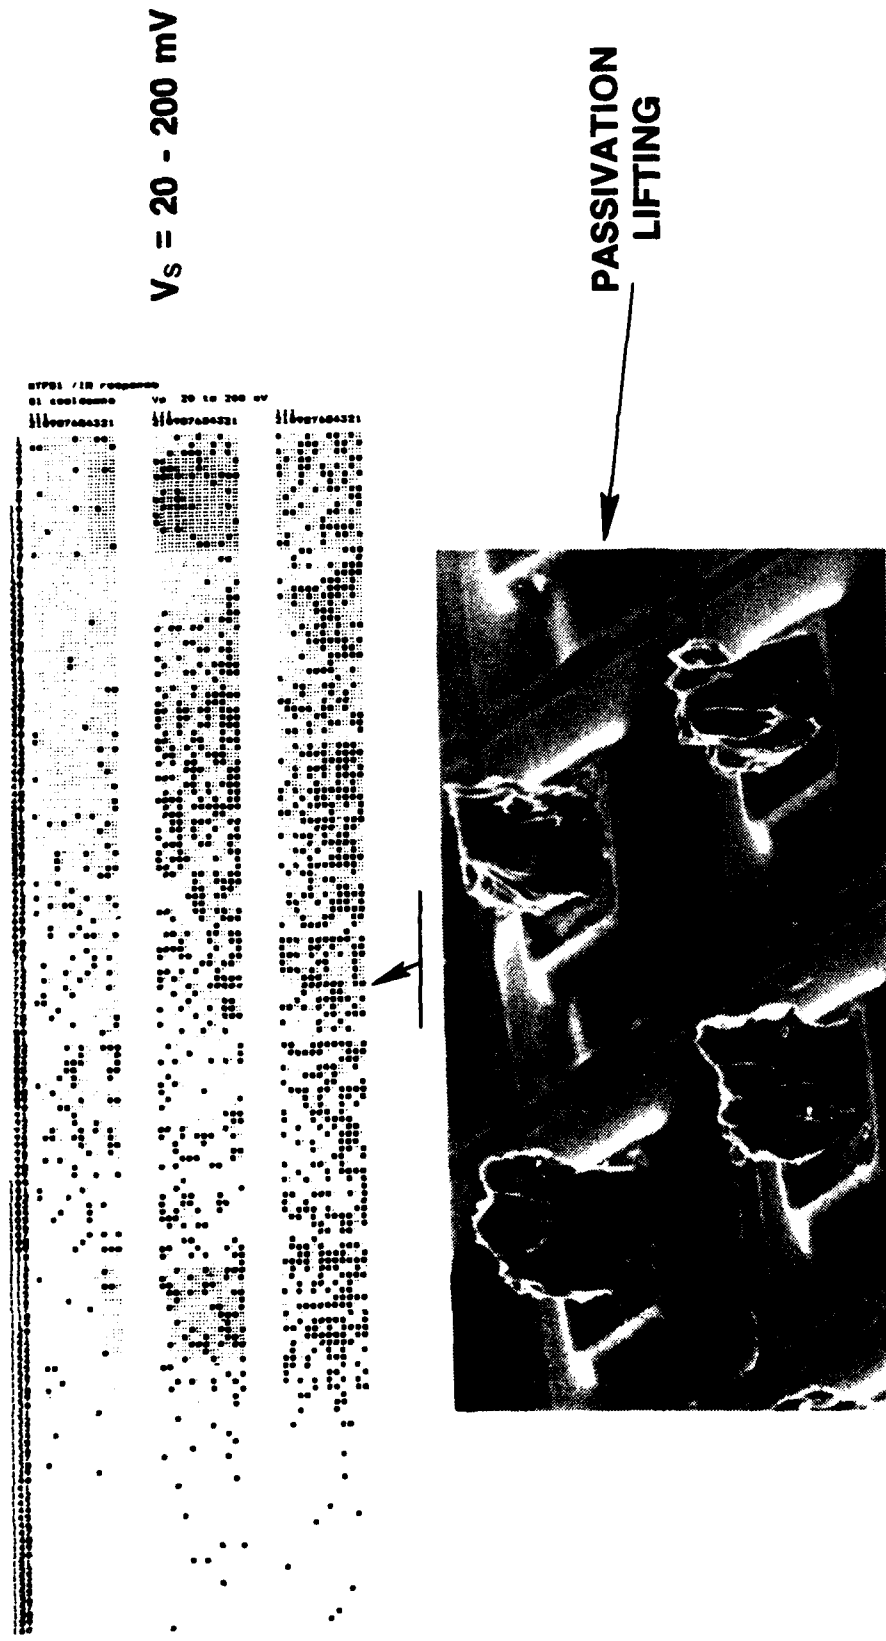
Figure 2-8a shows the gray scale map of device operability of the 160 × 3 (12) LWIR HgCdTe hybrid array (Assembly 5089) after 81 cumulative thermal cycles and Figure 2-8b shows an SEM micrograph of several pixels on the array which showed poor IR response. Figure 2-8b shows that the SiO₂ passivation layer is lifting from the surface and is thus ineffective in passivating the array surface and results in poor uniformity of operability across the array. This again was probably due to surface contamination prior to the passivation step and is not an inherent process limitation.

Figure 2-8. (a) Gray-scale Map Showing Detector IR Response Uniformity after 81 Cumulative Thermal Cycles (Assembly 5089). (b) SEM Micrograph of Pixels (after pulling apart hybrid) Showing Poor IR Response Due to Passivation Layer Delamination.

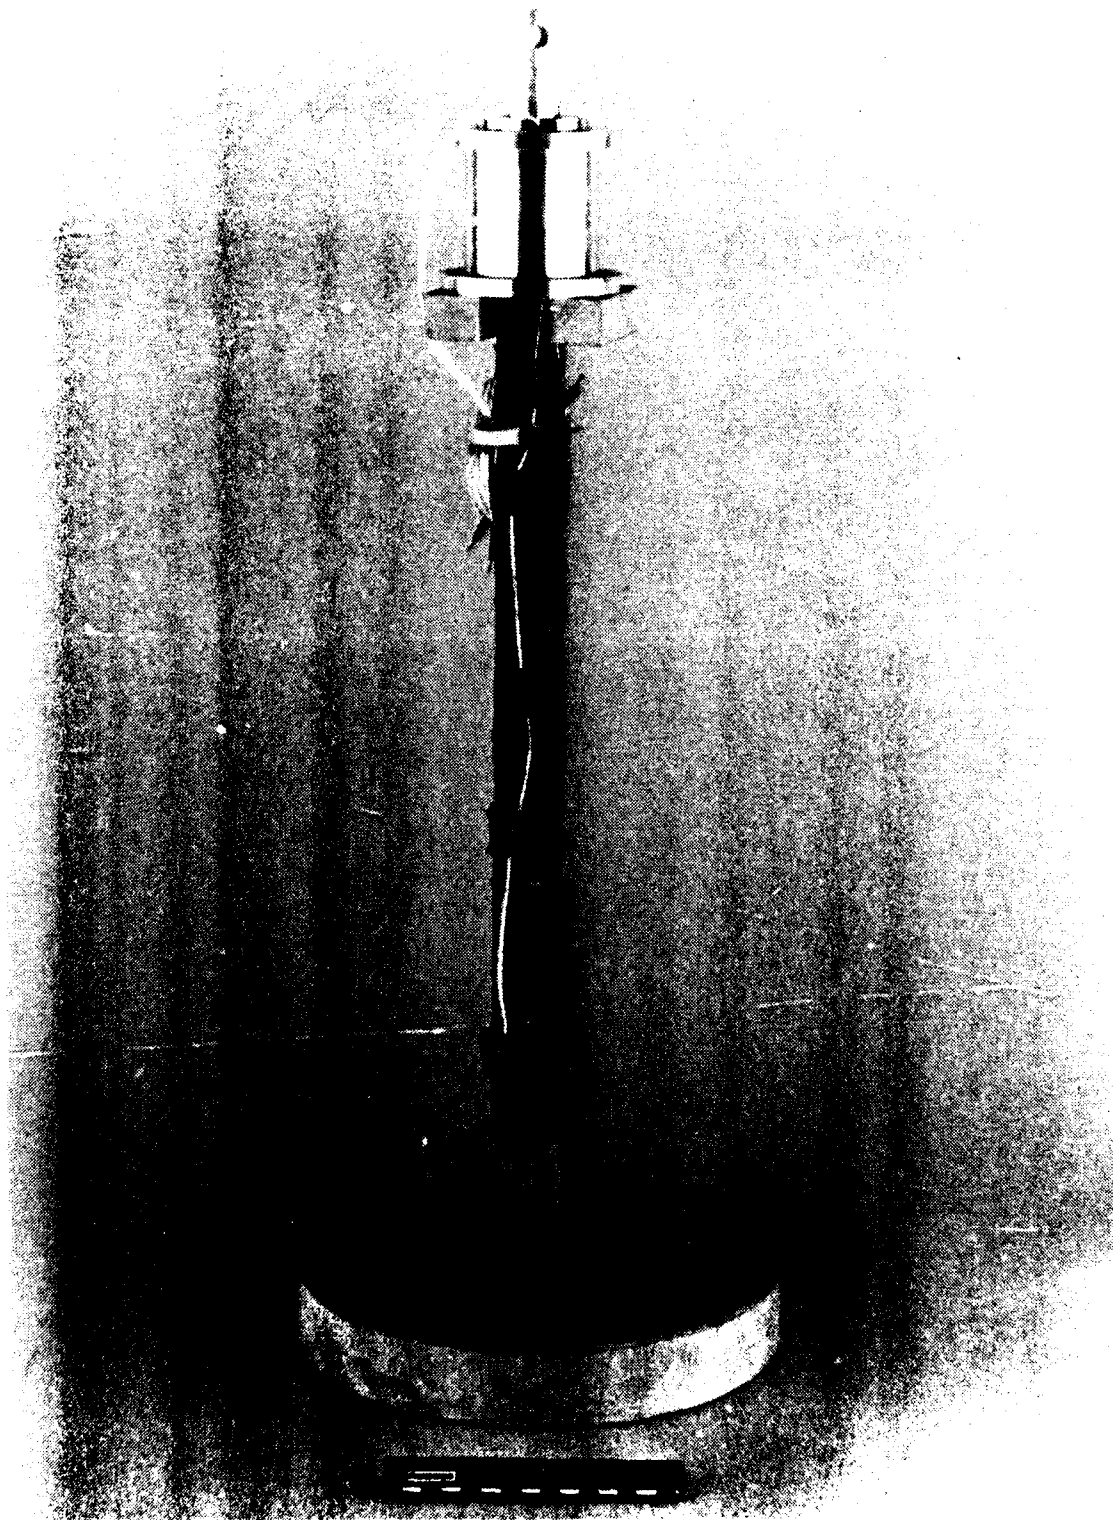
Figure 3-1. Overall Specimen-holding Fixture

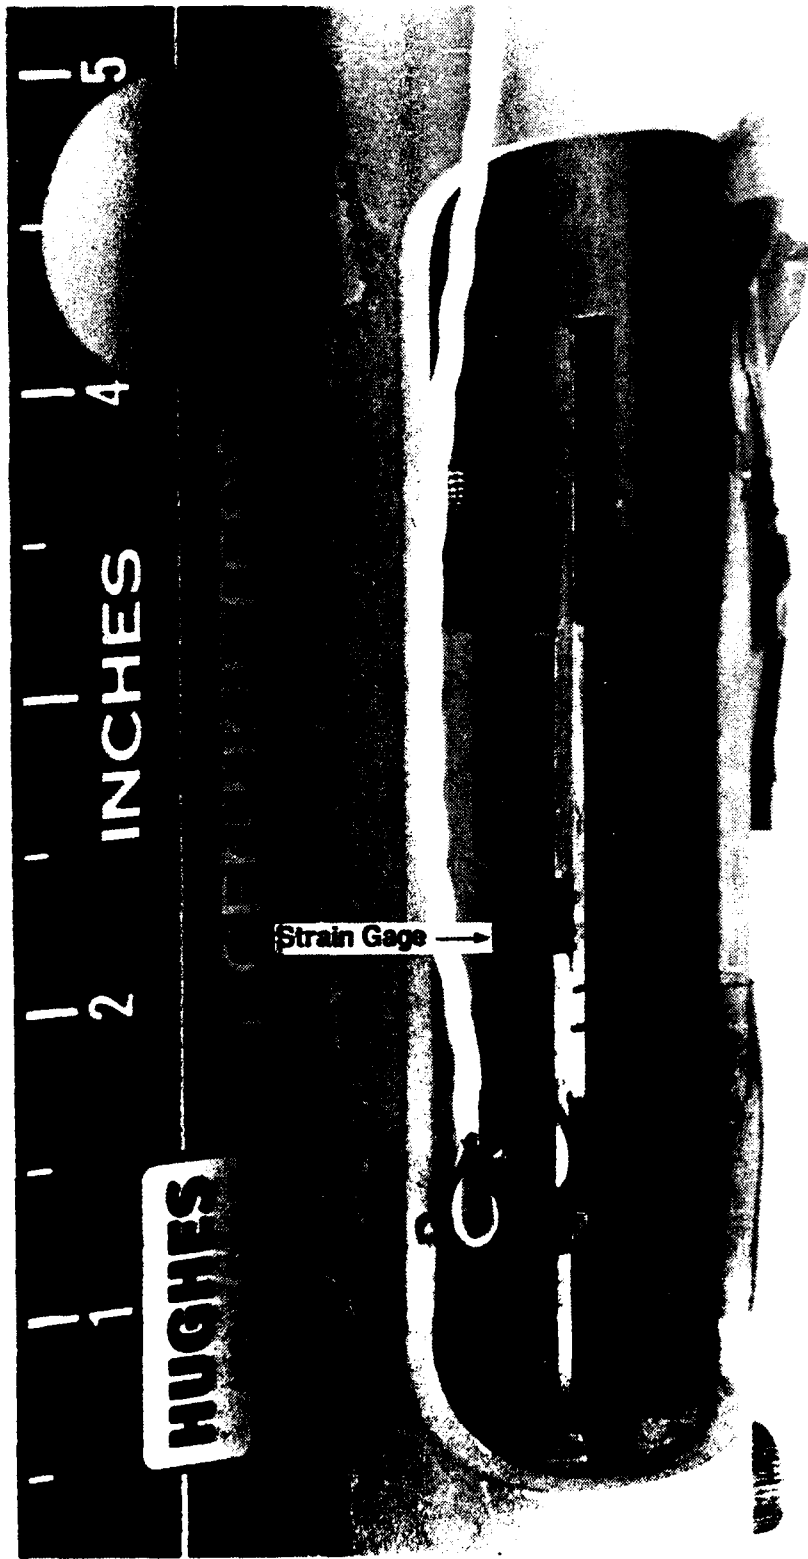
Figure 3-2. Close-up of Test Specimen in Holding Fixture

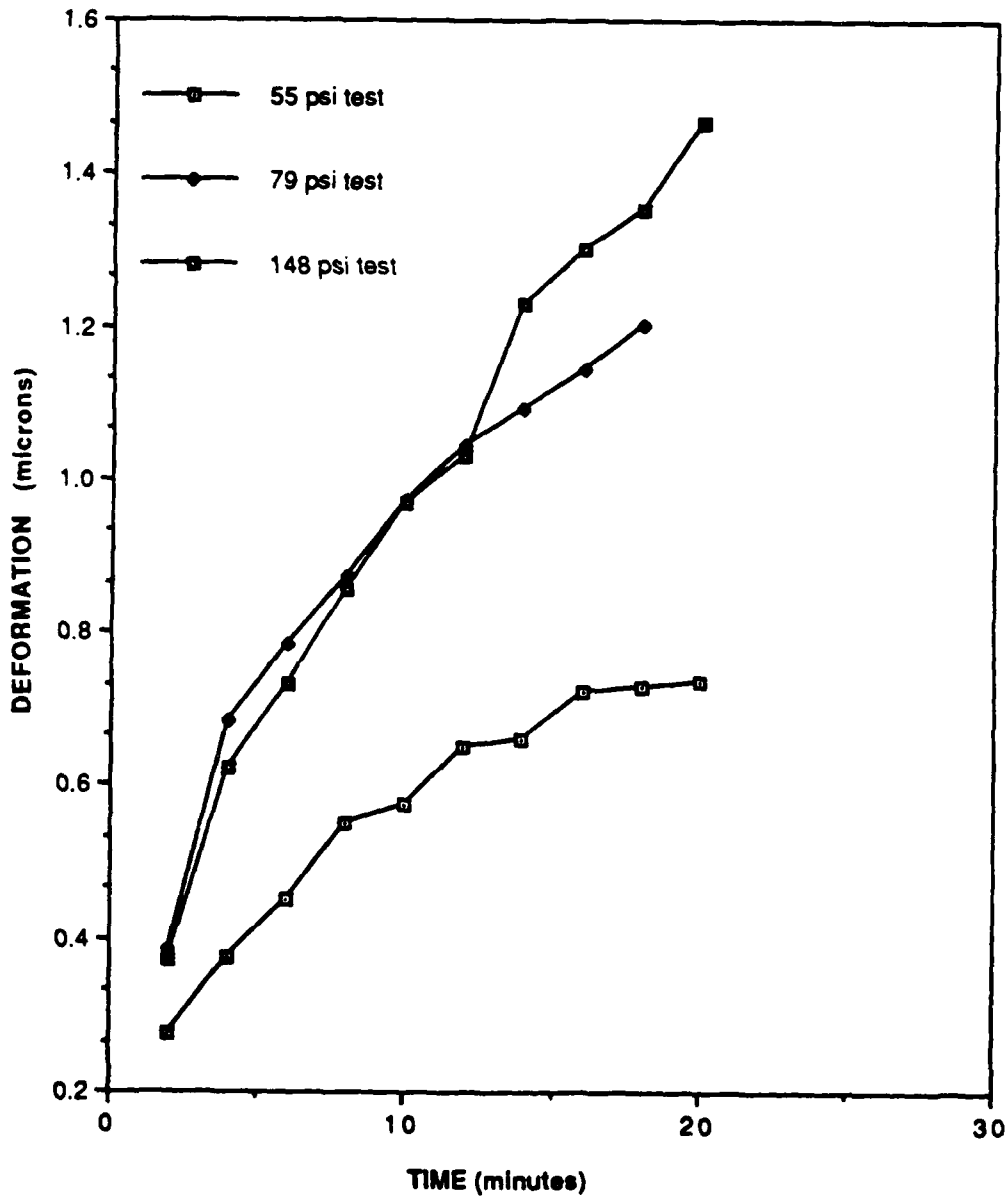
Figure 3-3. Room-temperature Creep Tests at 294K

1. Creep rate in the indium increases with increasing test temperature and holding stress.
2. The near linear slope of the major portion of the curves is similar to the start of second stage or steady state creep. The rapid deformation exhibited by adding a small cyclic loads to the steady state load after the 189K and 77K creep tests is not typical creep behavior.
3. Small cyclic loading and relaxation unloading around the constant holding stress also accelerates the creep rate in specimens tested at 189K and 77K.

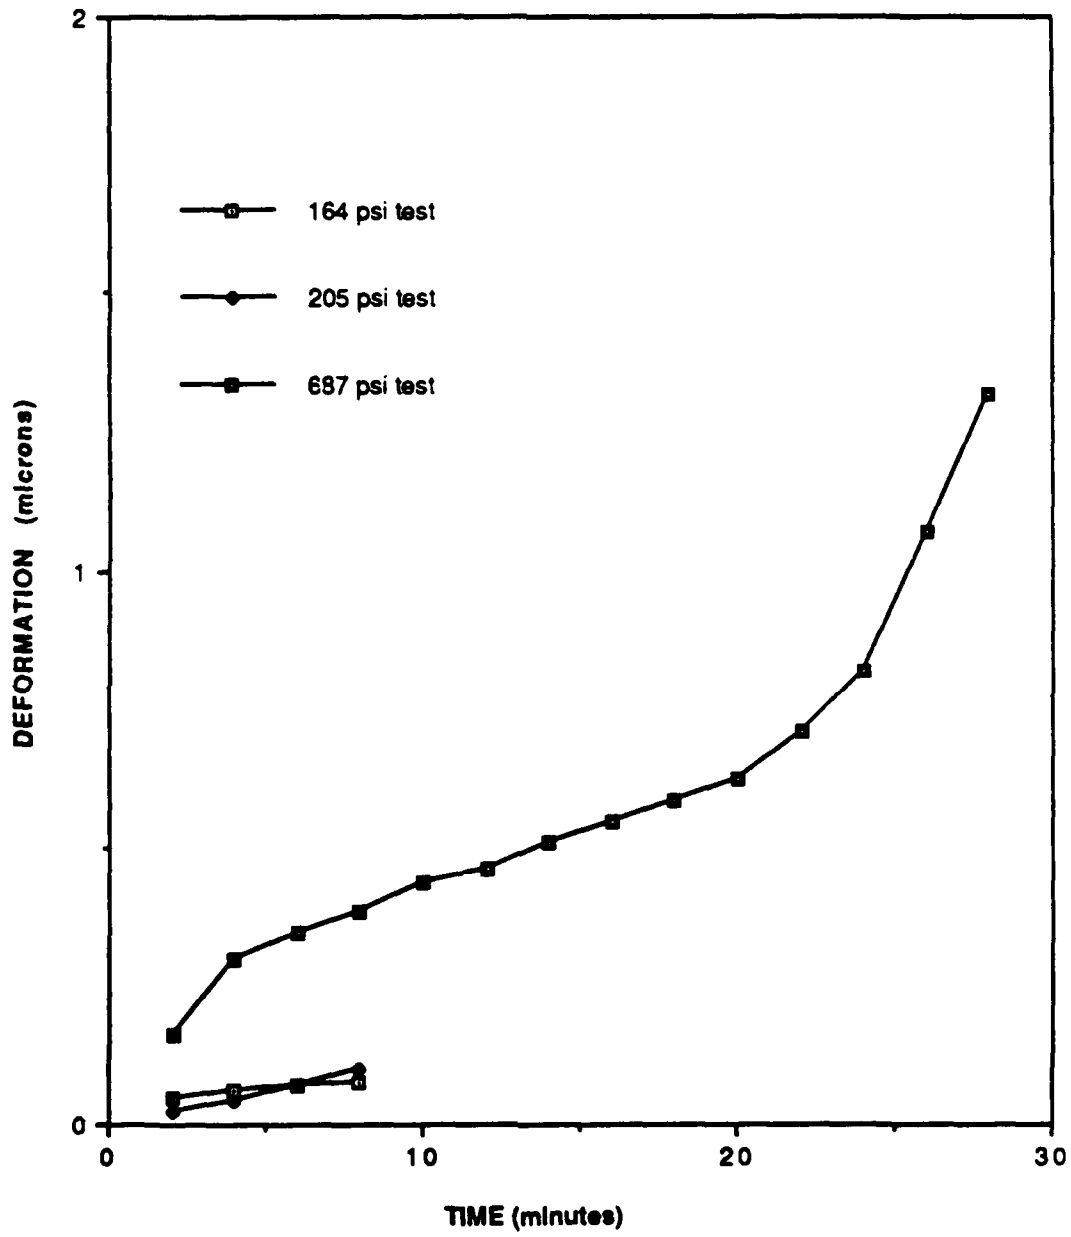
The creep characteristics of the specimen tested in dry ice and acetone are shown in Figure 3-4, and actual values are recorded in Table 3-2. The specimen held at 164 psi was first deformed a total of 3.1 μm at a constant rate of 0.6 $\mu\text{m}/\text{min}$. The specimen held at 205 psi was first deformed 5.0 μm at a rate of 0.9 $\mu\text{m}/\text{min}$. These specimens were held at constant load for 8 minutes when the test had to be terminated due to strain gage failure. The specimen held at 687 psi was deformed 7.5 μm at a constant rate of 1.2 $\mu\text{m}/\text{min}$ and held at constant stress for 20 minutes. The curve beyond 20 minutes represents the deformation that occurred as the stress was cycled from 671 psi to 703 psi for 4 cycles. Creep rate is seen to increase with increasing constant stress for the three tests. The portion of the 687 psi test from 20 to 28 minutes indicates that large deformations resulted from ± 16 psi changes in the constant stress level, and do not represent normal creep behavior.

Figure 3-4. Dry -ice and Acetone Creep Tests at 189K

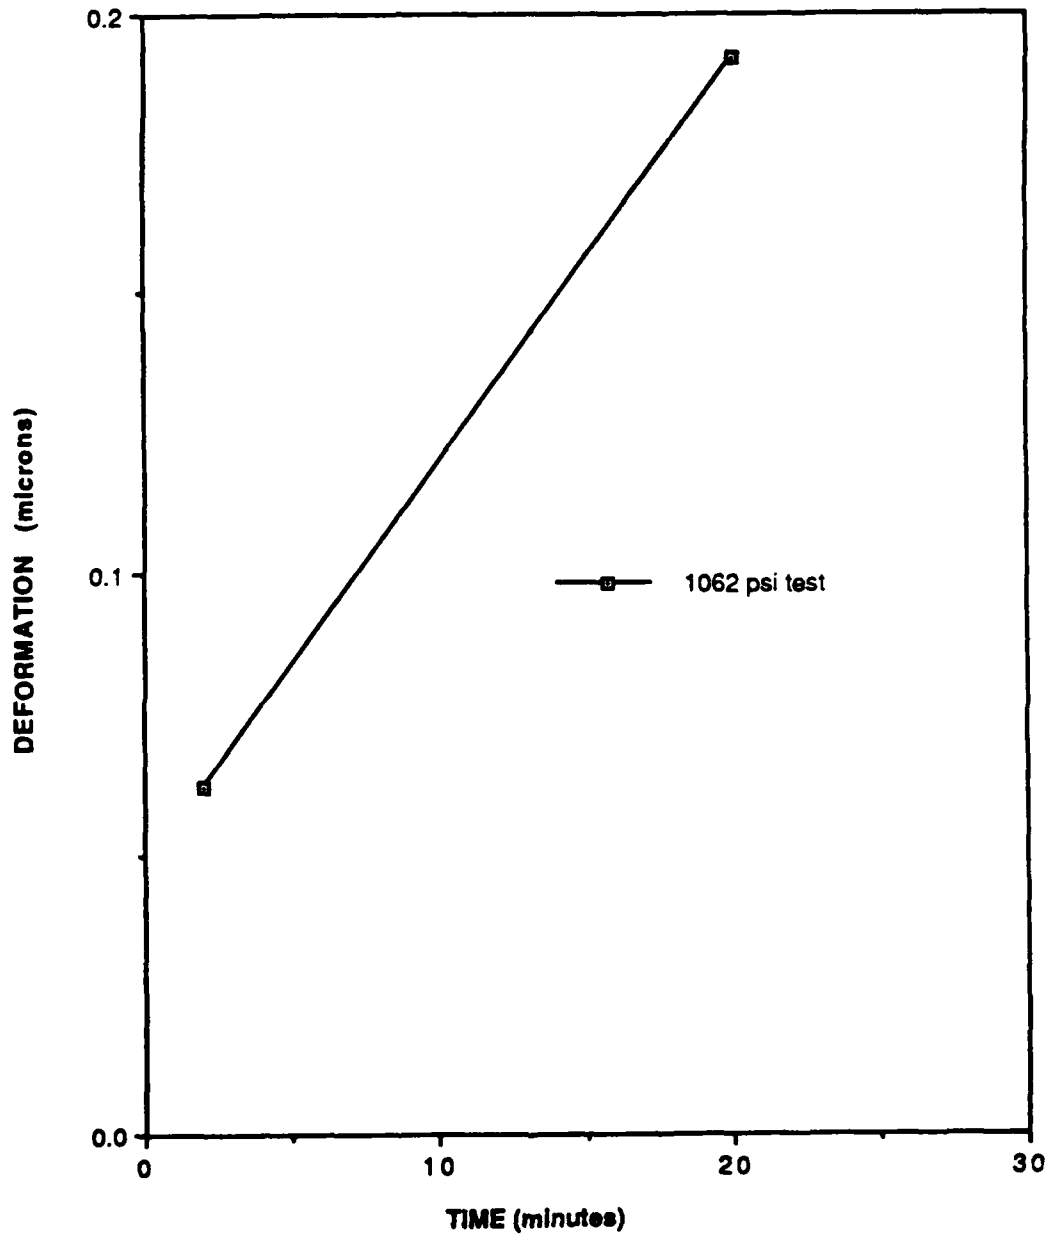
Figure 3-5. Liquid-nitrogen Creep Tests at 77K

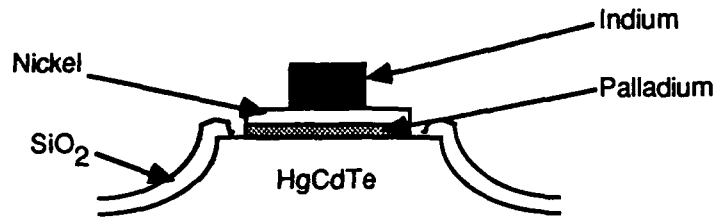
The next step was to strip 128² devices of their layers (metal and SiO₂) so that defect etching could be performed. The architecture of devices, with a description of the thin film layers, is shown in Figure 4-1. Stripping occurred in three steps:

Figure 4-1. Architecture Layers of Diode

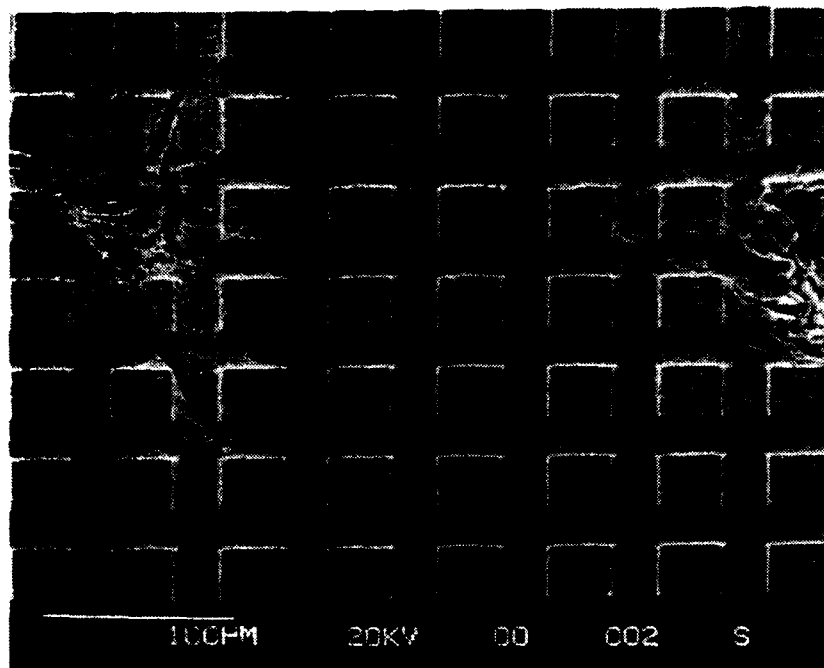
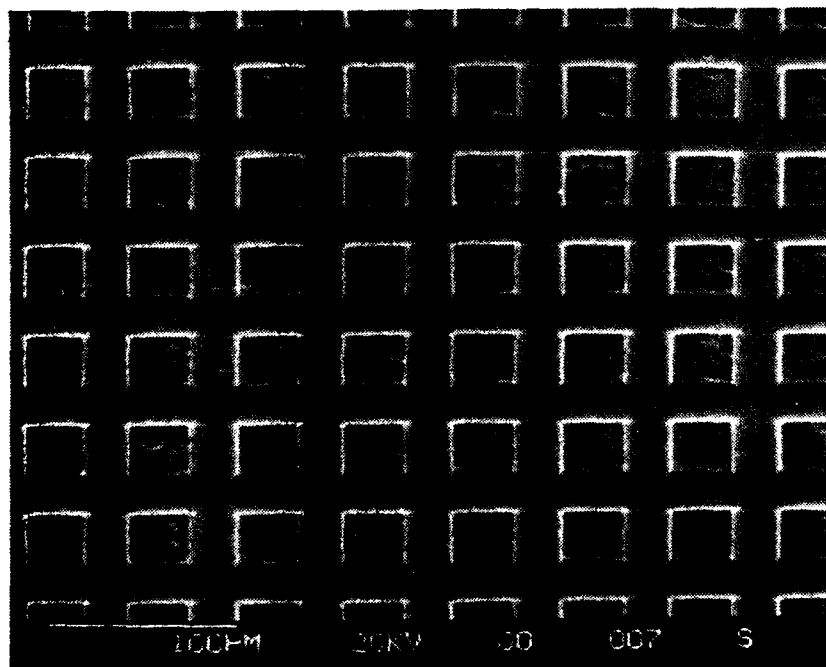
Electrical testing revealed that performance of diodes near induced damage was significantly lower than for remote diodes. The 11 numbered diodes shown in Figure 5-1 were among those diodes accessed electrically through the fanout, to which the array was hybridized. The I-V curves of the nine numbered diodes shown in Figure 5-1a are plotted in Figure 5-2a. The two numbered diodes pictured in Figure 5-1b and seven additional diodes from areas isolated from induced damage have their I-V curves plotted in Figure 5-2b.

Figure 5-1. Increased Etch-pit Density near Induced Damage. The dramatic increased in the density of revealed dislocations can be seen by comparing the densities near and remote from damage.

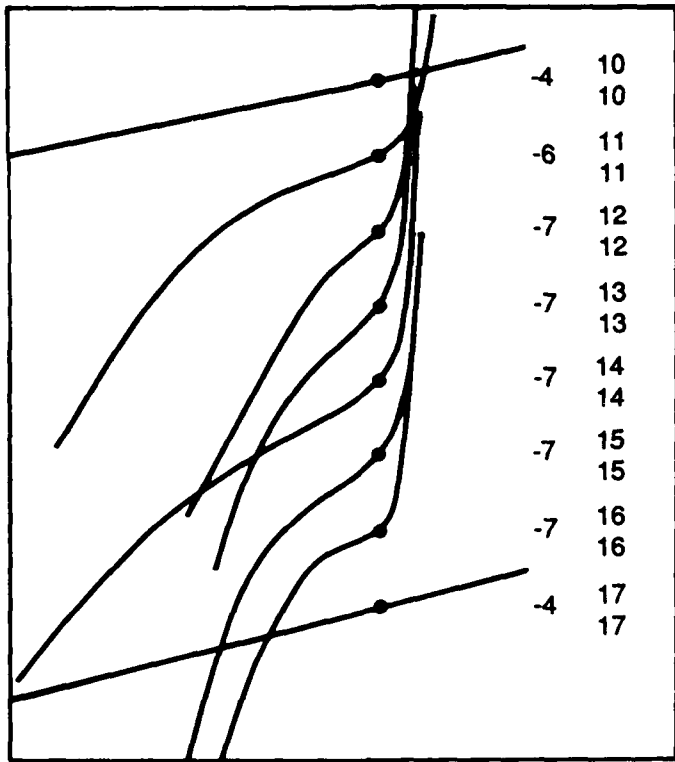
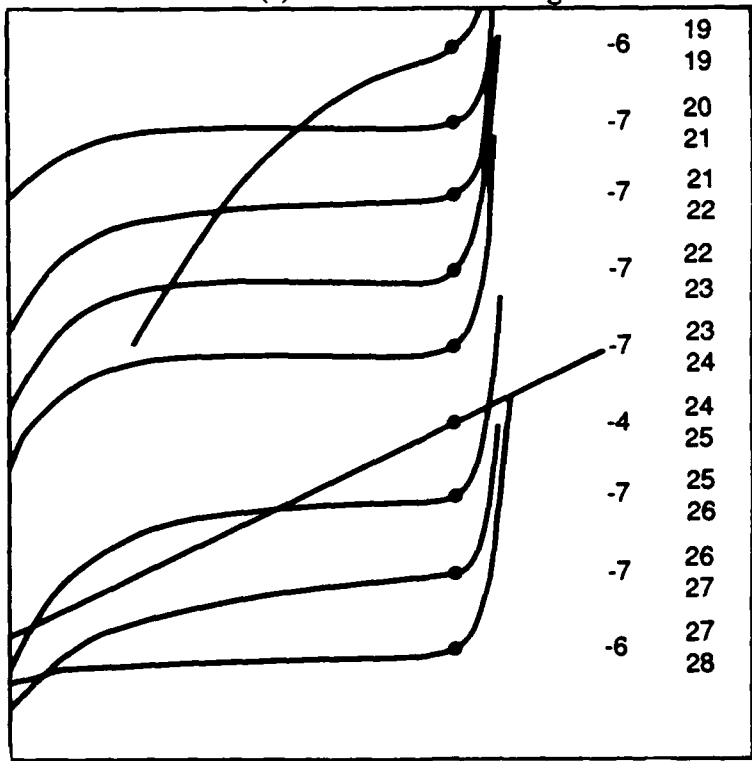
The degradation in I-V characteristics of diodes near points of induced damage can be seen by comparing the curves in Figure 5-2a to those in Figure 5-2b. Two quantities that decrease with degraded electrical performance are R_0 , the resistance at zero voltage, and R_T at -50 mV. Decreased R_0 of the damaged diode is seen as an increased I-V curve slope at the origin and decreased R_T can be seen as increased slope at -50 mV. One additional visual indication of reduced performance is reverse bias breakdown of the curves plotted in Figure 5-2a. The two linear I-V curves, diodes 10 and 17, indicate shorts. From Figure 5-1a it shows that diode 10

Figure 5-2. Degraded Electrical Performance near Manually Induced Damage. Degradation of electrical performance of diodes near induced damage can be seen as increased slope at 0 mV and -50 mV when compared to diodes remote from damage.

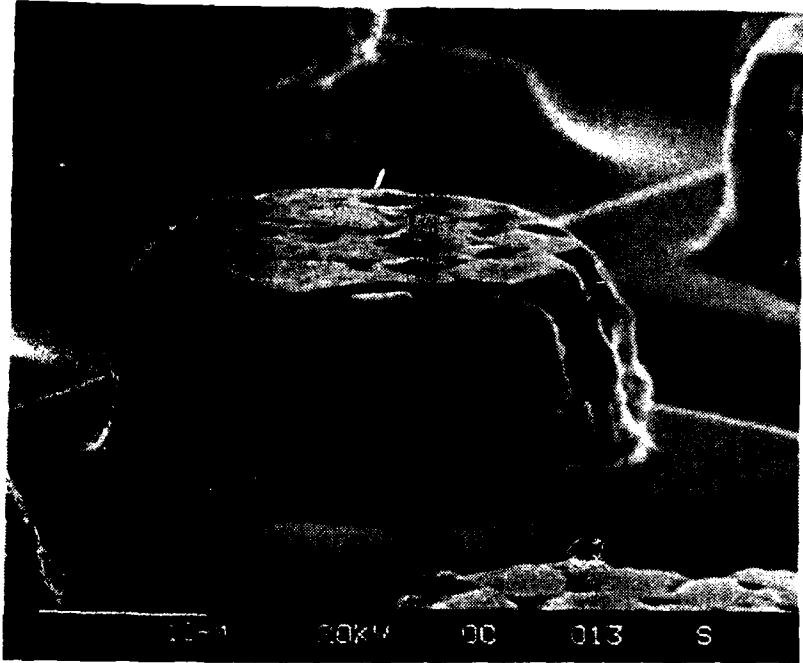
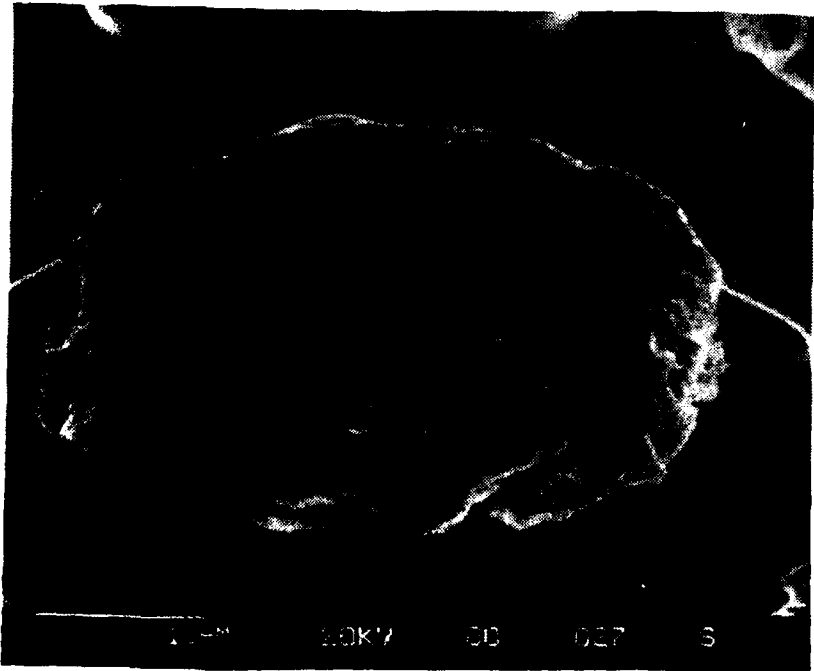
Figure 5-3. Hybridization Stress Buffered by Cold Flow Characteristics at Indium Bumps. Stress Calculated by dividing applied force by resulting cross-sectional indium area does not increase with increased hybridization force.

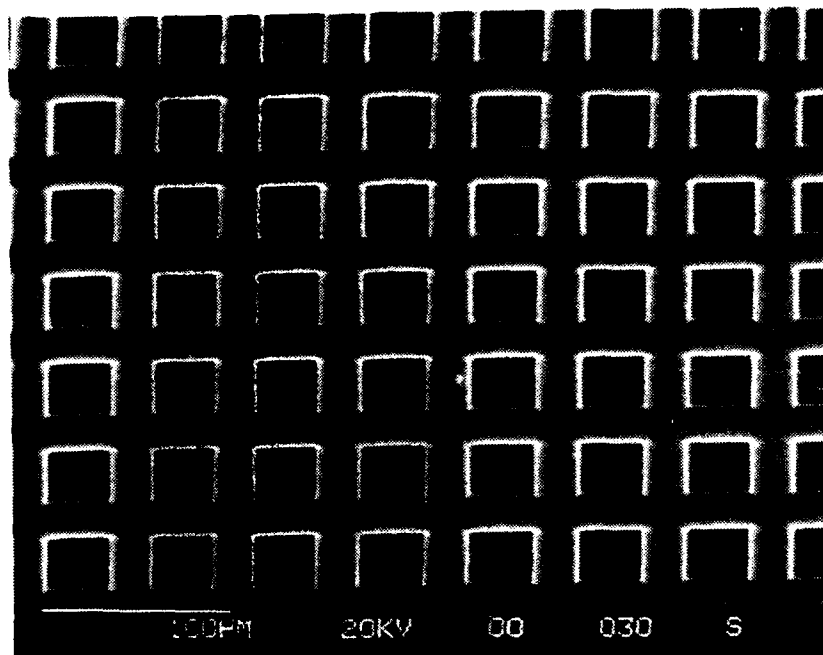
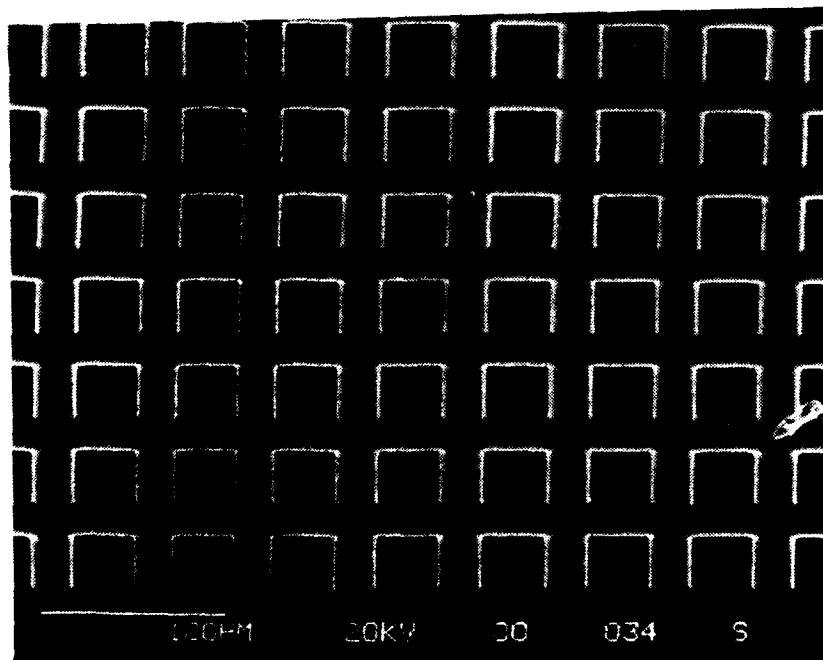
Figure 5-4. Etch-pit Density Not Increased by Hybridization Forces between 0 and 120 lb. It can be seen that the density of revealed dislocations is unaffected by a four fold increase in hybridization face.

SEM analysis of the Task 2 IRFPAs revealed that increased etch pit densities occurred only where hybridization forces equal to or larger than 120 lb were applied. Etch pit densities typical of the arrays hybridized at pressures ranging 0.0 lb (unhybridized arrays) to 35 lb are presented in Figure 5-4. These arrays were hybridized at 8.4 lb (Figure 5-4a) and 35.1 lb, (Figure 5-4b) and the etch pit were densities found to be statistically equal to that of arrays that were not hybridized. The etch pit densities of the arrays pictured in Figure 5-4 as well as the remainder of Task 2 arrays hybridized with pressures up to 35 lb are compiled in Table 5-3. The tabulated results show that there is no change in etch pit density with increased pressure which corresponds well with the independence of stress and hybridization force discussed above.

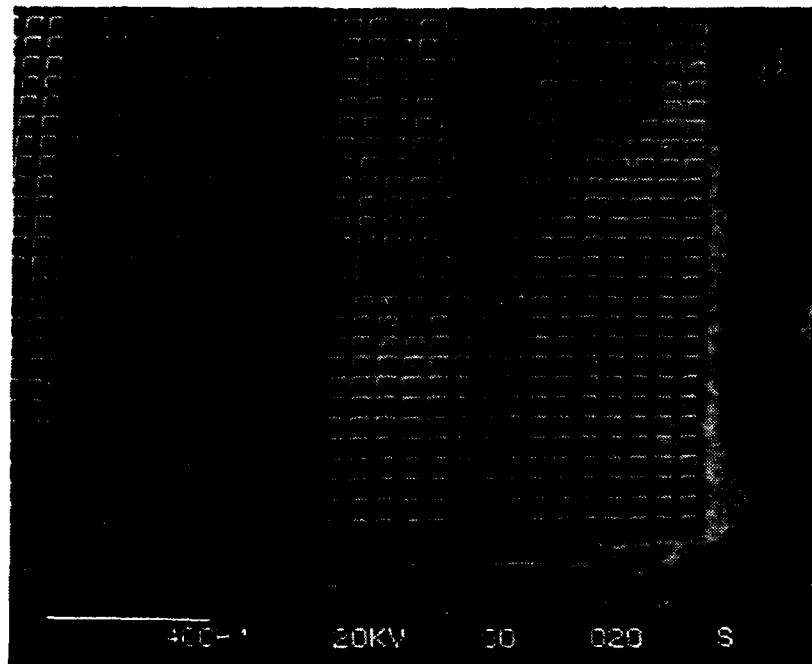
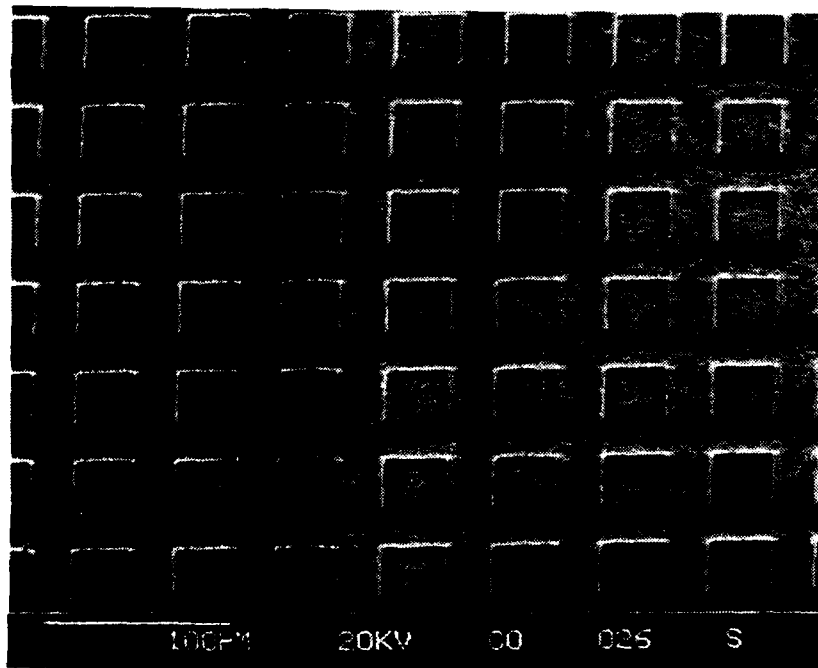
Figure 5-6. Increased Etch-pit Density Due to Hybridization a Force in Excess of 120 lb. A dramatic increase in the density at revealed dislocation can be seen to the right of the "line" of demarcation.

The observation that the etch pit density is increased only in areas where indium buffering does not exist is confirmed quantitatively in Table 5-3 where the pit densities and the equivalent hybridization force at several location across the array are tabulated. The two etch pit values at 120 lb are for the diodes immediately to the left and to the right of the "line" of demarcation. The density value listed for 0 lb was obtained from the corner of the array where no contact was made. The densities at points exposed to forces less than 120 lb show no significant increase from the density at 0 lb.
