NRL HYBRID RELIABILITY

**PHYSICS OF FAILURE
INITIAL STUDY**

**FINAL REPORT FOR
PERIOD 1 OCTOBER 1986 TO 30 SEPTEMBER 1988**

NRL HYBRID RELIABILITY PHYSICS OF FAILURE INITIAL STUDY

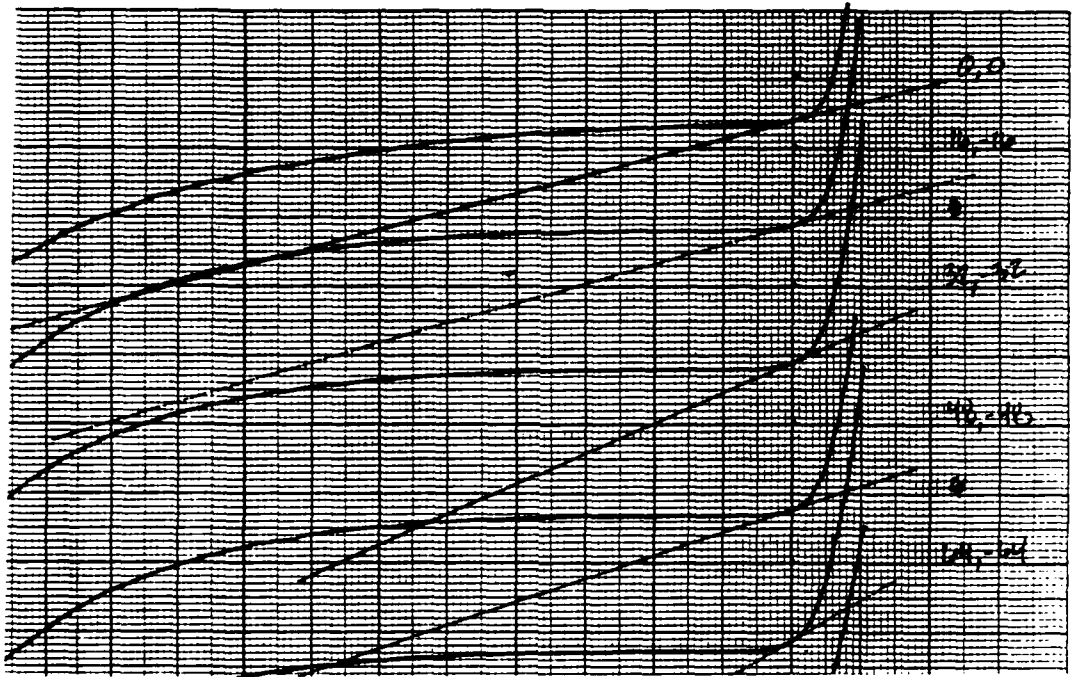
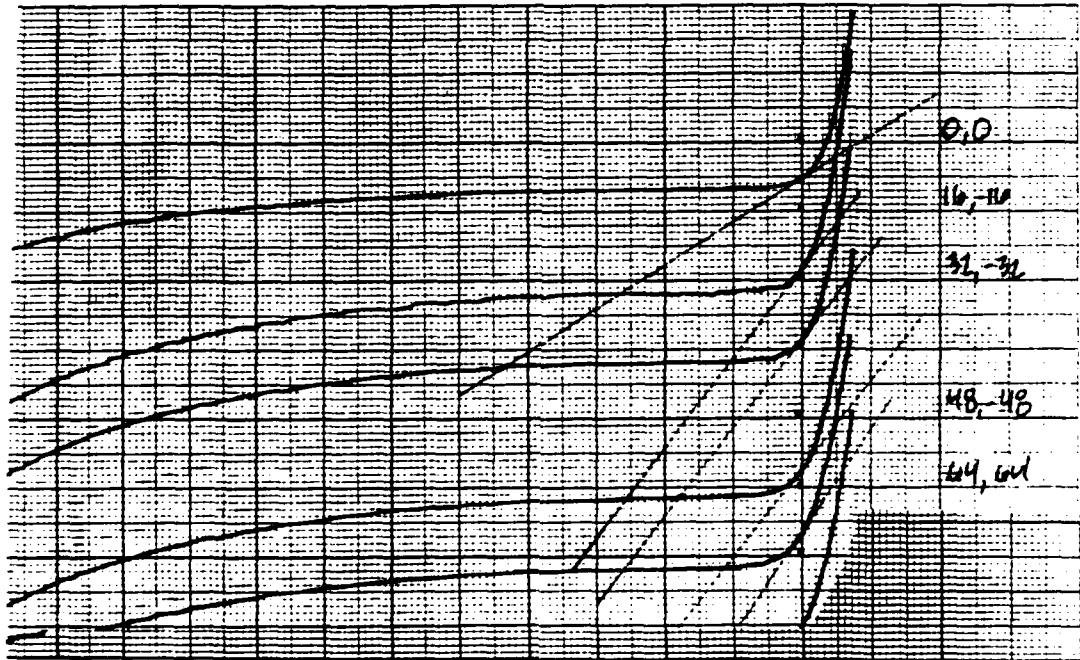
I-V curves of several diodes from a Task 2 array hybridized at 34 lb are shown in Figure 5-7. The pictured array and several others were tested using open-dish probing. The I-V curves in Figure 5-7a were measured before hybridization and those in Figure 5-7b were generated after hybridization. A comparison of the two sets of I-V curves show that the I-V characteristics of the tested diodes are unchanged by hybridization. Indications of degradation such as early reverse bias breakdown or a change in slope at zero bias, R_0 , do not occur. The only consistent changes that occur is a shifting of the curves along both the current and voltage axis. These shifts

Figure 5-7. Open-field-of-view Electrical Performance Unchanged by Hybridization at 35 lb. I-V curves typical of arrays viewing warm scene show no degradation due to hybridization.

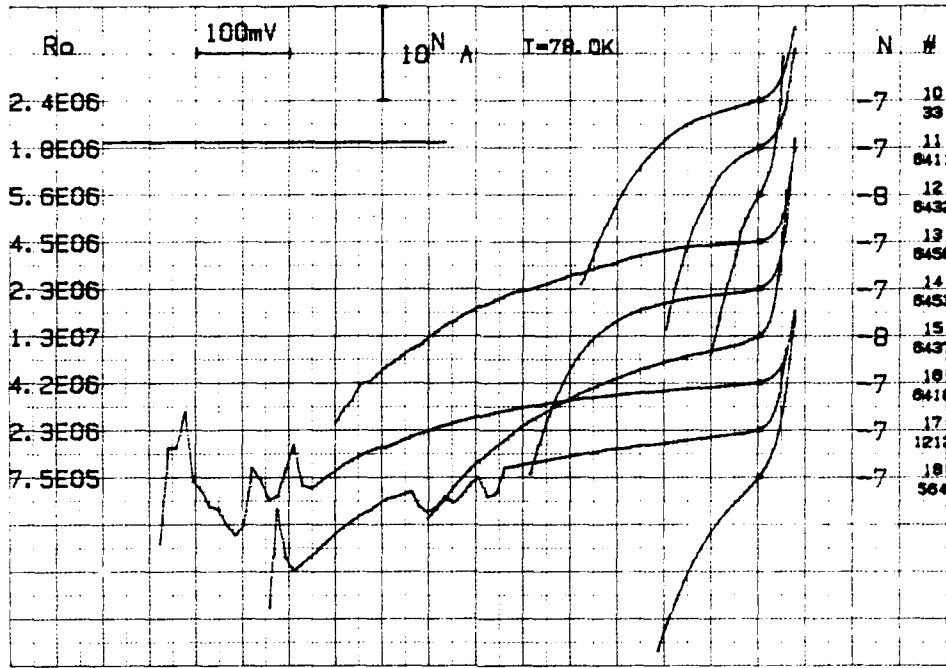
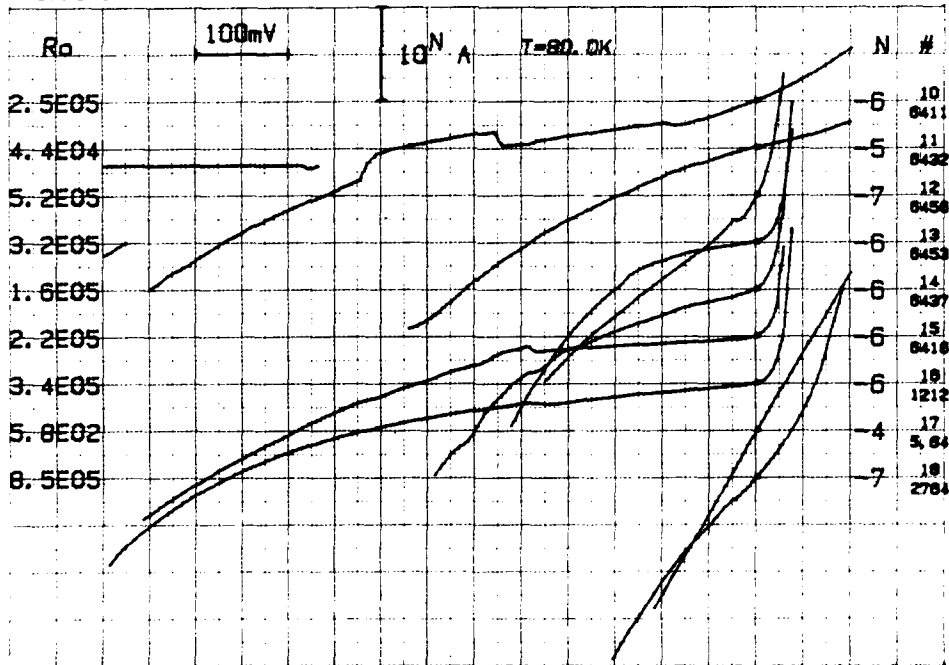
Figure 5-8. Zero Field-of-view Electrical Performance Unchanged by Hybridization at 35 lb. I-V curves typical of arrays viewing a cold scene show no degradation due to hybridization

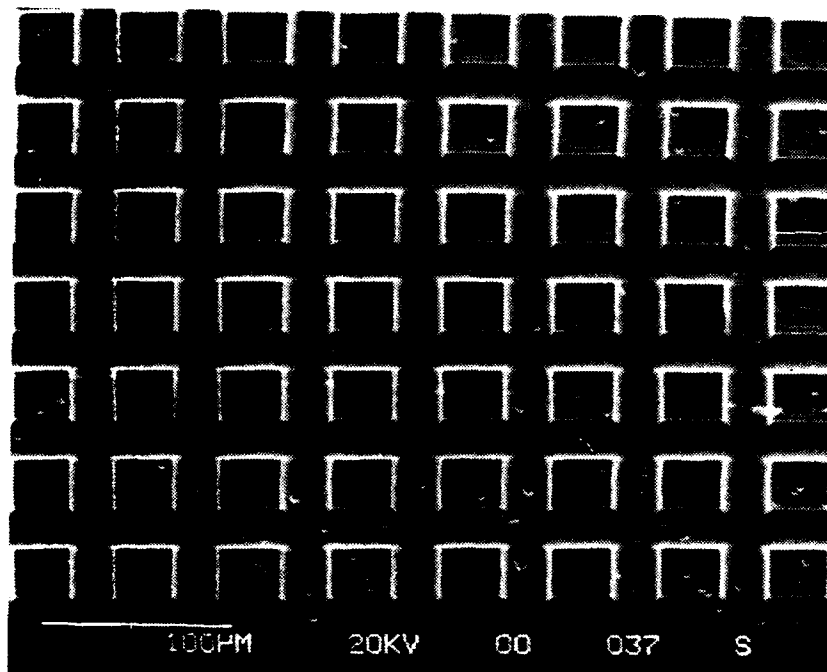
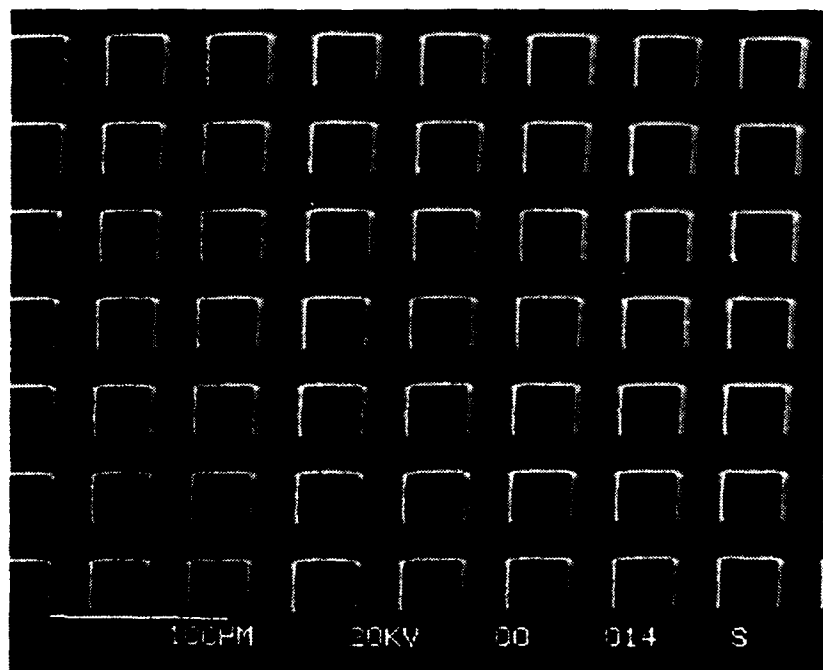
Figure 5-9. Etch Pit Density Not Affected by 200 Thermal Cycles. It can be seen that no increase is revealed dislocations occur as a result of 200 thermal cycles.

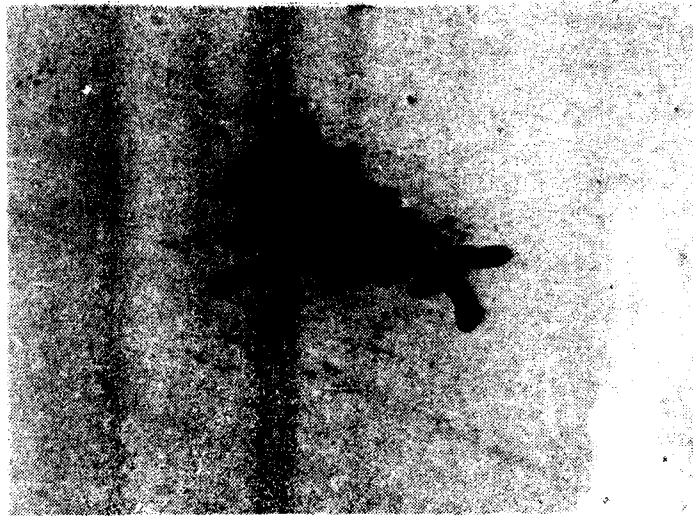
Micrographs of Etched HgCdTe Surface (500X) After Various Etch Times ($\text{H}_2\text{O}_2:\text{NH}_3\text{OH}$ 2:1,
(a) 10 min, (b) 15 min, and (c) 20 min.

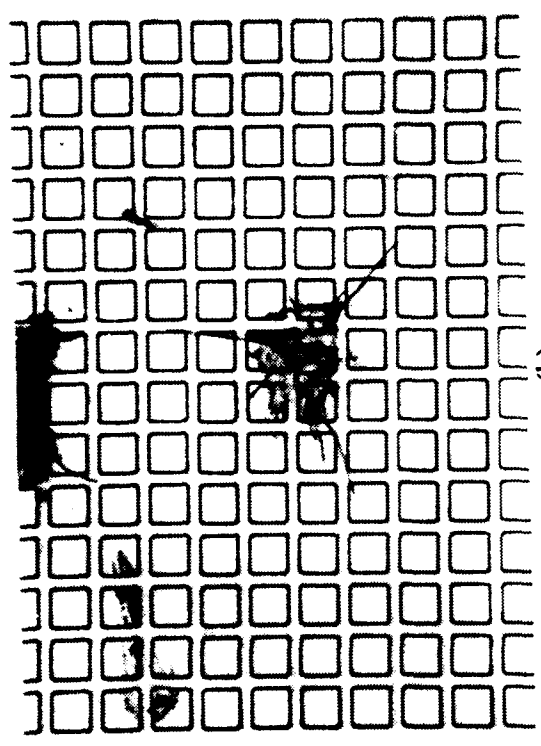
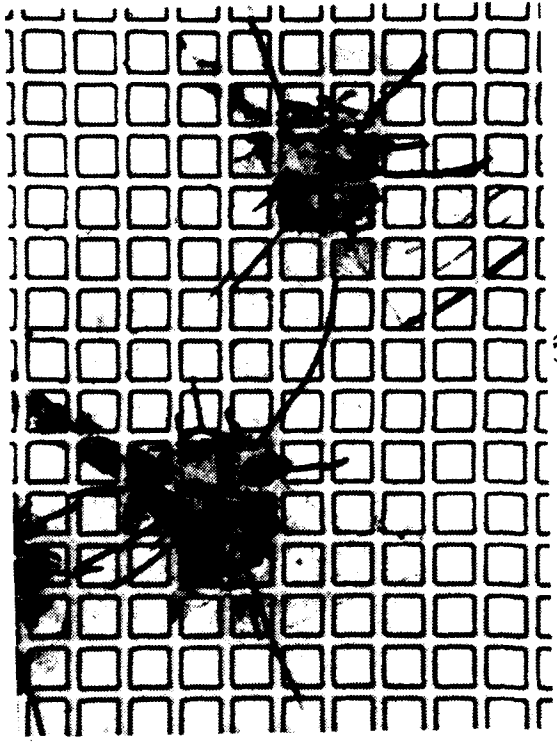
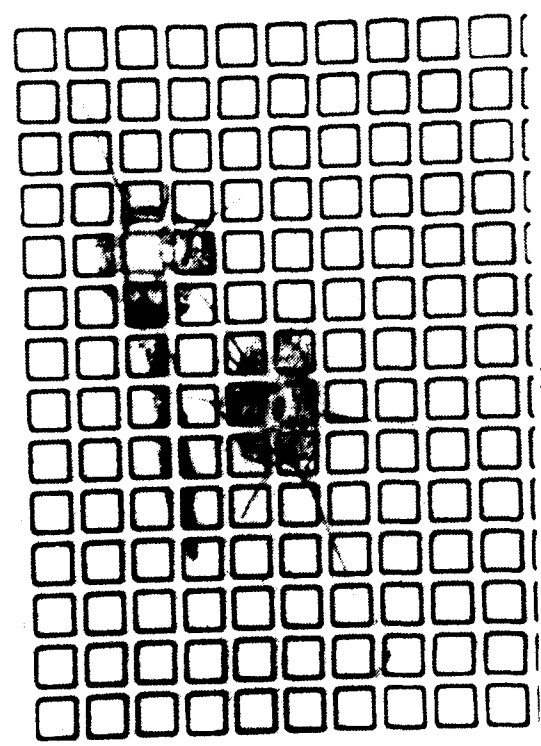
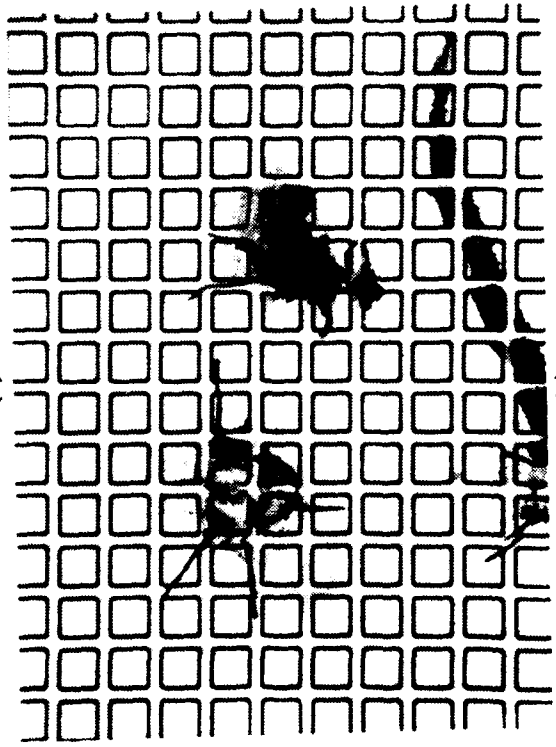
Micrographs of Etched HgCdTe Surface (200X) After Various Etch Times ($H_2O_2:NH_3$ OH 2:1, (a) 4 min, (b) 6 min, (c) 8 min, and (d) 10 min.

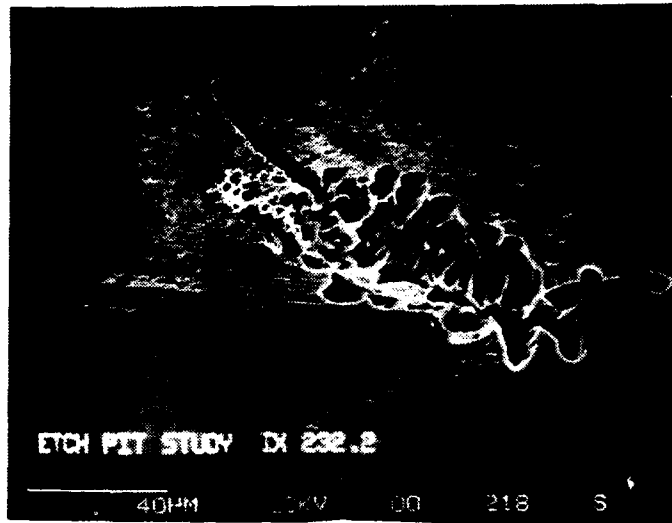
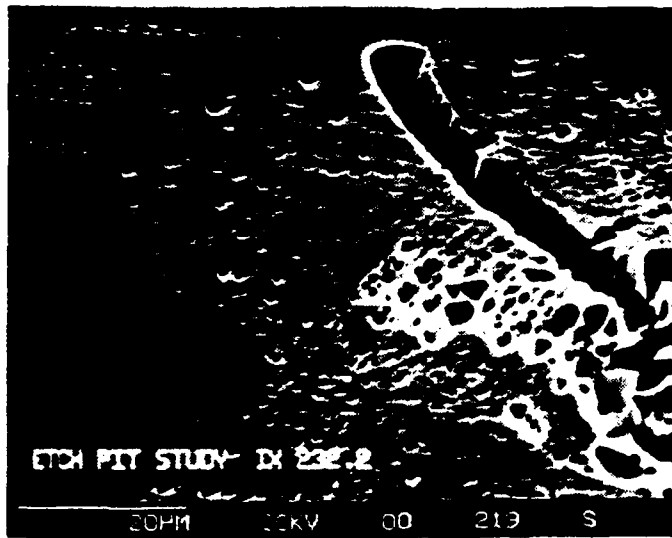
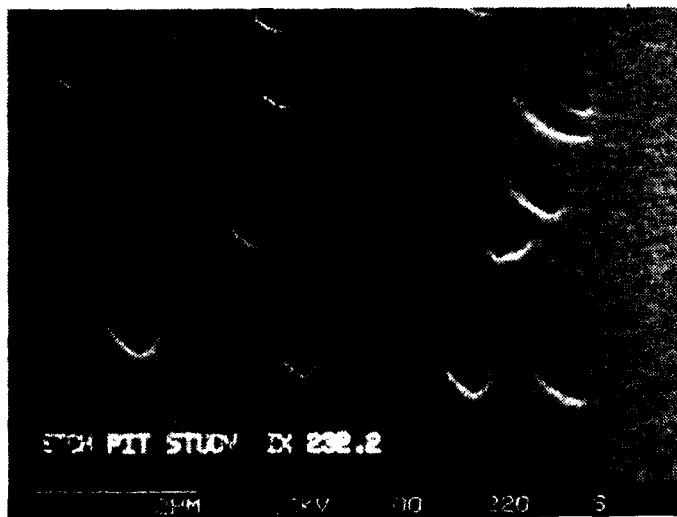
SEM Micrographs Showing Etch Pits on HgCdTe Surface After 10 Min Etch

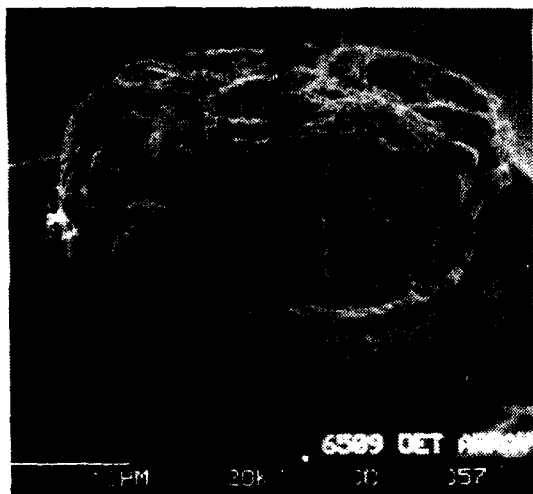
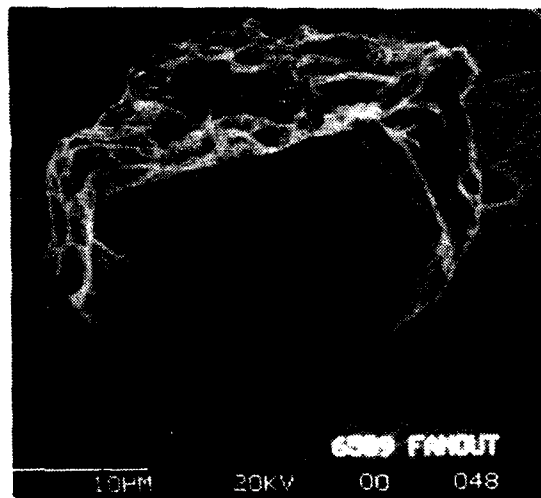
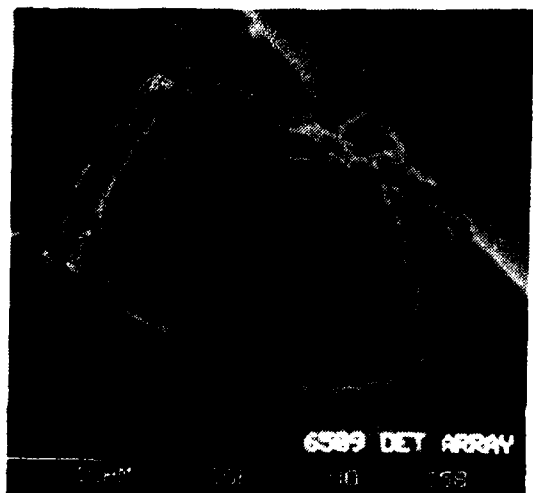
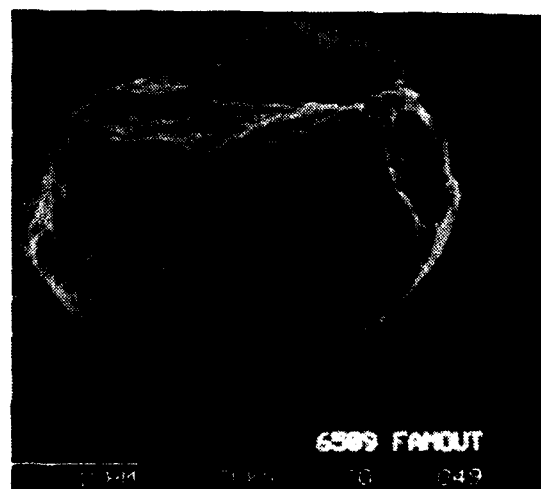
SEM Micrographs of Indium Bumps on Diodes and Fanout Metallization for (a) Diode 42 (b) Fanout for Diode 42, (c) Diode 43, and (d) Fanout for Diode 43

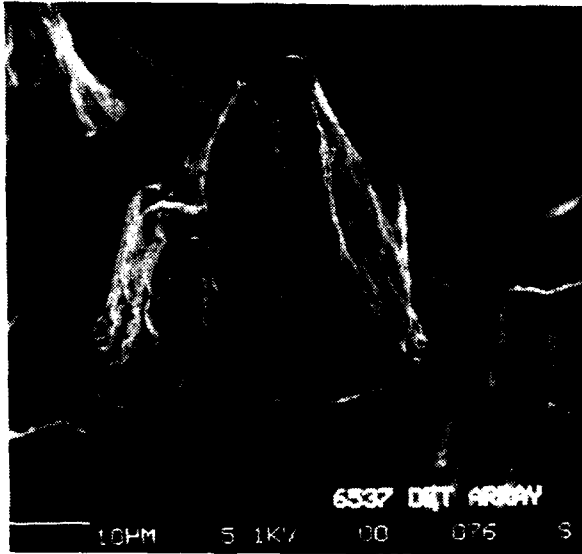
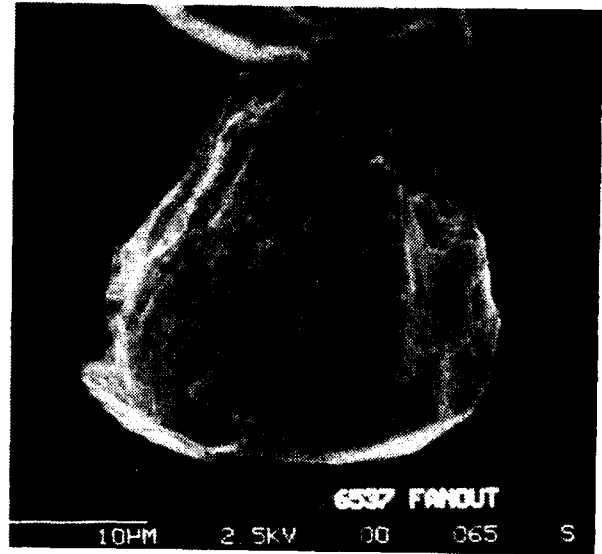
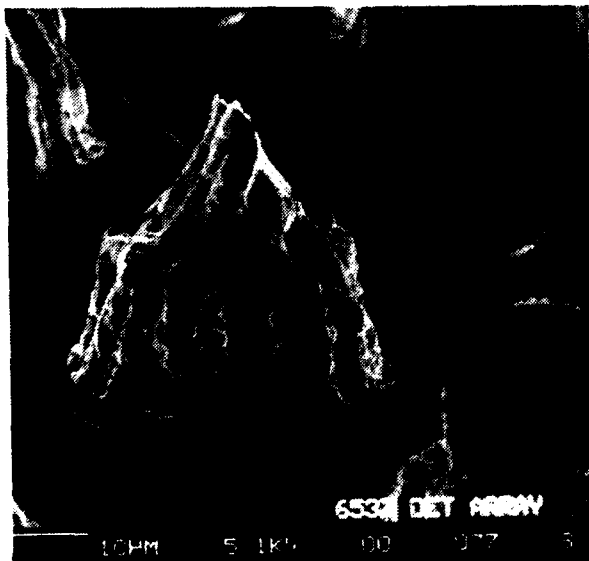
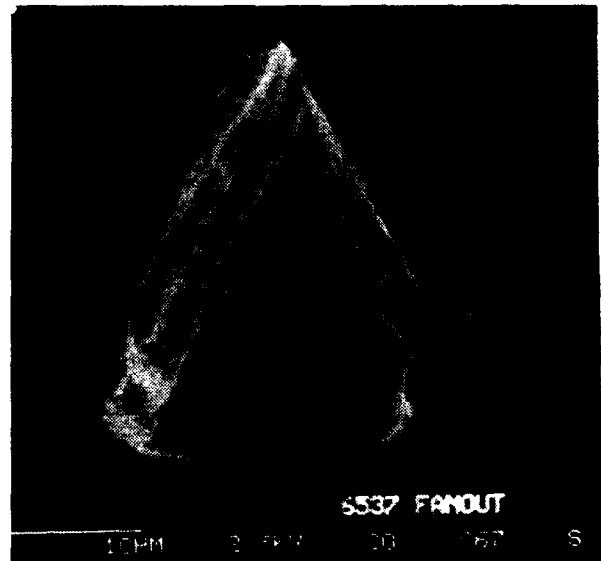
SEM Micrographs of Indium Bumps on Diodes and Fanout Metallization for (a) Diode 9 (b) Fanout for Diode 9, (c) Diode 11, and (d) Fanout for Diode 11

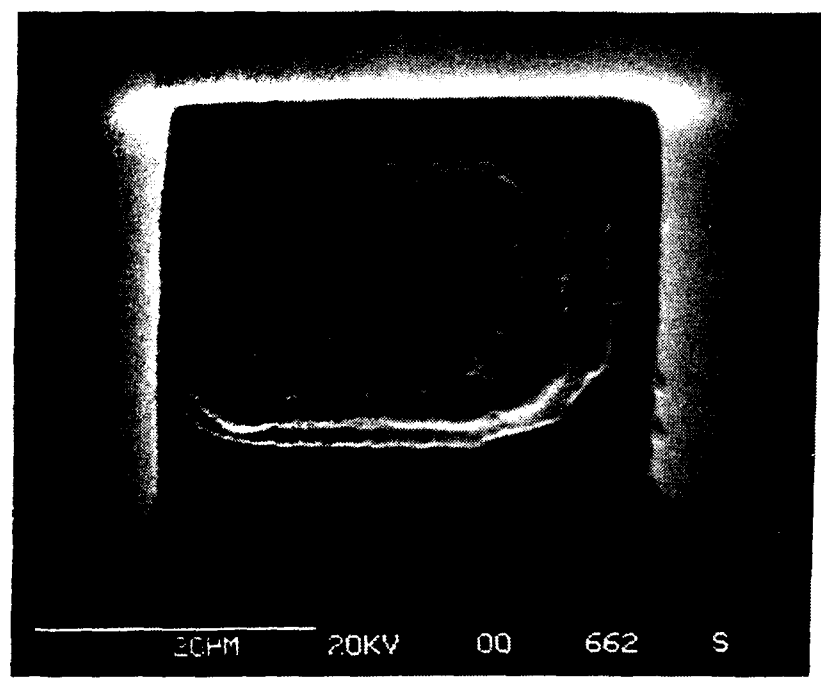
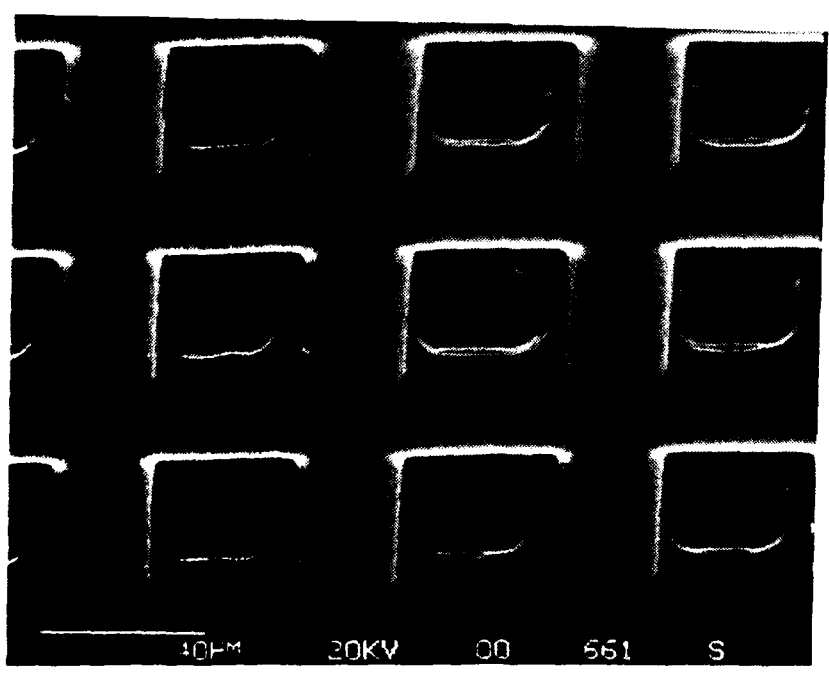
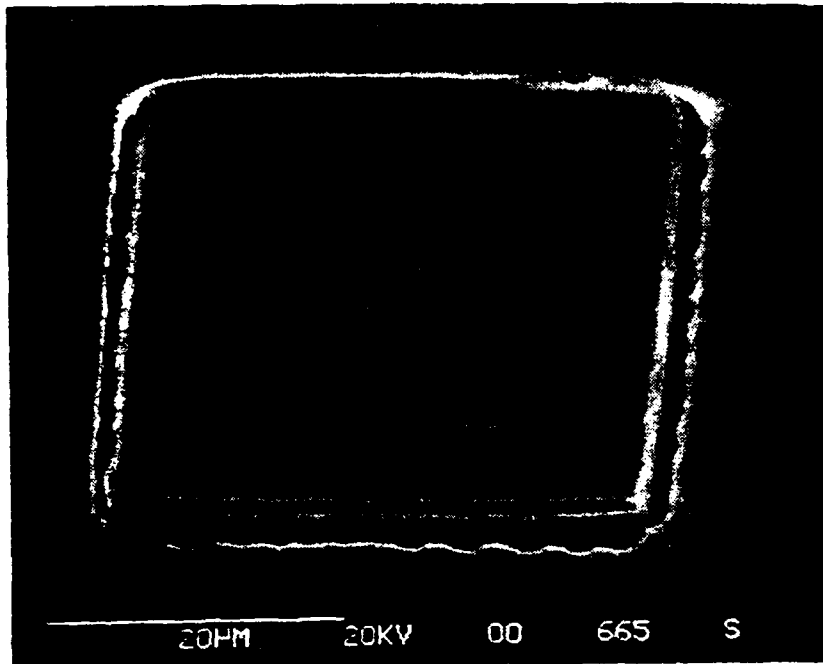
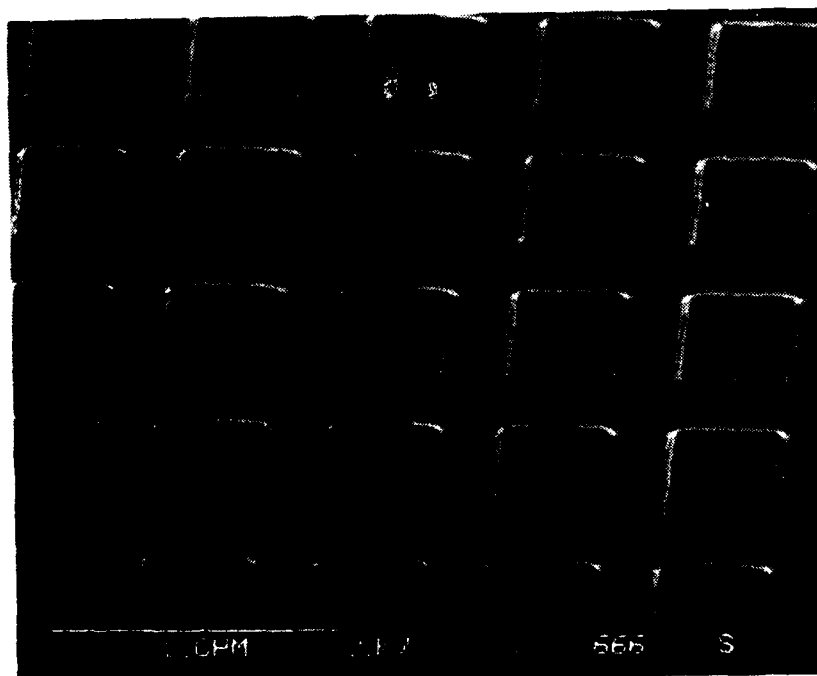
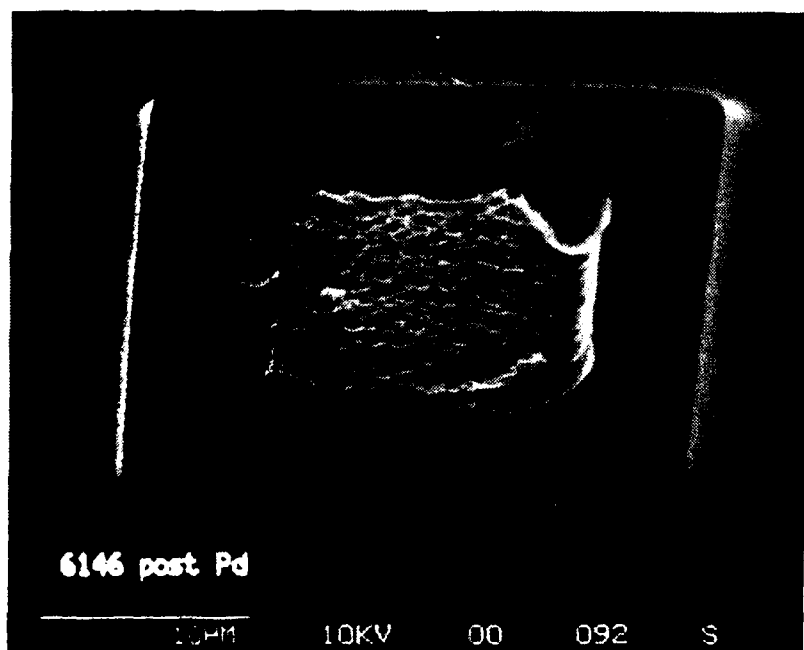
SEM Micrographs of HgCdTe Mesa Diodes After Etching of Pd Metallization

The dislocation etch did not reveal a significant difference in dislocation density between control diodes and degraded diodes as was hoped, but the results were affected by the etchants for the removal of palladium contacts. The etch pits varied from hybrid to hybrid without correlation to thermal stress. The dislocation etch was an appropriately sensitive diagnostic technique, however, as shown in the test samples in Appendix A.

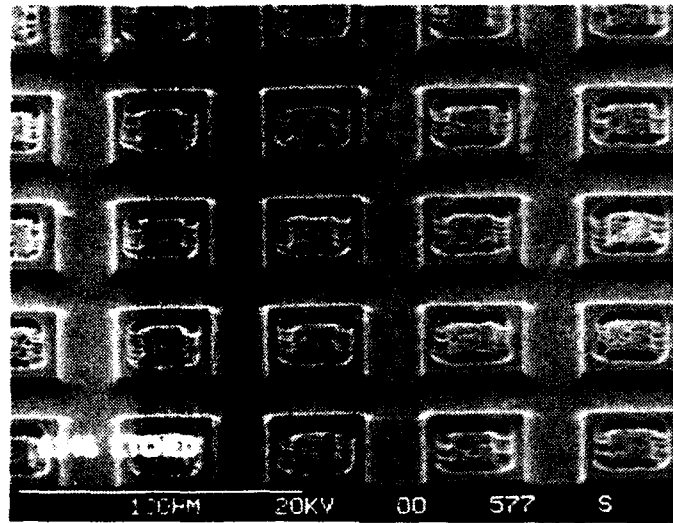
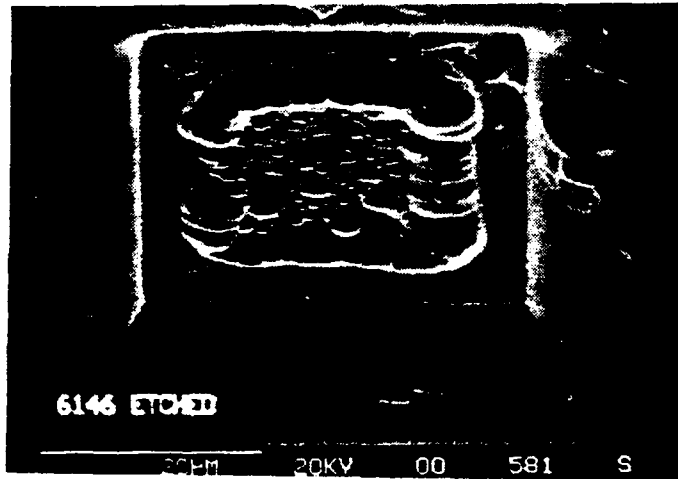
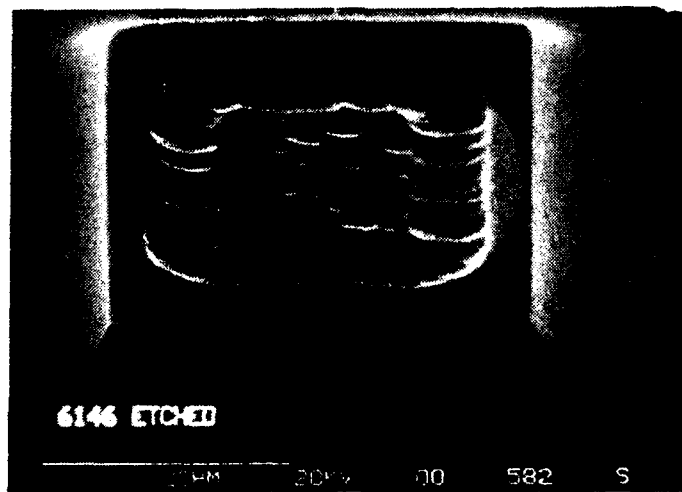
SEM Micrographs of HgCdTe Mesa Diodes After First Etching to Remove Pd and Then to Delineate Etch-Pits

Some dislocation differences were noted in the nonhybridized arrays and the hybridized arrays. The dislocation etch morphologies between the two were different, suggesting that either hybridization and/or thermal cycling altered the material under the mesa. Conclusive results are difficult, however, due to the problems encountered with the palladium etchant. Both etchants etched the underlying HgCdTe more than expected. Pictures of test samples with the palladium
