COMPUTER TOMOGRAPHY OF THERMAL BATTERIES AND OTHER  
CLOSED SYSTEMS

Richard H. Bossi

Boeing Aerospace Company  
P. O. Box 3999  
Seattle WA 98124

Interim Report For Period August 1988 - June 1989

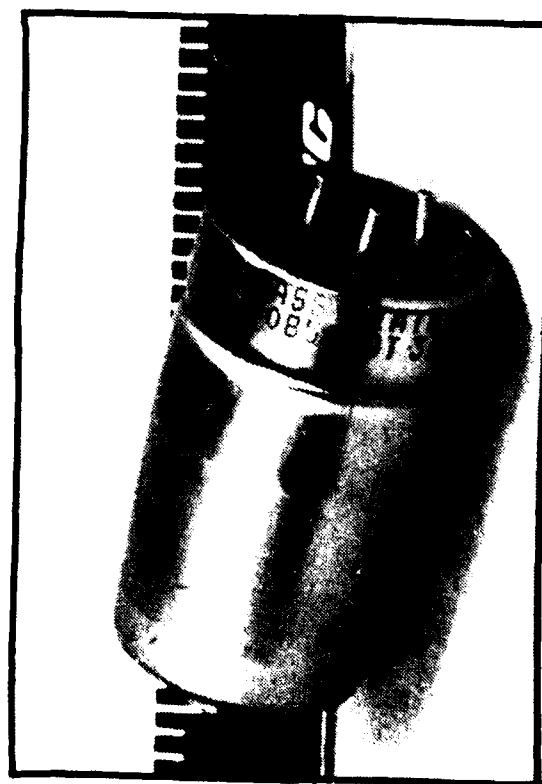
Figure 3.1-11 Small battery #102

Batteries #102 and #110 are both less than 3.5 cm (1.38 in) in diameter and easily fit into the small format CT systems. Battery #102 (P/N 406340), Figure 3.1-11, is used as an electronic counter measures decoy power source. It contains different cell stacks and resolving the small (less than 0.6 mm (0.024 in.)) cells was important. The primer and lead attachments are of special interest because they often had problems in assembly. A longitudinal CT image from System D, Figure 3.1-12, shows the different cell stacks, leads and primer with excellent detail. Primer configuration is easily seen in a progression of CT slices taken through it. Lead attachments were imaged with CT, but it did not offer more resolution than conventional film radiography.

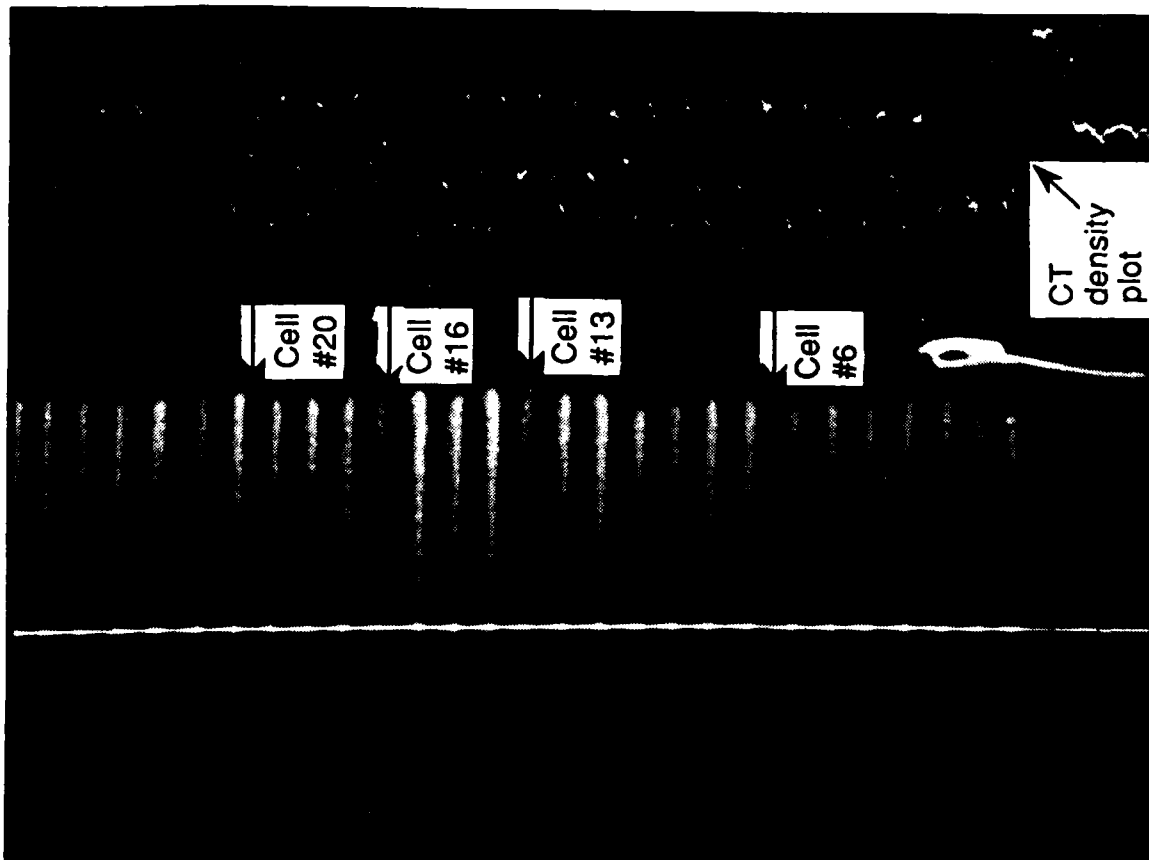
Figure 3.1-31 Ct view and density plot of anomalous cells in battery #109
