**Task Order 2  
Enhanced Preliminary Assessment**

**CAPE ST. GEORGE RESERVATION  
LITTLE ST. GEORGE ISLAND, FLORIDA**

USATHAMA Task Order 2  
ENHANCED PRELIMINARY ASSESSMENT

CAPE ST. GEORGE RESERVATION  
LITTLE ST. GEORGE ISLAND, FLORIDA

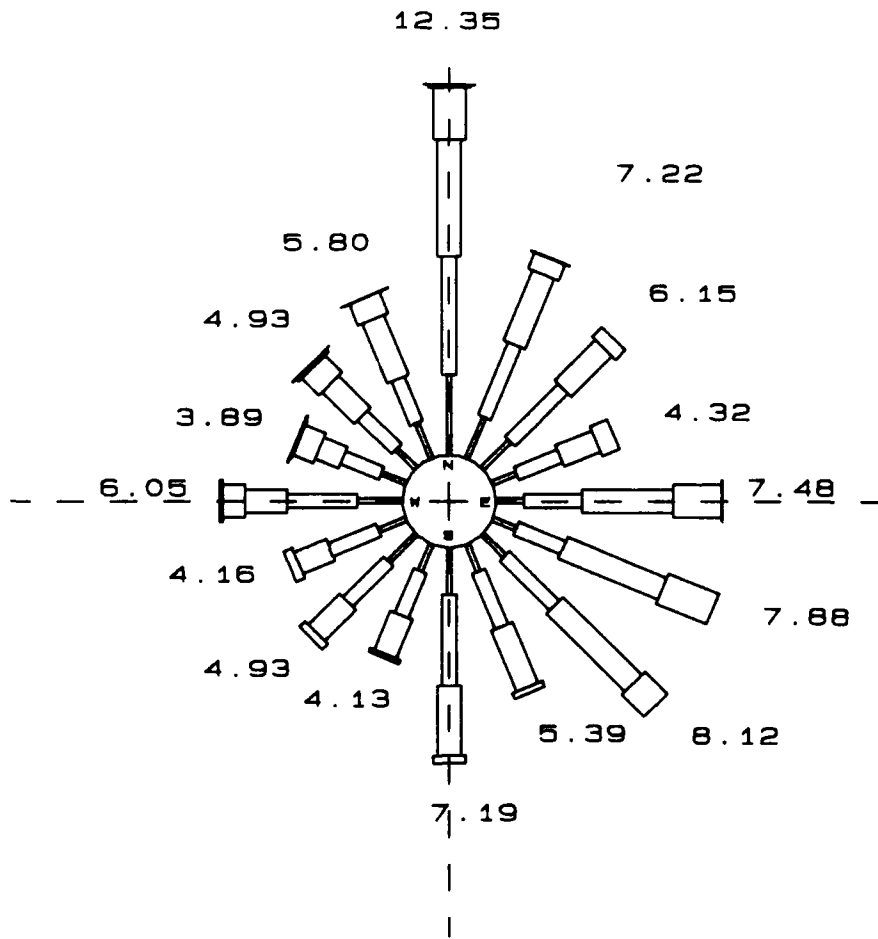
FIGURE 2-3 WIND ROSE

Because of the moderating effect of the Gulf, and proximity to the Atlantic Ocean, temperatures are mild and subtropical in nature. Figure 2-3 is a wind rose for the Apalachicola weather station during 1988. The prevailing wind direction during 1988 was from the north and a secondary maximum occurred from the southeast.

WIND SPEED (KNOTS)						PERCENT OCCURRENCE						
	0-3	3-6	6-10	10-16	16-21	>21	0-3	3-6	6-10	10-16	16-21	>21	
N	2.69	3.92	3.90	1.73	0.09	0.01	S	1.87	3.06	2.31	0.25	0.00	0.00
NNE	1.50	2.62	2.50	0.58	0.02	0.00	SSW	0.97	1.62	1.40	0.15	0.00	0.00
NE	1.28	2.49	1.91	0.48	0.00	0.00	SW	1.29	1.91	1.47	0.26	0.00	0.00
ENE	0.85	1.56	1.30	0.61	0.00	0.00	WSW	0.98	1.72	1.14	0.32	0.00	0.00
E	0.92	1.92	3.01	1.62	0.01	0.00	W	1.49	2.33	1.39	0.73	0.11	0.00
ESE	0.83	1.67	3.57	1.80	0.00	0.00	WNW	0.86	1.37	0.84	0.73	0.05	0.03
SE	1.03	2.36	3.69	1.06	0.00	0.00	NW	0.91	1.89	1.80	0.60	0.11	0.01
SSE	0.98	2.02	2.19	0.20	0.00	0.00	NNW	1.27	1.61	2.14	0.76	0.01	0.01
