LOCALIZED CORROSION INDUCED IN  
GRAPHITE/ALUMINUM METAL-MATRIX COMPOSITES  
BY RESIDUAL MICROSTRUCTURAL CHLORIDE

L.H. Hihara and R.M. Latanision

Technical Report  
to  
Office of Naval Research  
Grant No. N00014-89-J-1588

February 1990-

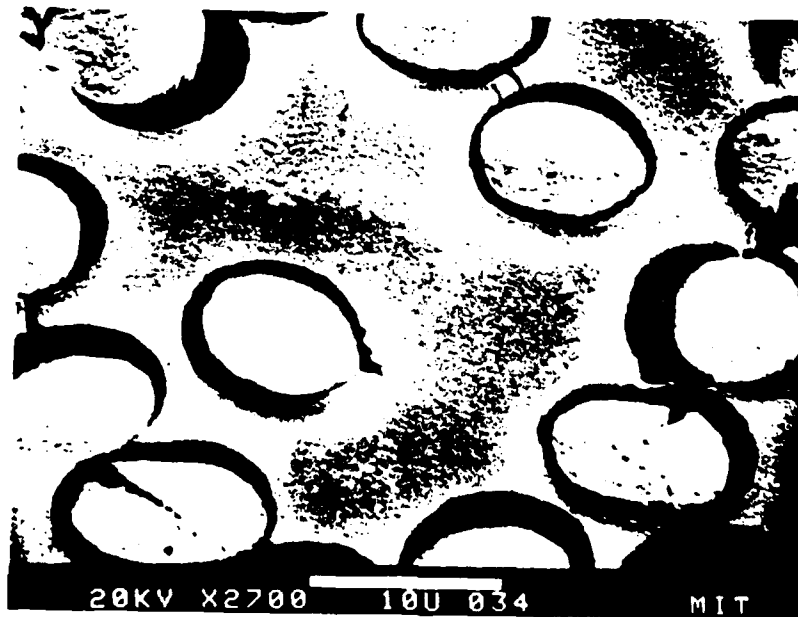
Figure 14: SEM micrograph showing crevices along the perimeters of graphite fibers in a planar G/6061-T6 Al MMC six-ply plate electrode that was anodically polarized at  $2.0 \text{ V}_{\text{SCE}}$  for 3.2 h in deaerated  $0.5 \text{ M Na}_2\text{SO}_4$  of pH 7 at  $30^\circ\text{C}$ . The formation of crevices was caused by  $\text{CO}_2$  evolution, resulting from the oxidation of graphite.

Figure 14 shows crevices that formed along perimeters of graphite fibers during anodic polarization at 2.0  $V_{SCE}$  for 3.2 hours at 30°C in deaerated 0.5 M  $Na_2SO_4$ .

Finally, comments are due regarding crevices that formed along fiber perimeters (Figure 14) which could be mistaken for dissolution of fiber-matrix interfaces. The crevices formed during anodic polarization in 0.5 M Na<sub>2</sub>SO<sub>4</sub>. The corrosion morphology shown in Figure 14 is identical to that seen in graphite/epoxy composites<sup>10</sup>. Epoxy is unaffected by anodic polarization whereas the graphite fibers are oxidized primarily to CO<sub>2</sub><sup>10</sup>. Since the Al matrix in G/6061-T6 Al MMCs should passivate near fiber-matrix interfaces (where microstructural chloride is rarely found<sup>9</sup>), the corrosion morphology is expected to be similar to that of graphite/epoxy composites. Thus, the apparent interfacial dissolution was actually the result of graphite oxidation.
