HDL-TR-2170

February 1990

Evaluating a HEMP-Hardened Signal Entry TPD  
Enclosure

19. ABSTRACT (Continue on reverse if necessary and identify by block number) <b>Working within the sponsorship and authority of the Naval Electronics Engineering Activity, Pacific (NEEACT PAC), personnel of the Harry Diamond Laboratories (HDL) evaluated the performance of a prototype signal entrance enclosure exposed to transient signals related to high-altitude electromagnetic pulse (HEMP). This report discusses the prototype enclosure design, supporting laboratory experiments, and data analysis, such as (1) shielding effectiveness, (2) degree of transient suppression as provided by internal terminal protection device (TPD) circuits, (3) response to high transient current levels, and (4) discrepancies and methods for improvements.</b>

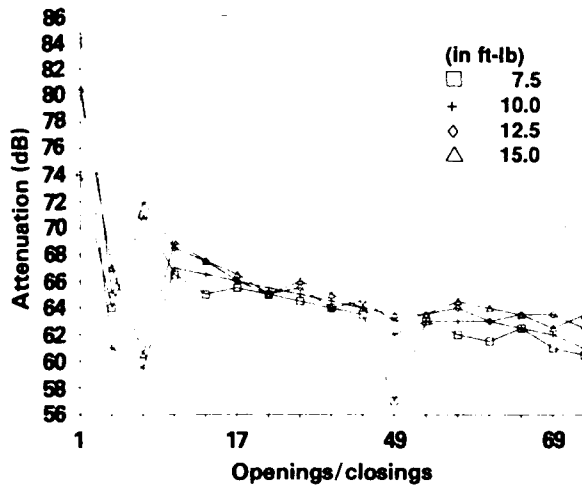
Figure 10. SE degradation curves for compartment 1 (dirty side).

One set of tests assessed the degradation in SE due to multiple openings and closings of the enclosure's doors. For this assessment, test methods, equipment, and procedures were the same as those described in section 4.2. Results are as shown in figures 10 to 12.

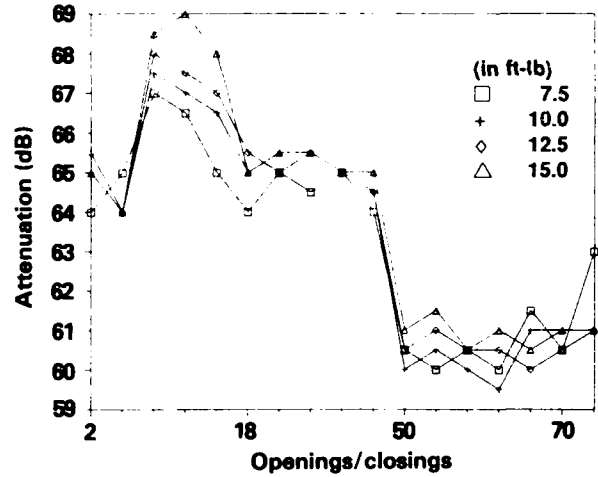
Figure 11. SE degradation curves for compartment 2 (dirty side).

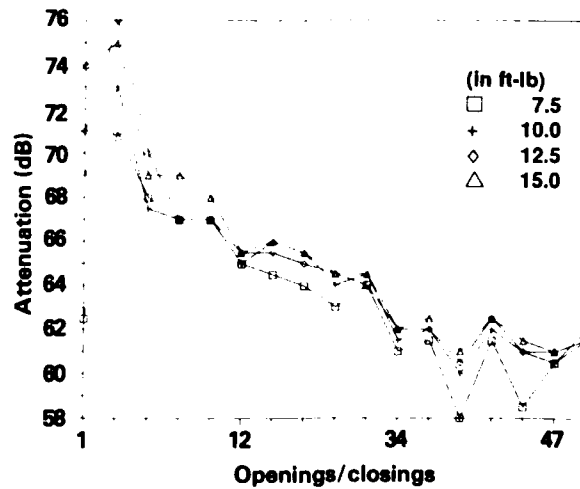
Figure 12. SE degradation curves for compartment 3 (clean side).

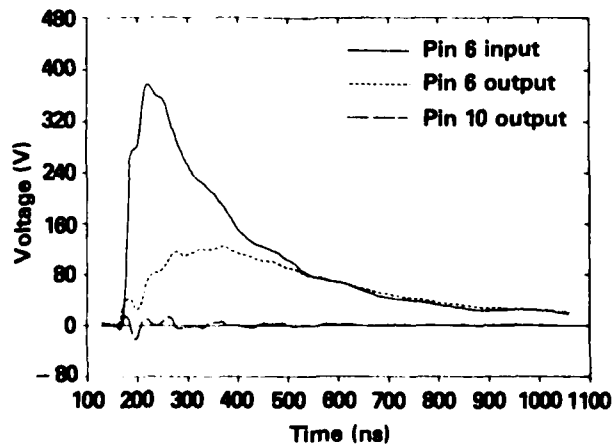
The 25-pin F-type connector, when excited at approximately 400 V, was found to be extremely susceptible to pin-to-pin cross coupling during the transient and would therefore be inefficient in the present design. Differences in output signals were minimized by replacing the F-type connector with a D-type connector.

Figure 13. F-type connector sample voltages.

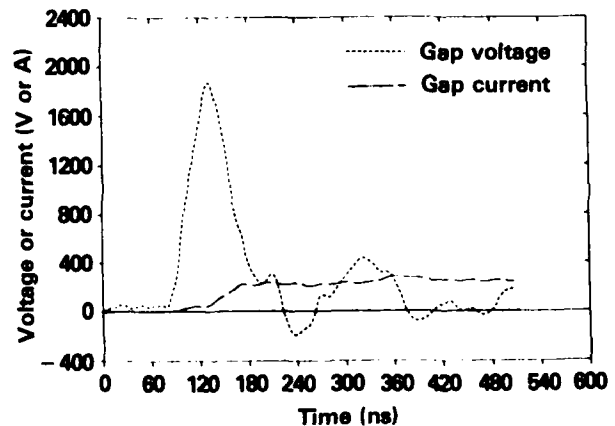
Figure 15. Spark-gap voltage versus current.

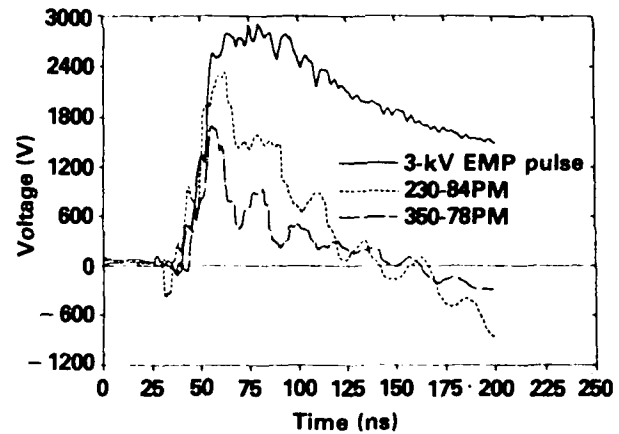
Figure 17. 230-84 PM spark gap versus 350-78PM voltage response.

When excited by a fast-rise-time pulse (typically about 10 ns), the device had a transition time—the interval between the arrival of the applied signal and the moment when the device ignites (or arcs)—between 20 and 40 ns. This can be observed from both figures 16 and 17. Also shown in figure 17 is the device's relatively wide arc region (typically about 60 to 80 ns). Figure 17 compares the voltage response of the 230-84PM arrestor to that of a comparable surge arrestor, the 350-78PM.

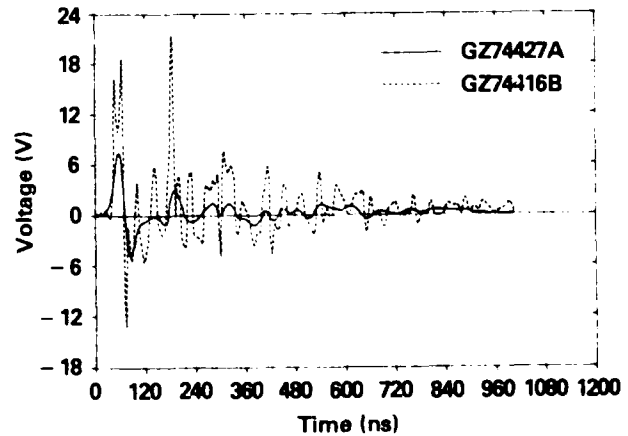
Figure 22. Typical cross-coupling voltage with D-type connector.

As noted in earlier filter pin connector tests, cross coupling was apparent, which may create upset problems in connected equipment. Therefore, output responses at both the D- and F-type connector were monitored for cross coupling.

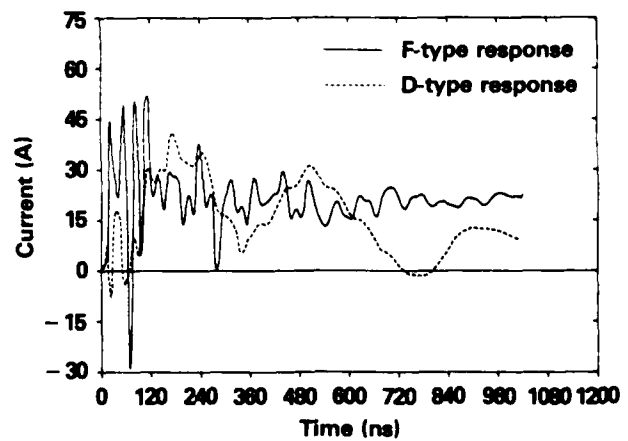
Measuring the currents on the cable harness between the surge suppressor board and the PC boards verified that the F-type connector's performance degrades the TPD enclosure's characteristics: the maximum degradation for the D-type connector occurred at 45 A; the maximum for the F-type connector occurred at 55 A. Typical current responses are shown in figure 29.

Figure 29. F-type and D-type current responses.

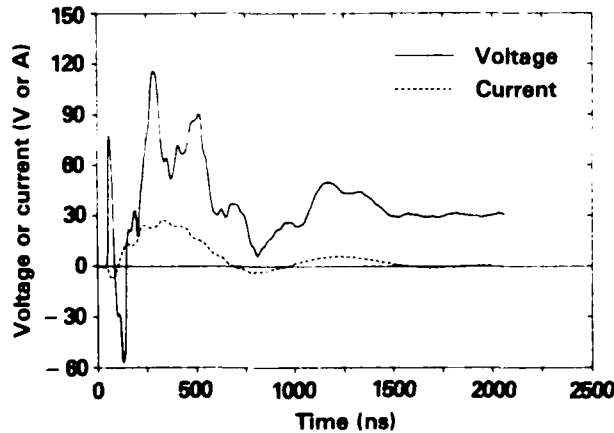
Figure 32. Load characteristics.

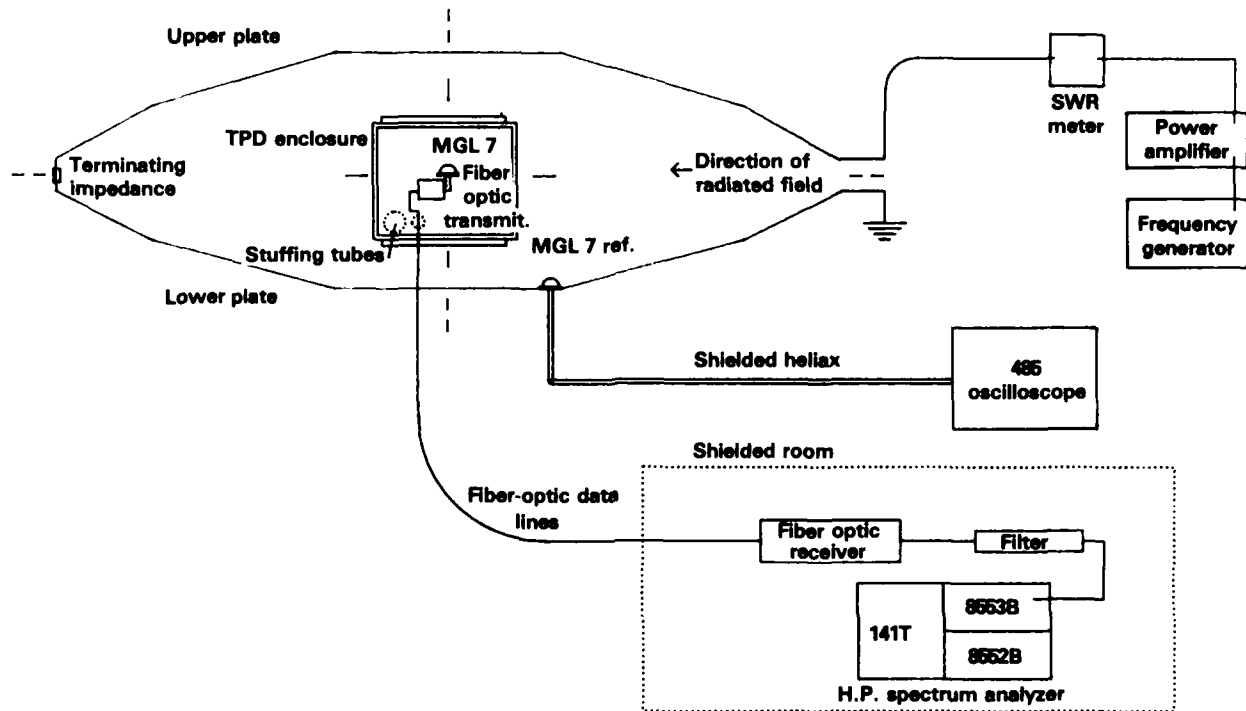
The parallel plates were again injected with the indicated frequencies and at the respective reference levels. Sensor output levels were observed and recorded as before.

Figure A-4. Low-frequency SE assessment test setup.

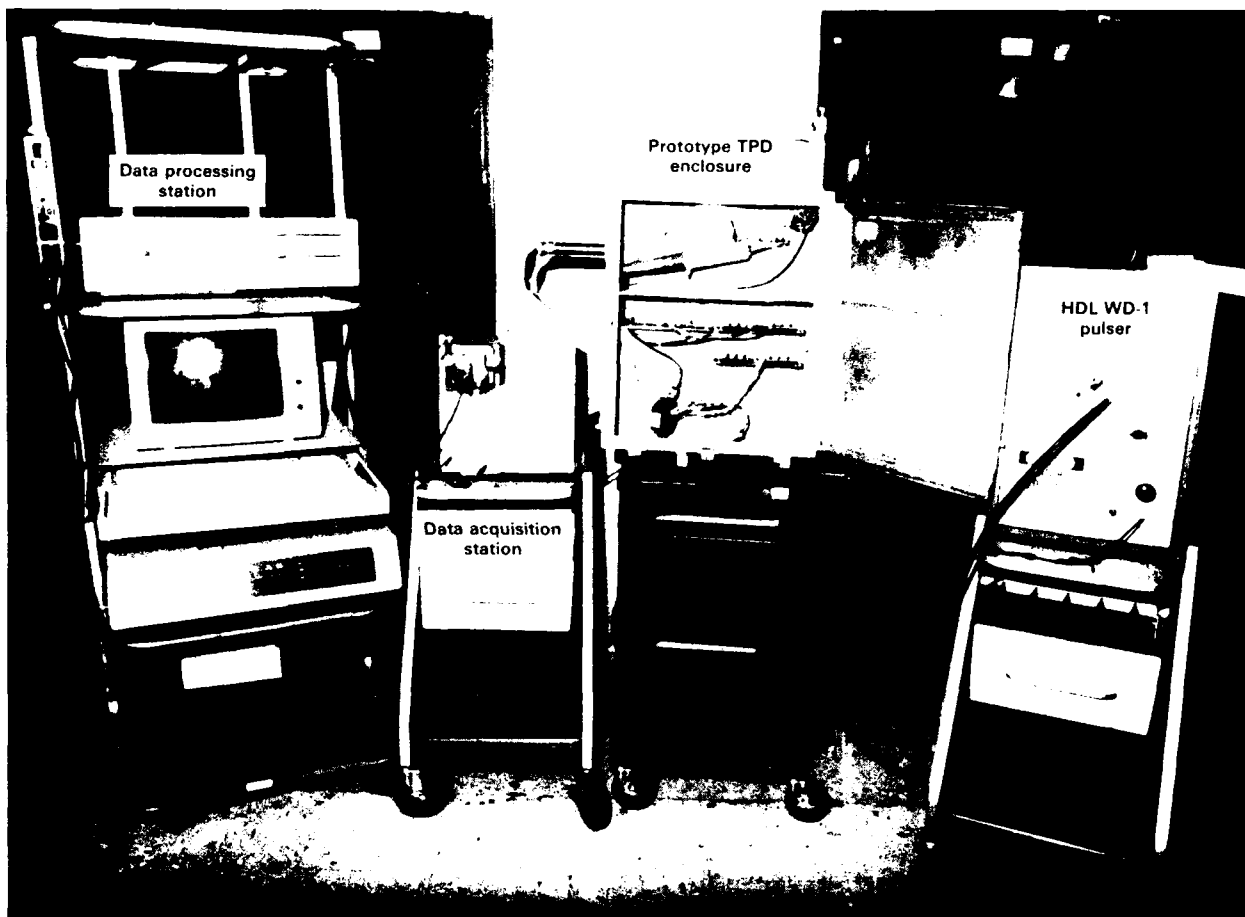
**Figure A-9. Present architecture evaluation test setup.**

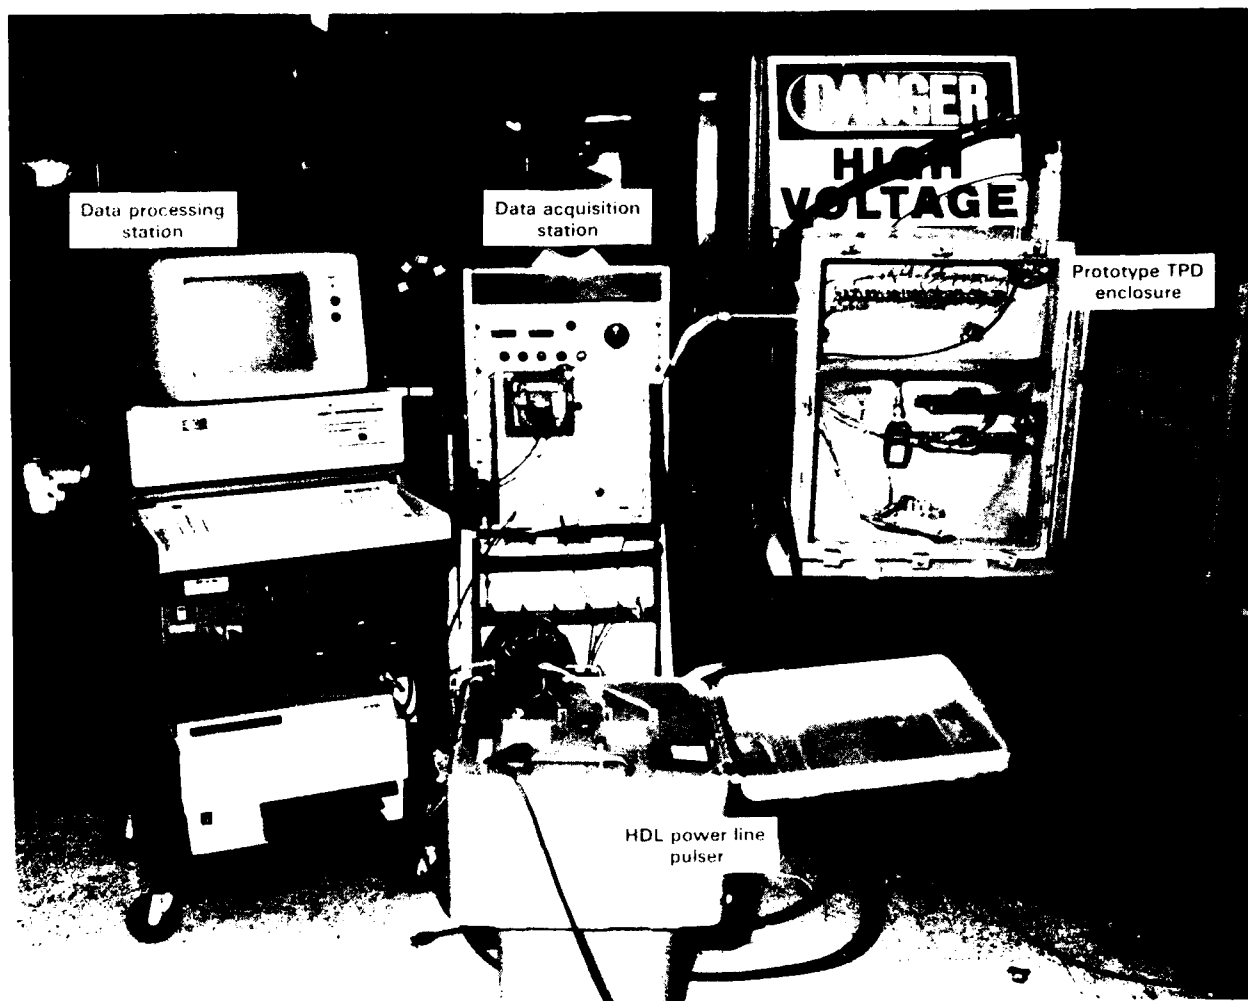
Figure A-10. Current injection test setup.
