U.S. Army Toxic and Hazardous Materials Agency  
**ENHANCED  
PRELIMINARY  
ASSESSMENT REPORT:**

Navajo Depot Activity  
Bellemont, Arizona

March 1990

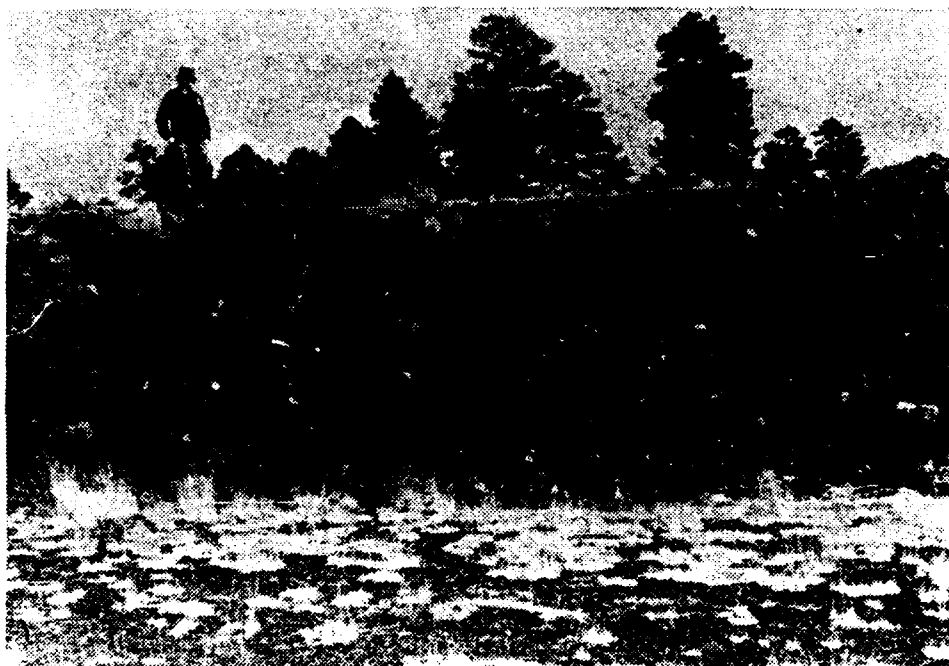
23. Slipface between the upper lift and the lower lift at the Former Sanitary Landfill

Records indicate the Former Sanitary Landfill received virtually all types of solid wastes generated by NADA from its inception until 1966. Groundwater downgradient from the Former Sanitary Landfill has been found to contain evidence of leachate. The recently identified Igloo Area C Drum Site contains three drums, which may be releasing contaminants to the surrounding soils. Although there is low potential for human exposure and moderate potential for wildlife exposure, the uncontained nature of this small site suggests that it should receive immediate action. Other solid waste disposal areas have not been sampled.

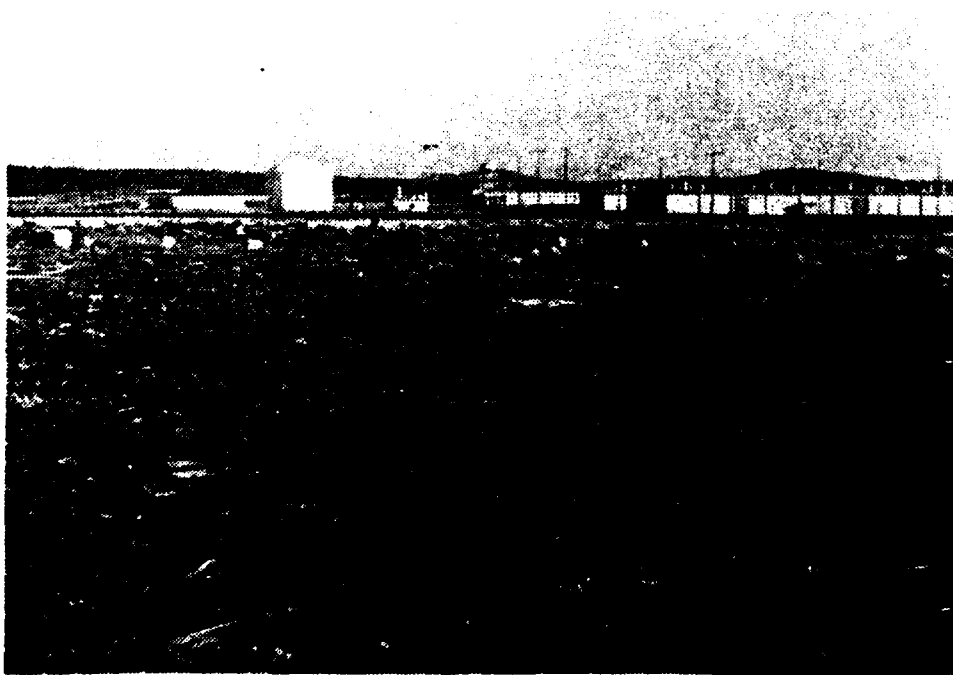
26. Former Construction Debris Landfill in the Warehouse Area

| AREEs | SWMU*<br>Number | Description | Suspected<br>Contaminants | Releases to Media | | Conclusions | Recommendations |
|---|---|---|---|---|---|---|---|
| Former Construction<br>Debris Landfills | NADA-27<br>NADA-32 | Construction materials mostly<br>covered by soil | Asbestos | | Soil | Buried construction<br>materials do not pose a<br>hazard | Add cover soil to close sites |

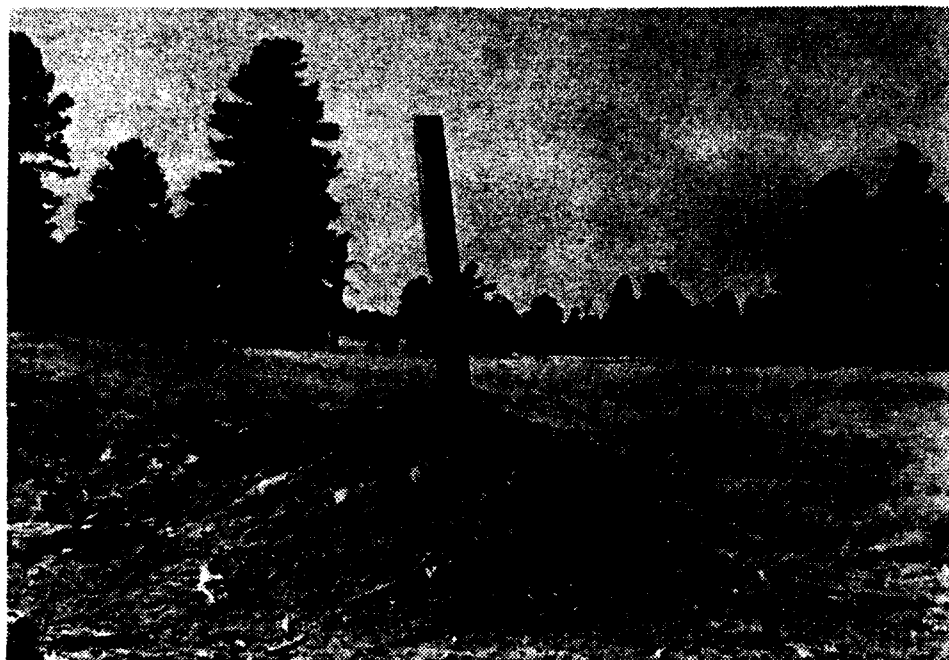
27. Probable Drum Burial Site in the CK/CG Demilitarization Area of the Demolition Area

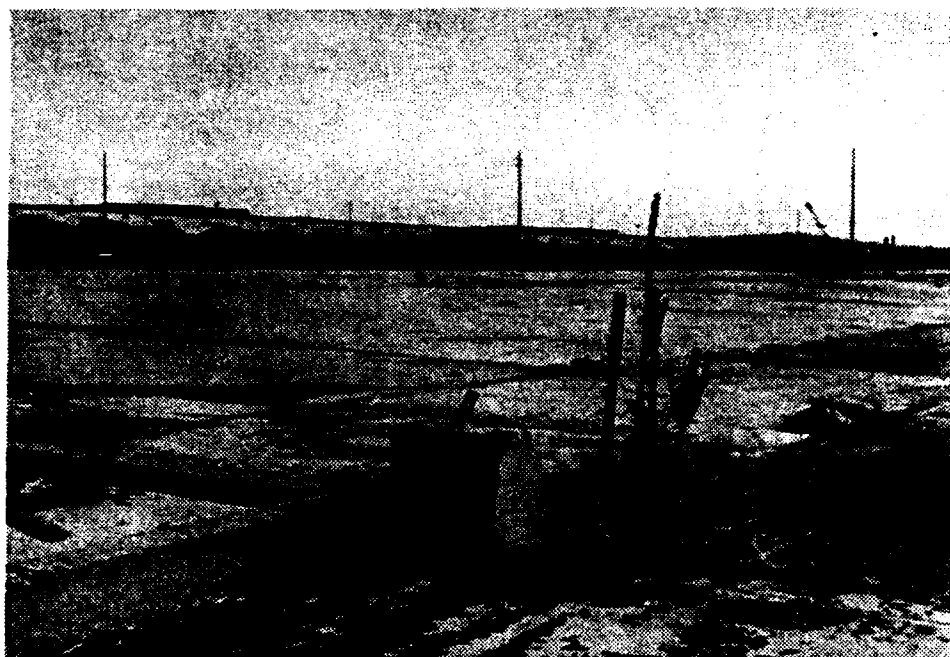
31. Diesel and gasoline contaminated soil piles (background) in the Warehouse Area
