SSC-331

# DESIGN GUIDE FOR SHIP STRUCTURAL DETAILS

SHIP STRUCTURE COMMITTEE

1990

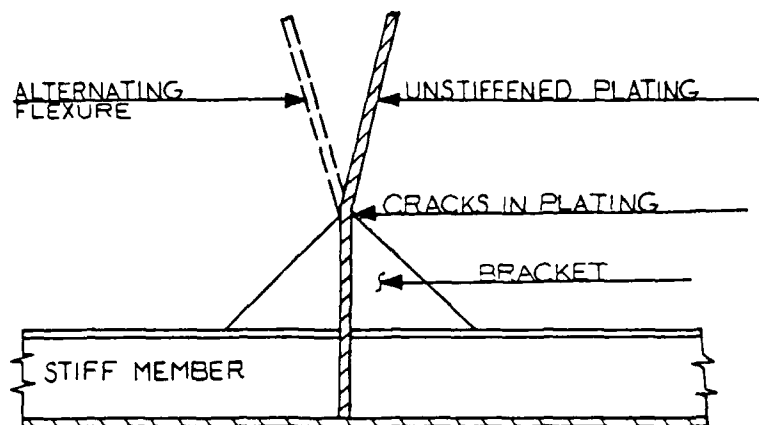
FIGURE 2-1  
FLEXURE OF UNSTIFFENED PLATING ABOUT BRACKET  
TOE LEADING TO CRACKS (REF.49)

Ref. 49 includes many sketches of failures in ship structural details. The bulk of failure examples were taken from a booklet by "Lloyd's Register of Shipping" (Figs. 2-1, 2-2, 2-3 and 2-4) and a paper by Mr. A. Haaland on ship structural design (Figs. 2-5 and 2-6). Figs. 2-1 and 2-2 illustrate a typical problem when installing brackets on stiffeners in way of a watertight or oiltight bulkhead. The bulkhead plating is relatively flexible and tends to bend over the hard spot caused by the relatively stiff bracket. The high stresses produced in the bulkhead frequently lead to cracks in the bulkhead. Fig. 2-3 illustrates similar problem areas and improved details which should reduce the potential for failures. Sound structural design considerations such as continuity and proper reinforcement can solve most of the problems shown in Fig. 2-3. Similar suggested improvements to typical ship structural details are presented in Refs. 30, 53, 58, 62, and 68. Fig. 2-4 shows that serious fractures can occur from very simple details if special care is not taken in design and construction. In this case, the girder web butt weld probably failed first due to the difficulty in providing good endings to the weld at "X". In general, scallops should be kept to a minimum.

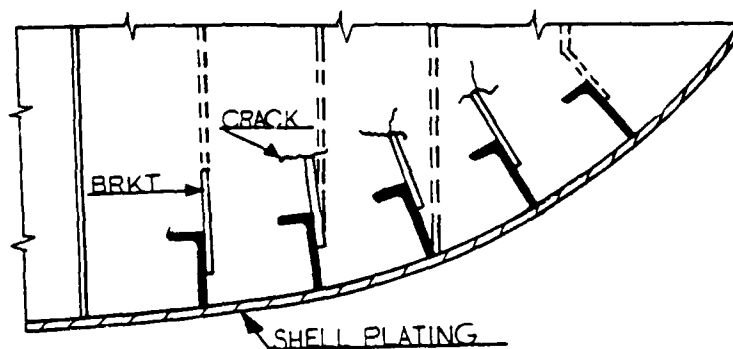
FIGURE 2-2  
CRACKS INITIATING AT BRACKETS INSTALLED ON  
BOTTOM LONGITUDINALS (REF. 49)

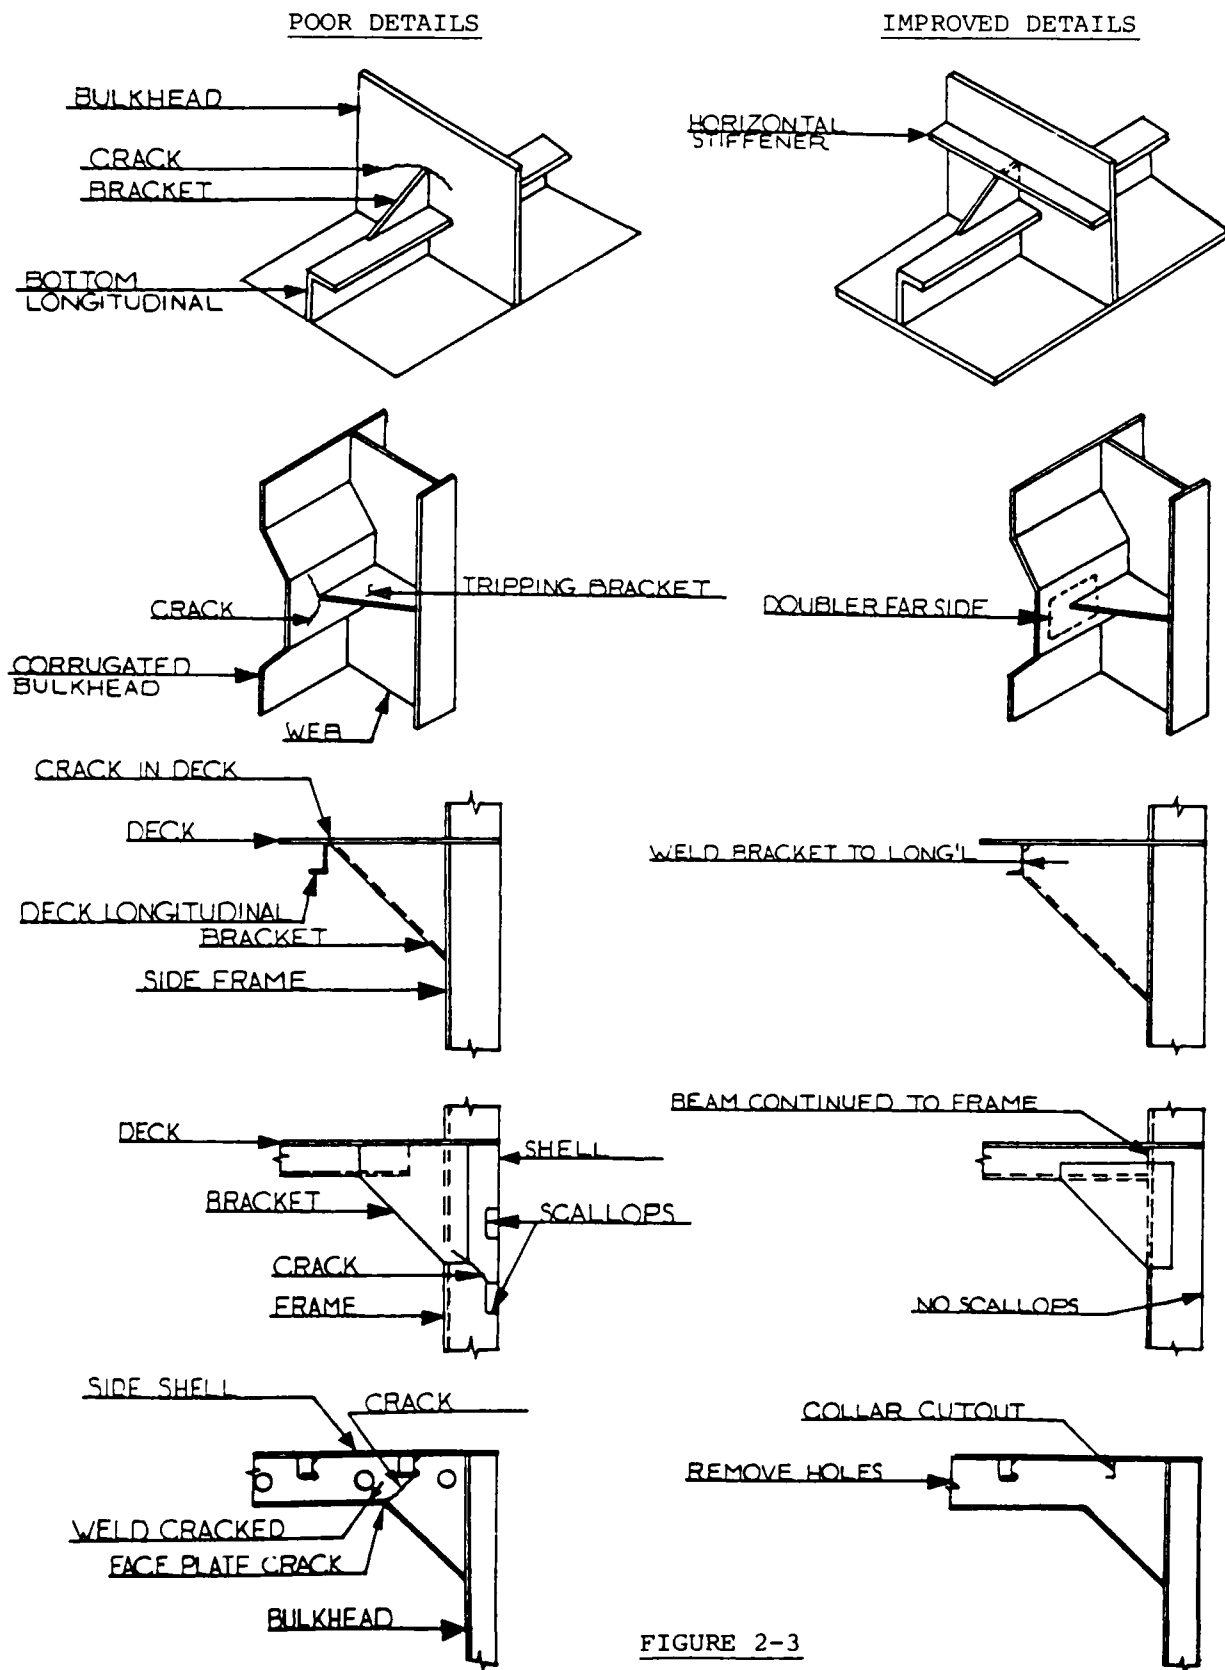
FIGURE 2-3

EXAMPLES OF FAILURES IN BEAM BRACKETS (REF. 49)

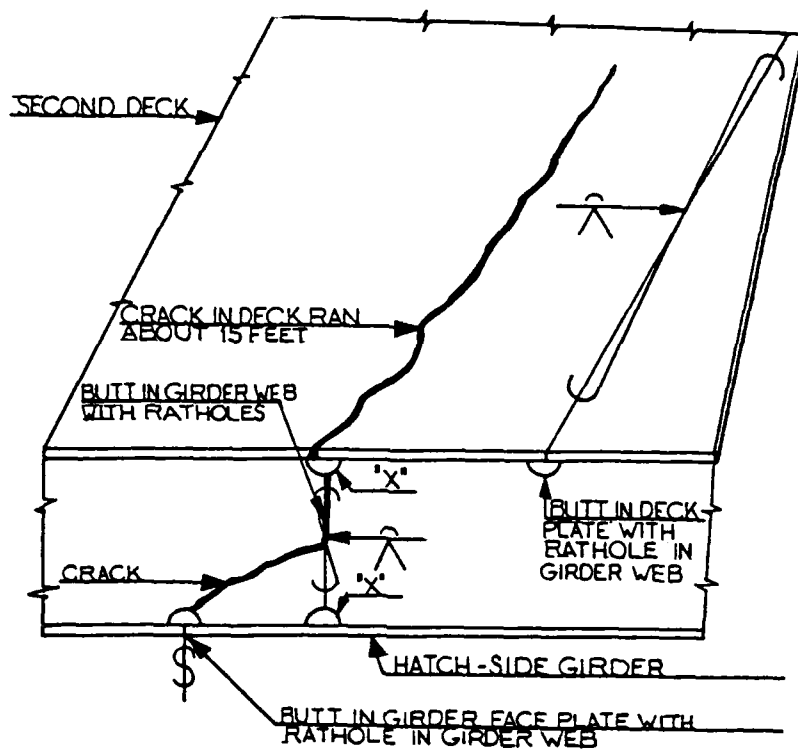
FIGURE 2-4

FRACTURE OF HATCH SIDE GIRDER AND DECK PLATE  
AT "POOR RATHOLE" CUTOUT (REF. 49)

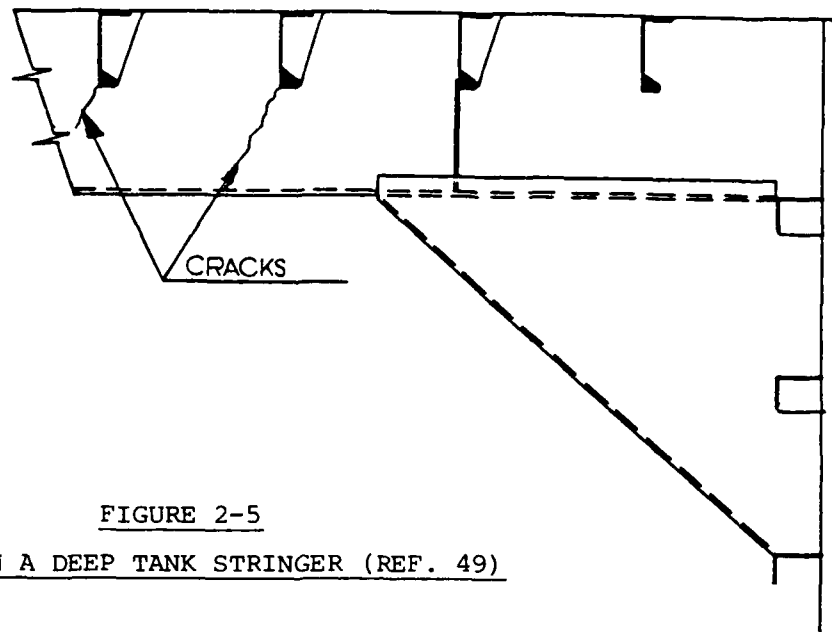
FIGURE 2-5  
CRACKS IN A DEEP TANK STRINGER (REF. 49)

Structural intersections have been the source of many failures (Refs. 10, 11, 20, 24, 30, 32, 33, 36, and 45). Fig. 2-5 shows cracks near the end of a deep tank stringer where the shear force is greatest. The cross-sectional area of the girder web has been reduced by the large cutouts.

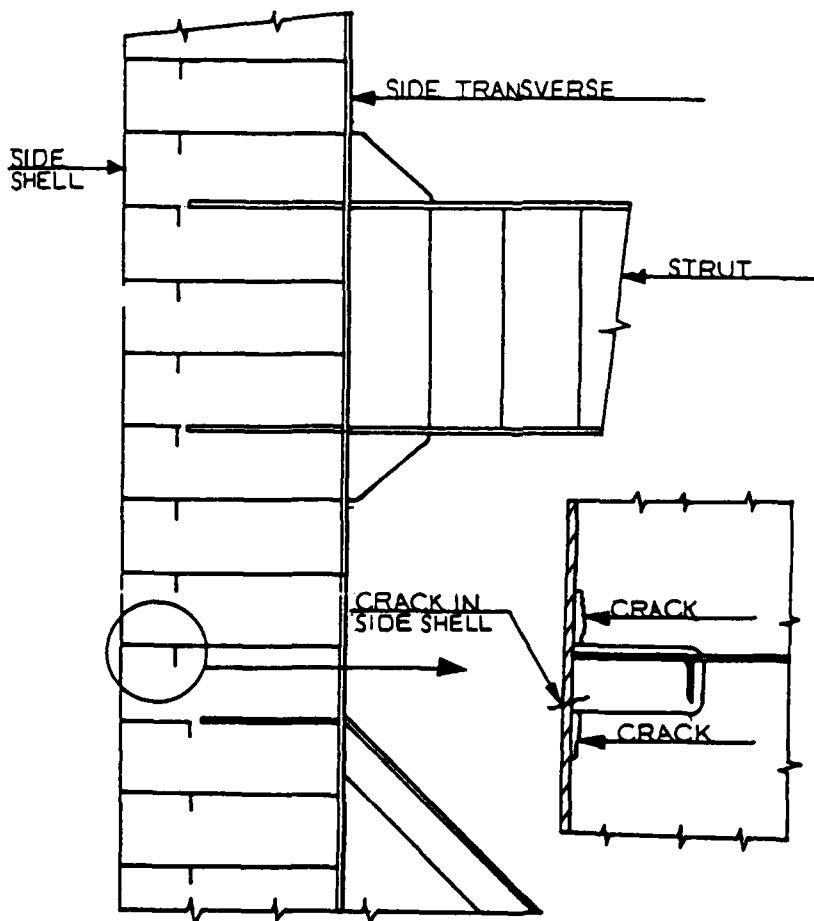
FIGURE 2-6  
CRACKS OCCURRING IN LARGE TANKERS AT THE  
JUNCTION OF SIDE LONGITUDINALS AND WEB FRAMES (REF. 49)

Fig. 2-6, ". . . shows cracks occurring at the junction between side shell longitudinals and transverse web frames because the cross-sectional area of the connection is too small, thus causing high shear stresses at the support. Normally cracks occur in the fillet weld, and when the connection has first been broken secondary cracks will appear in the shell at the edge of the scallop in the vertical web for the longitudinal and at the weld connection between the web and the shell.

"This problem may be eliminated by increasing the cross-sectional area of the connection with brackets, collar plates or lapped stiffeners." (Ref. 49)

As drawn in Fig. 2-6, there is no direct connection of the longitudinal to the web frame. Consequently, the end reaction of the longitudinal must first be transferred to the flat bar stiffener and then into the web frame. This connection between the longitudinal and the flat bar stiffener has been a source of cracks in heavily loaded members even when a direct web to longitudinal stiffener connection is provided as described in the next paragraph.

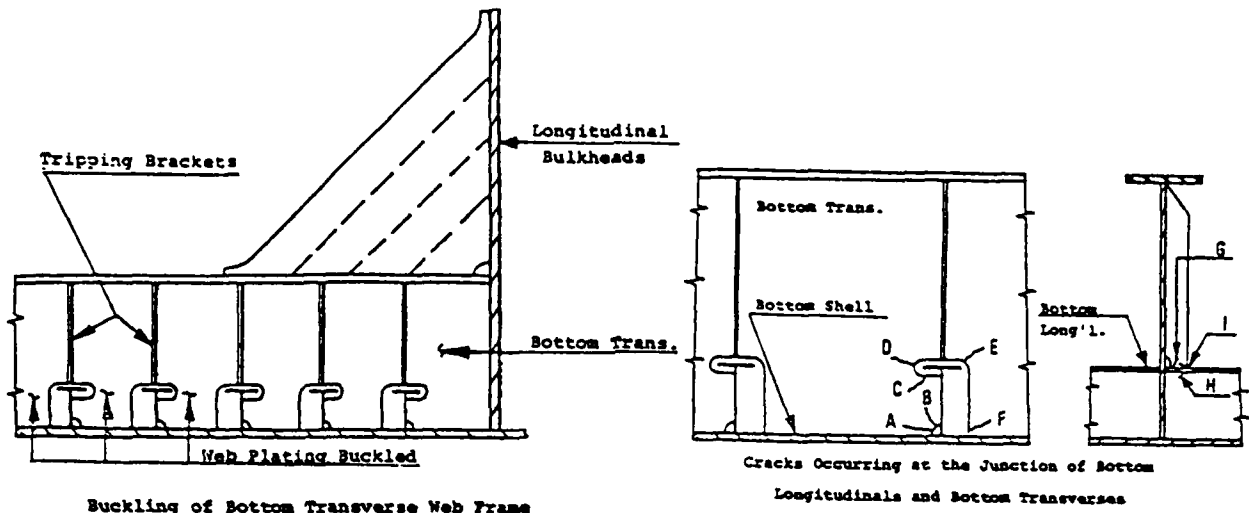
FIGURE 2-7  
FAILURES IN CONNECTION DETAILS (REF. 49)

Fig. 2-7 illustrates both cracking and buckling failures in way of structural intersections. As stated in Ref. 49: "Investigation reveals that approximately 75% of the total number of fractures found around slots are of Type G, H and I [cracks in or in way of the flat bar attached to the longitudinal flange]. Since most [of] the webs having D, E, and F type fracture [cracks in the girder web plate] also have G, H and I type fracture, it is considered that the fractures around slots may have begun at the lower end of the web stiffener as type G, H and I and then developed to type D, E and F type fractures. Type A, B and C [additional cracks in the girder web plate] occur rarely and may be a result of vibration of the transverse webs." Fig. 2-8 shows the configuration of a typical side shell longitudinal connection to a web frame and the sequence of crack initiation most commonly observed. Figs. 2-7 and 2-8 appear to be in general agreement on the sequence of crack initiation. "Although these details were used successfully for many years with smaller vessels, the increased draft, web frame spacing, and size of the larger tankers were probably not fully considered in designing the details." (Ref. 60)

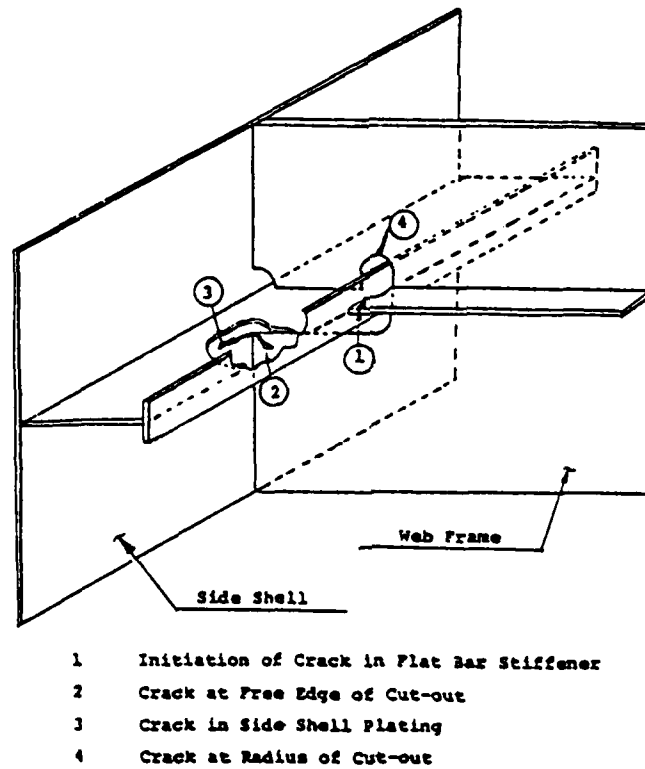
FIGURE 2-8  
SEQUENCE OF CRACK INITIATION (REF. 60)

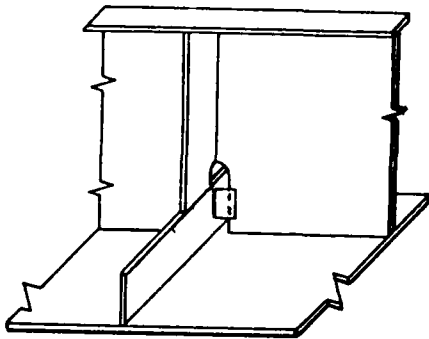
When the force to be transferred from the longitudinal to the girder exceeds the force-carrying capacity of the two lugs alone a common solution has been to locate a vertical stiffener at the web plate and connect this stiffener to the longitudinal. This connection must, however, be very well designed in order to avoid cracks at the weld between the longitudinal and the vertical stiffener.

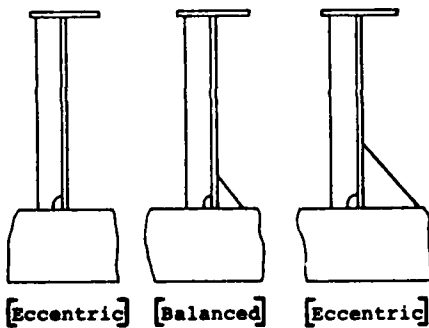
It is important that the vertical force is evenly distributed to the longitudinal i.e. minimum [eccentricity] relative to the plate.

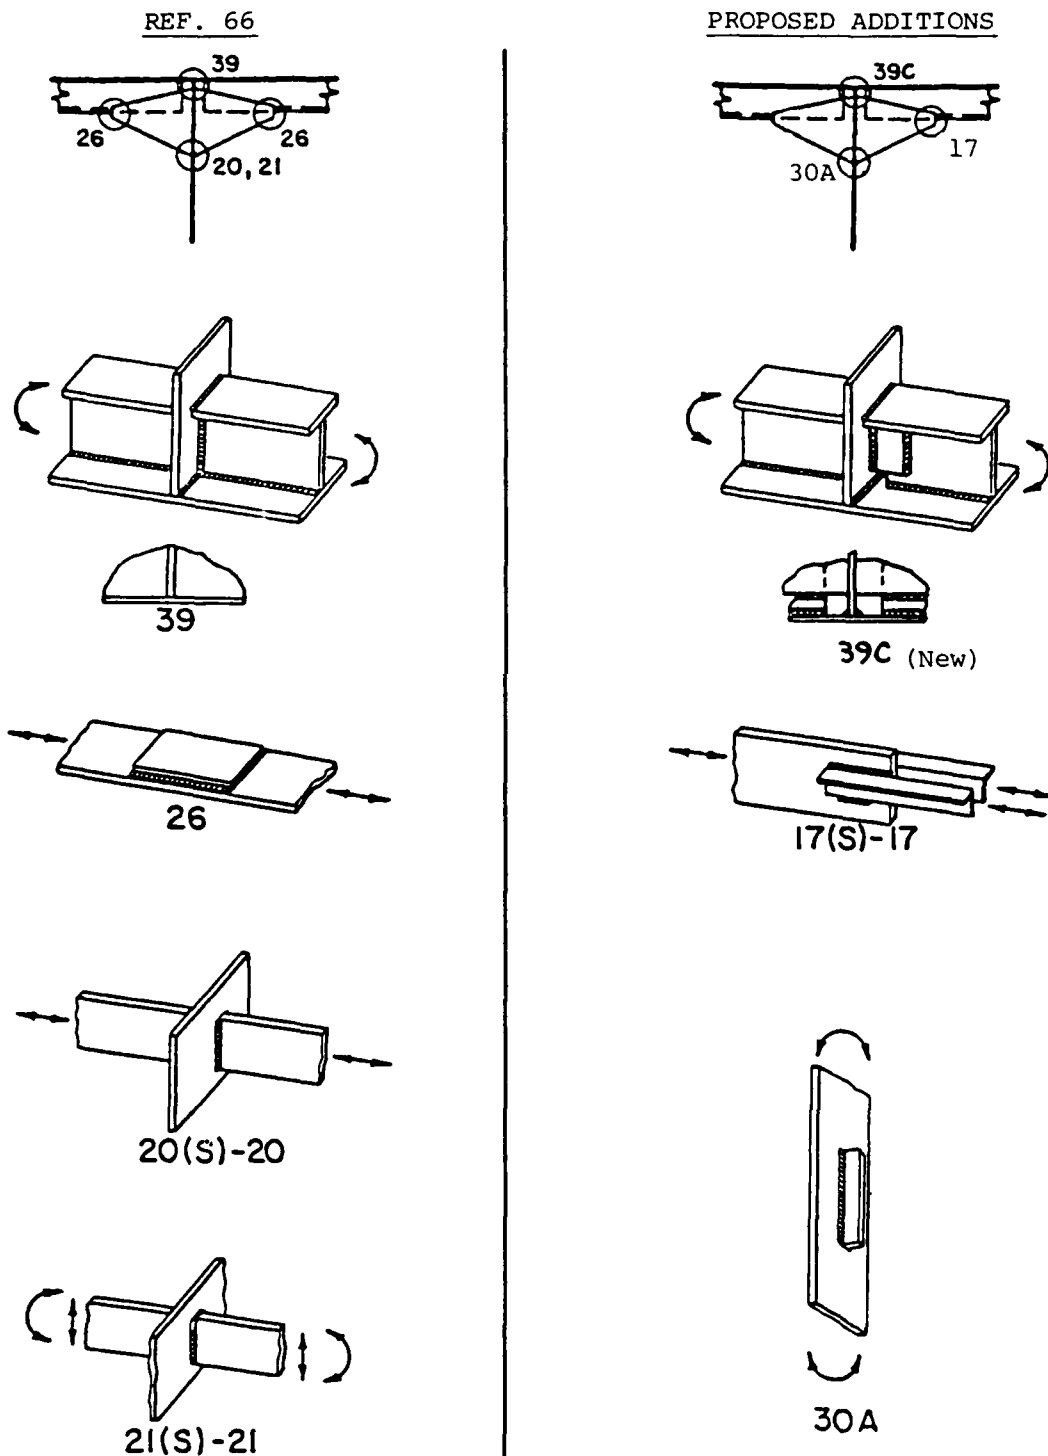
FIGURE 2-11

LOCAL FATIGUE DETAILS FOR SHIP STRUCTURAL DETAIL 1-A-1

Suggestions for modeling typical ship structural details using a series of simpler local fatigue details are given in Appendix A of Ref. 66. As an example, the left-hand side of Fig. 2-10 shows the local fatigue details recommended for analyzing ship structural detail 1-B-4 (this designation refers to family number 1, family group B, and detail number 4 as described in Section 3 and shown in Fig. 3-1). It is suggested that several additional local fatigue details be included as shown on the right-hand side of Fig. 2-10. Local fatigue detail 39C is a square cornered, lapped connection which can have a quite high stress concentration factor and consequently a low fatigue life. Local fatigue detail 17(S)-17 is suggested because the entire load in the stiffener must be transmitted to the bracket plate. Local fatigue detail 30A is probably the most significant potential failure mode. This represents bending of the relatively flexible bulkhead plating over the "hard spot" of the relatively stiff bracket which has been the cause of many cracks as shown in Figs. 2-1, 2-2, and 2-3. The basic loading may be due to either vibration or hydrostatic pressure on the bulkhead and the ship loading history (stress range versus cycles) is not well defined for either load. As Ref. 66 indicates, most of the available ship loading histories are for longitudinal hull girder bending stresses. Very little information on ship loading history is available for secondary structures such as transverse bulkheads or web frames. Fig. 2-11 presents similar data for ship structural detail 1-A-1. Local fatigue detail 37A represents flexing of the bulkhead plate similar to (but less severe than) local fatigue detail 30A of Fig. 2-10. Local fatigue detail 7-A shows a flange knuckle with tangency chocks, flange butt weld, and fillet welds to the flange all of which contribute to the fatigue problem. Local fatigue details 39C, 37A, and 7A are new configurations which are not currently covered by Ref. 66. However, neither of these details (1-B-4 or 1-A-1) is recommended for normal ship use (see further discussion in Section 3).

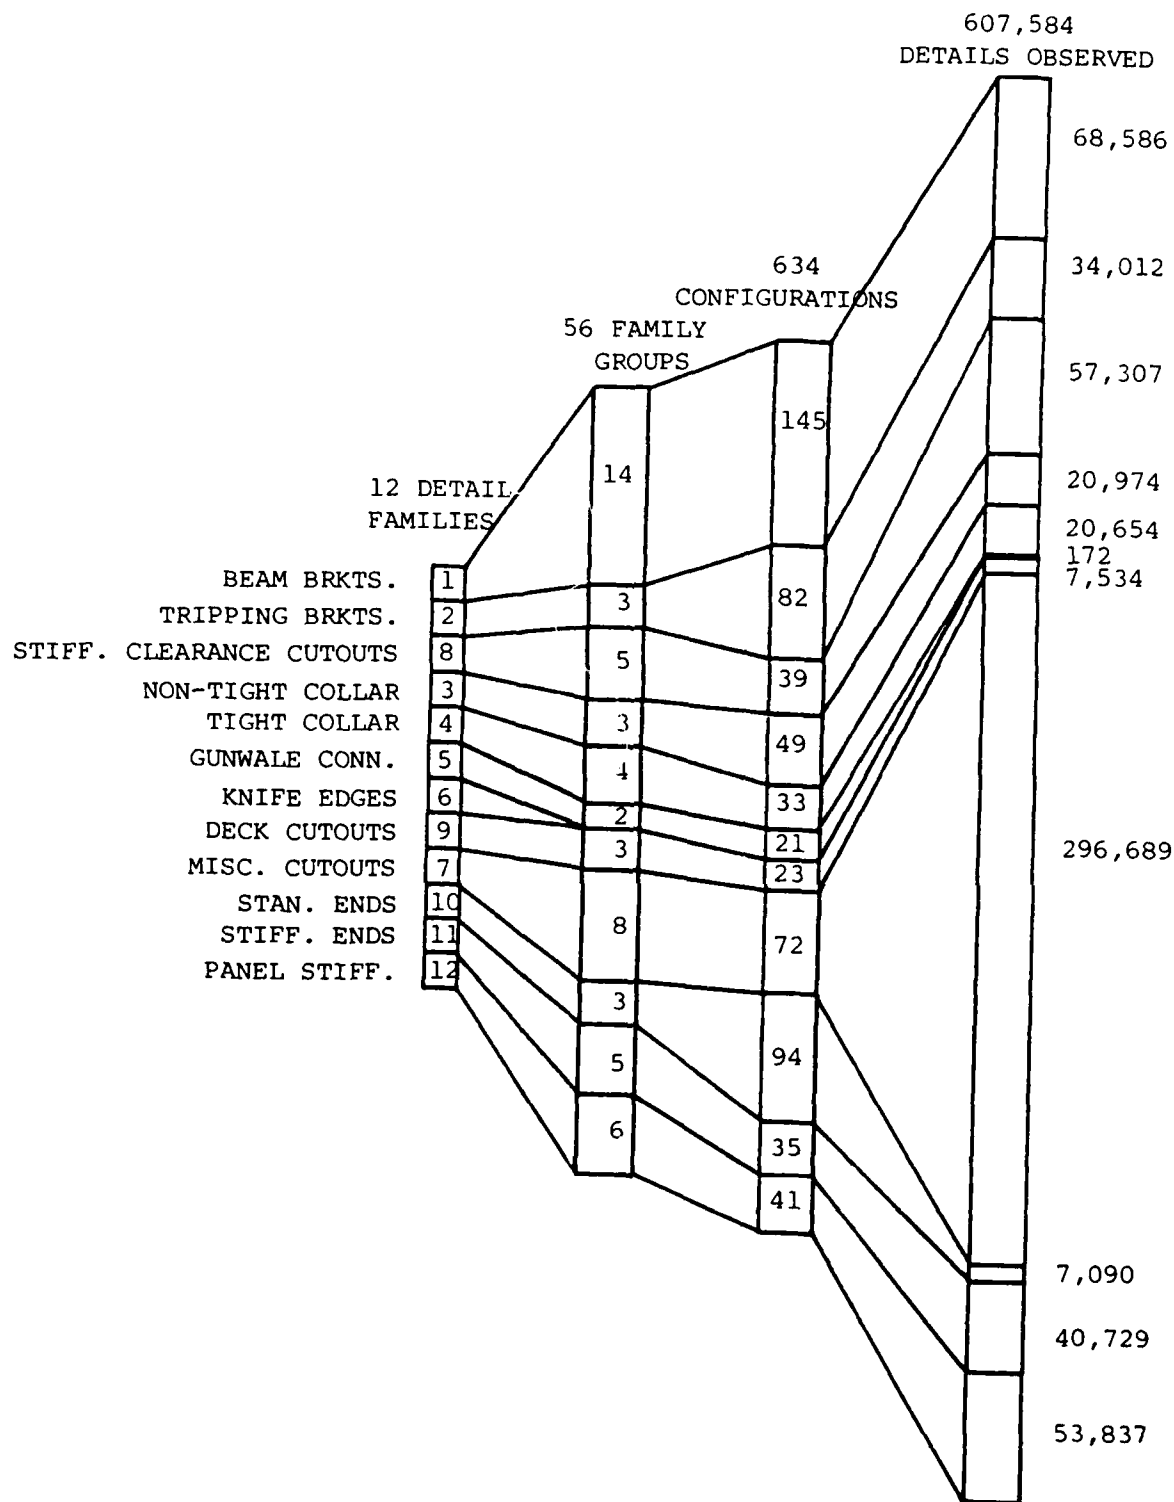
FIGURE 2-12

SUMMARY OF STRUCTURAL DETAILS SURVEYS

Fig. 2-12 summarizes the resulting data: 607,584 details were observed in 634 different configurations which were assigned to 56 family groups and 12 families. Fig. 2-13 gives a description of the primary function of each family along with a sketch of a typical configuration. Note that the family numbers are not in order. Family No. 8 (Stiffener Clearance Cutouts) is inserted before Family Nos. 3 and 4 (Non-tight and Tight Collars) because these details are so closely related. Also, Family No. 9 (Structural Deck Cuts) is inserted before Family No. 7 (Miscellaneous Cutouts) because the former is more important and should be discussed first. This order is maintained throughout the present report. Because of survey limitations, no Knife Edge Crossings (Family No. 6) were observed.

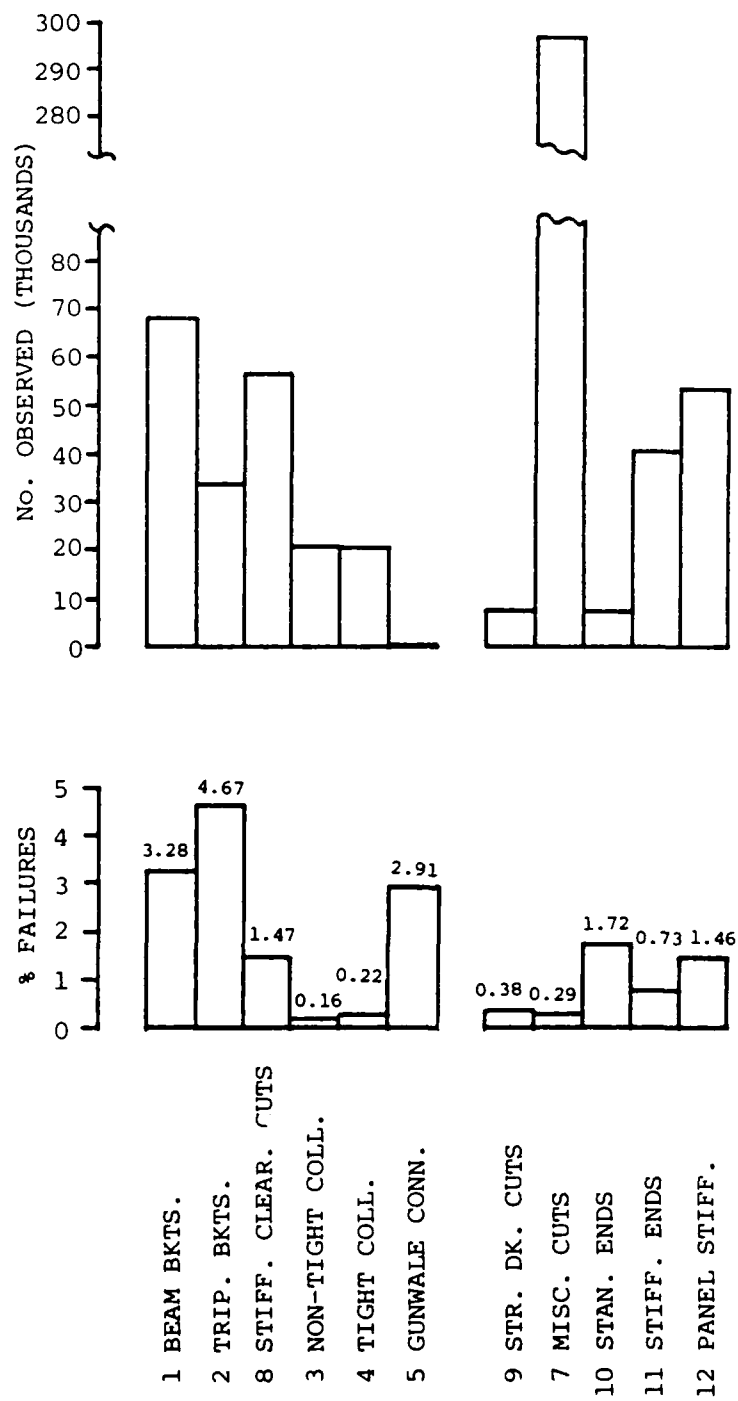
FIGURE 2-14

DATA SYNTHESIS BY DETAIL FAMILIES

A total of 6,856 failures were observed for an average failure rate of 1.13%. Fig. 2-14 summarizes the observations and failure rates for each family. Almost half of the details observed were Miscellaneous Cutouts (Family No. 7) followed by Beam Brackets (Family No. 1), Stiffener Clearance Cutouts (Family No. 8), and Panel Stiffeners (Family No. 12). The highest failure rates observed were in Tripping Brackets (Family No. 2), Beam Brackets (Family No. 1), and Gunwale Connections (Family No. 5).

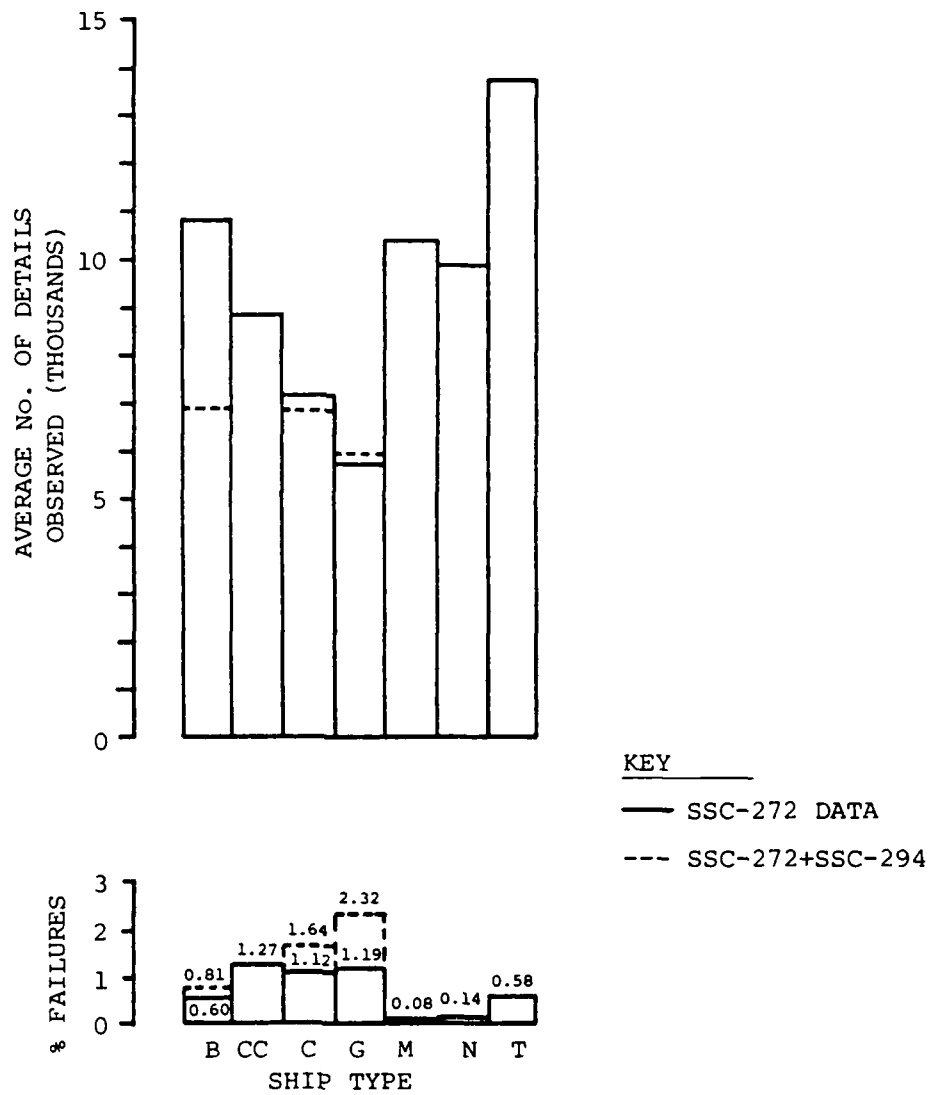
FIGURE 2-15  
DATA SYNTHESIS BY SHIP TYPE

Fig. 2-15 shows the average number of details observed and failure rate versus ship type. The most interesting result is that miscellaneous and naval ships had very small failure rates of 0.08 and 0.14 percent, respectively. Since only two miscellaneous ships were observed versus nine naval ships, the results from the latter type should be given a much higher confidence level. Since naval ships had almost an order of magnitude smaller failure rate than the average ship, the differences in naval and commercial ship details are discussed in Chapter 3 and Appendix C of this report. Ref. 72 gives the exact geometry of many naval ship details.

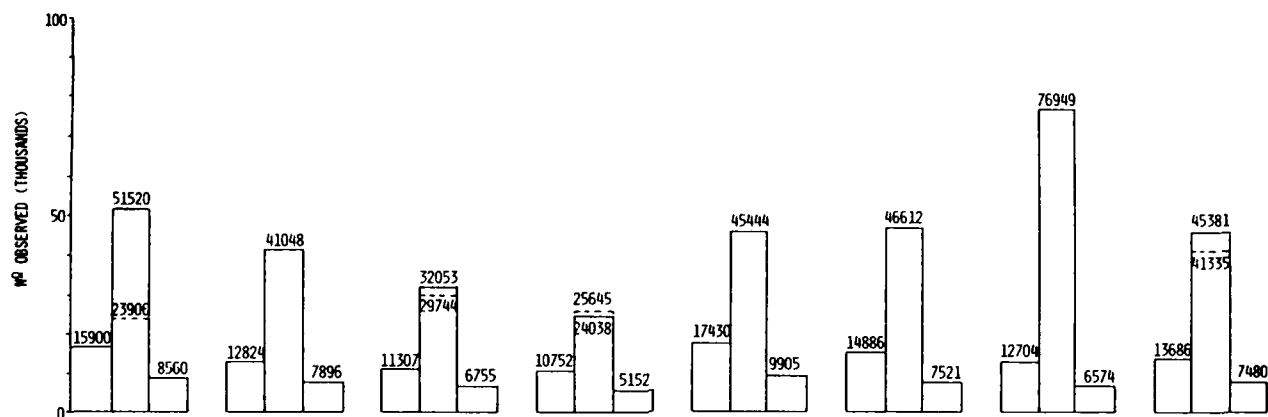
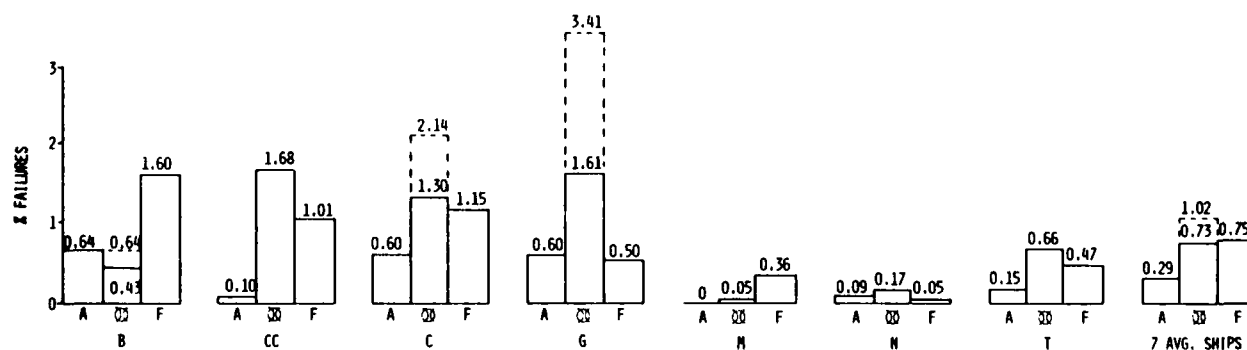
FIGURE 2-16  
SUM OF ALL DETAIL FAMILIES  
(NORMALIZED DATA FOR SEVEN SHIPS OF EACH TYPE)

Fig. 2-16 shows the number of details observed, the number of failures, and the failure rate by ship type and location (aft, midships, and forward). The data has been normalized or ratioed to represent seven ships of each type to permit more accurate comparison between ship types. From the combined results (Ref. 55 plus 59), the highest failure rate occurs amidships with the forward portion of the ships a close second. The highest failure rates were observed in the following order: amidships on general cargo ships, containerhips, and combination carriers followed by forward on bulk carriers, containerhips, and combination carriers. Similar plots for each detail family are included in Appendix A.

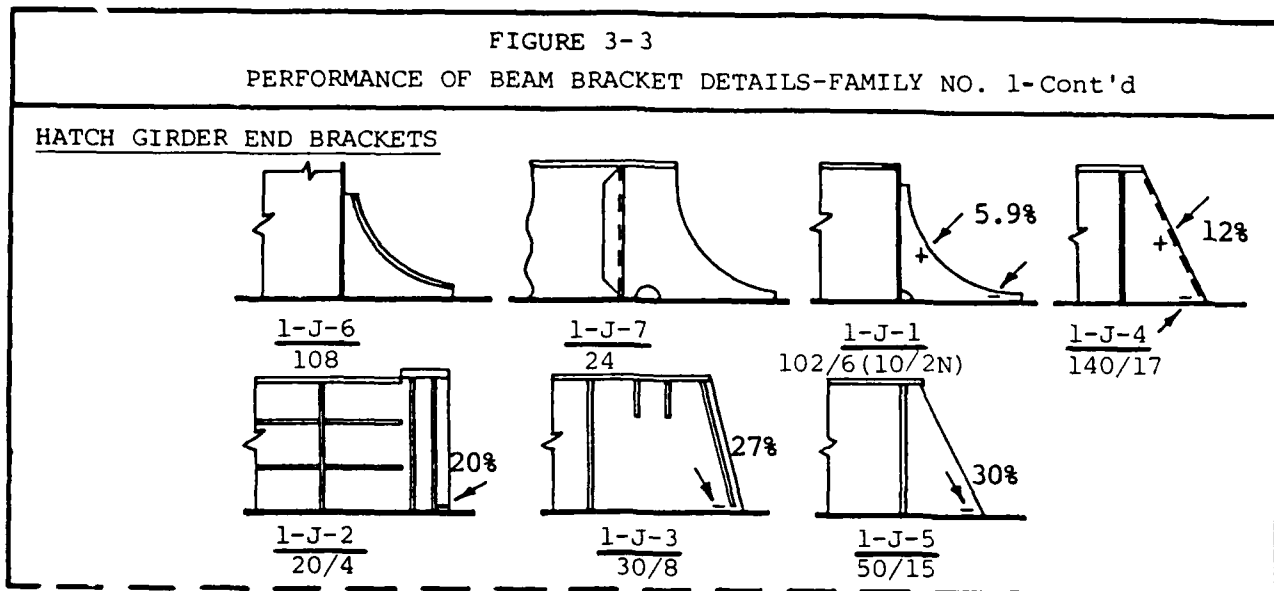
End brackets with large radii and adequate plate thickness performed well. Cracks can be expected with near right angle ends because of the hard spot.

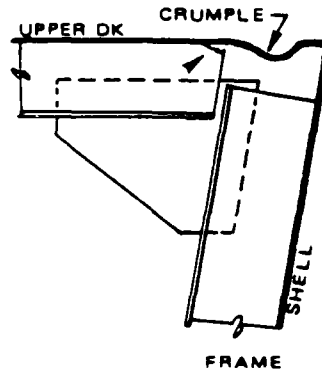
To reduce the potential for familiar tearings and fatigue cracks in decks, bulkheads and beams, transition brackets should be made continuous through the plating or be supported by stiffeners rigid enough to transmit the loads.

POTENTIAL FAILURES IN WAY OF CORNER BRACKET

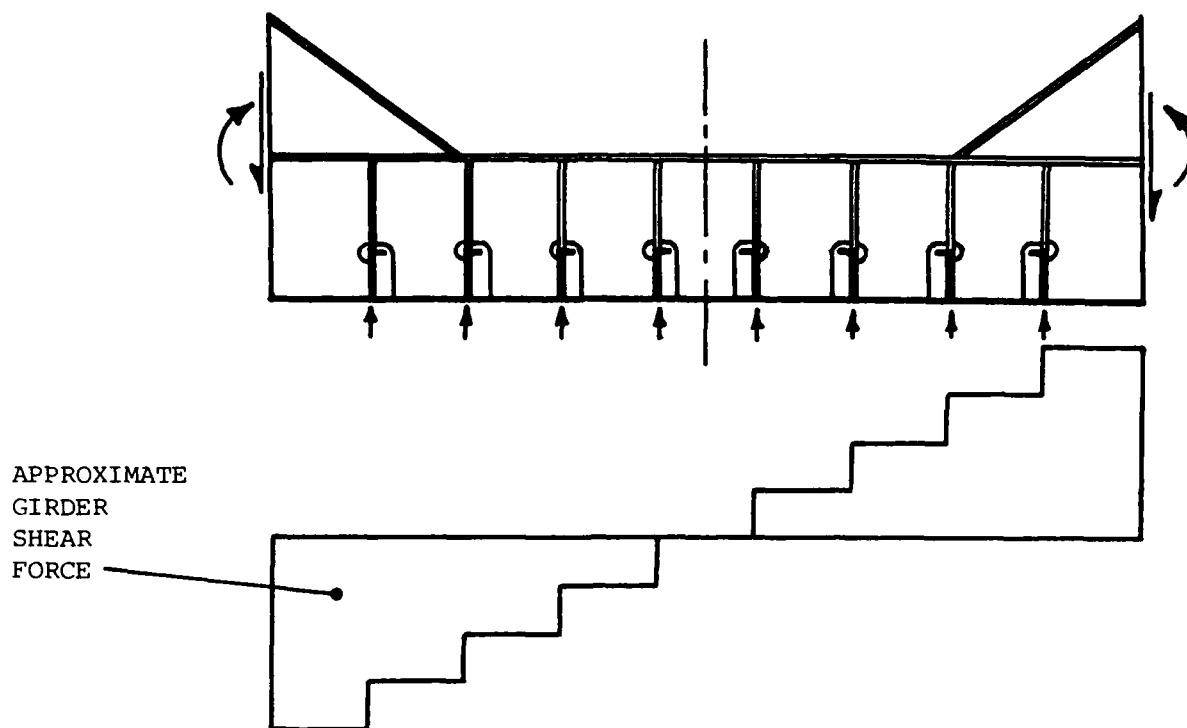
FIGURE C-7

PREFERRED ARRANGEMENT OF STIFFENER CLEARANCE CUTOUTS

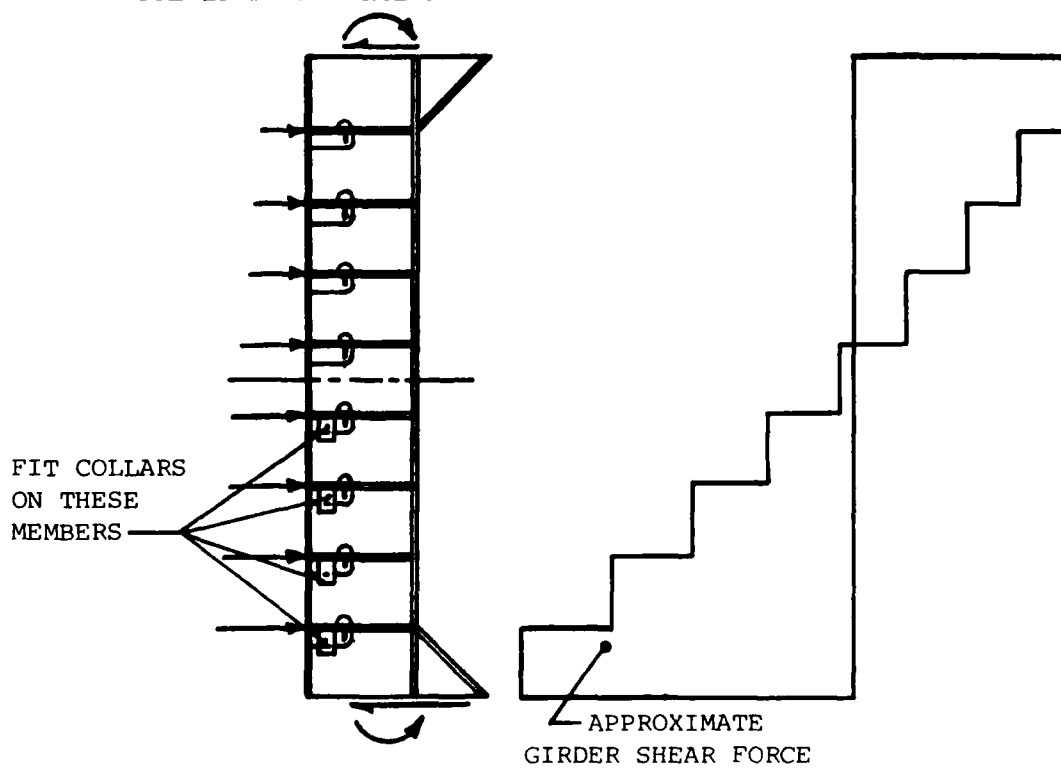
FIGURE C-8

STIFFENER CLEARANCE CUTOUTS IN A VERTICAL GIRDER

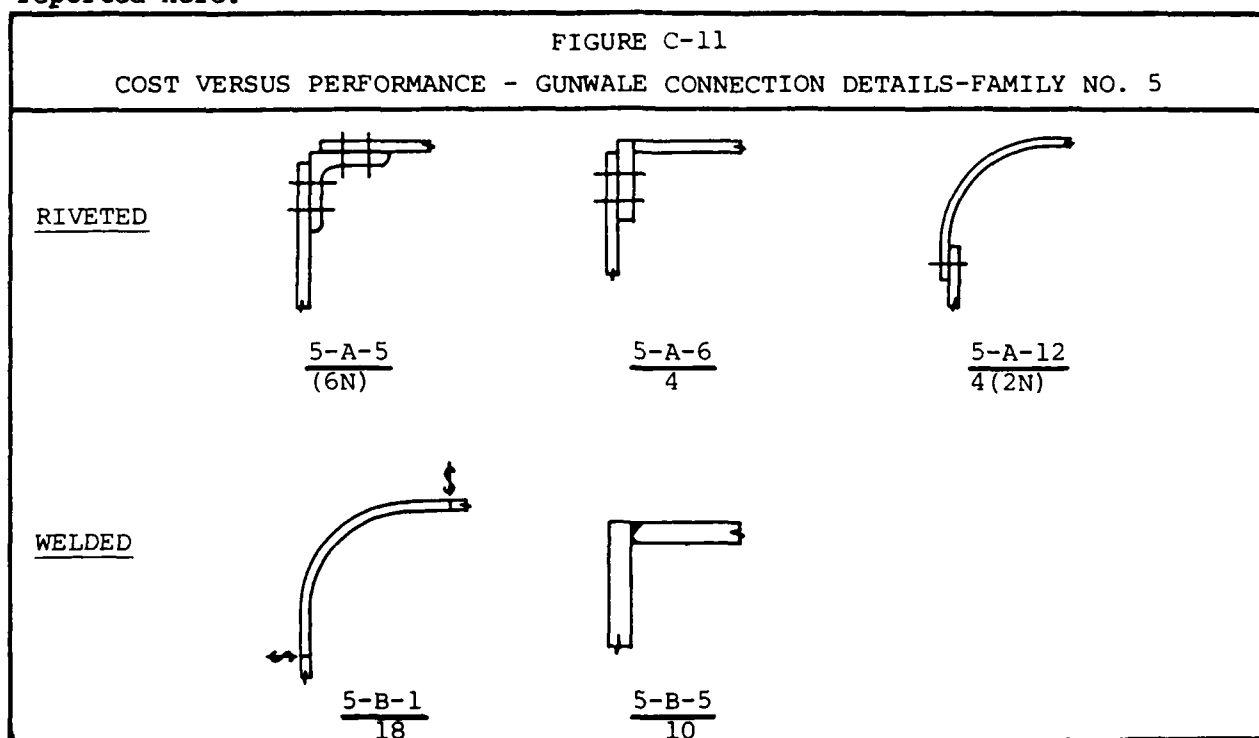
Two alternate welded designs are shown in Fig. C-11. The rolled plate of detail 5-B-1 eliminates the raw plate edge of detail 5-B-5 but it has the disadvantage of requiring transitions to square corners near the ends of the ship and loss of deck area. The latter may be a significant consideration on containerships and roll-on/roll-off vessels. This type of trade-off is beyond the scope of the project reported here.

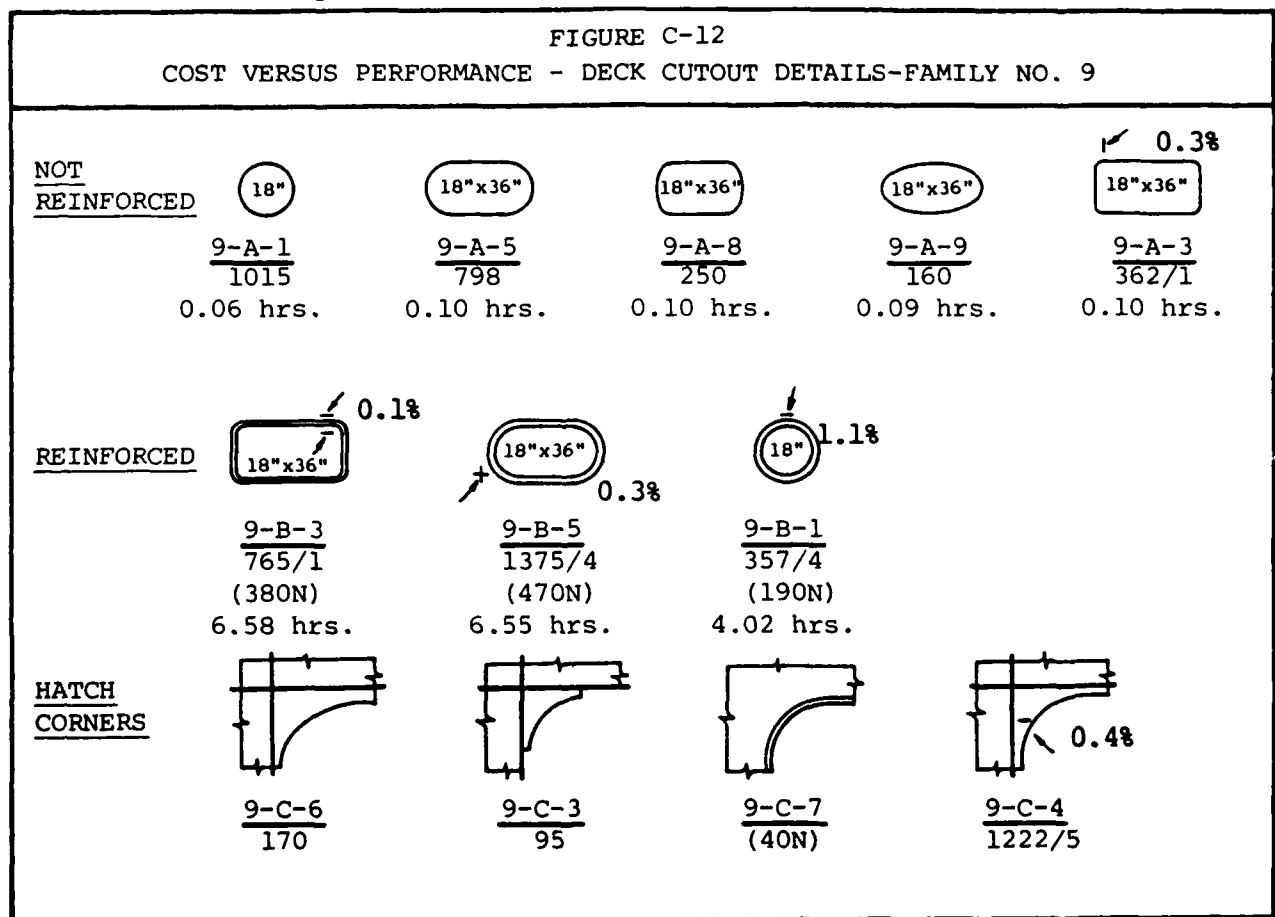
The expense of fitting reinforcement for openings in structural decks is well illustrated by Fig. C-12. With modern burning equipment, holes can be cut for a negligible cost compared to the expense of fitting and welding reinforcement. Construction costs can be minimized if necessary openings can be located in low stress areas and left unreinforced. An attractive alternative might be to group openings in a thicker plate inserted in the deck utilizing existing butts and seams. The cost of cutting the thicker plate would be negligible compared to the cost of fitting reinforcement.

Note: Hours shown are for 3/4" plate and automatic burning equipment.
