AFOEHL REPORT 90-161EH00008JEA

# Ecological Evaluation of Three Ponds and Three Streams, Andrews AFB DC

SEPTEMBER 1990

Final Report

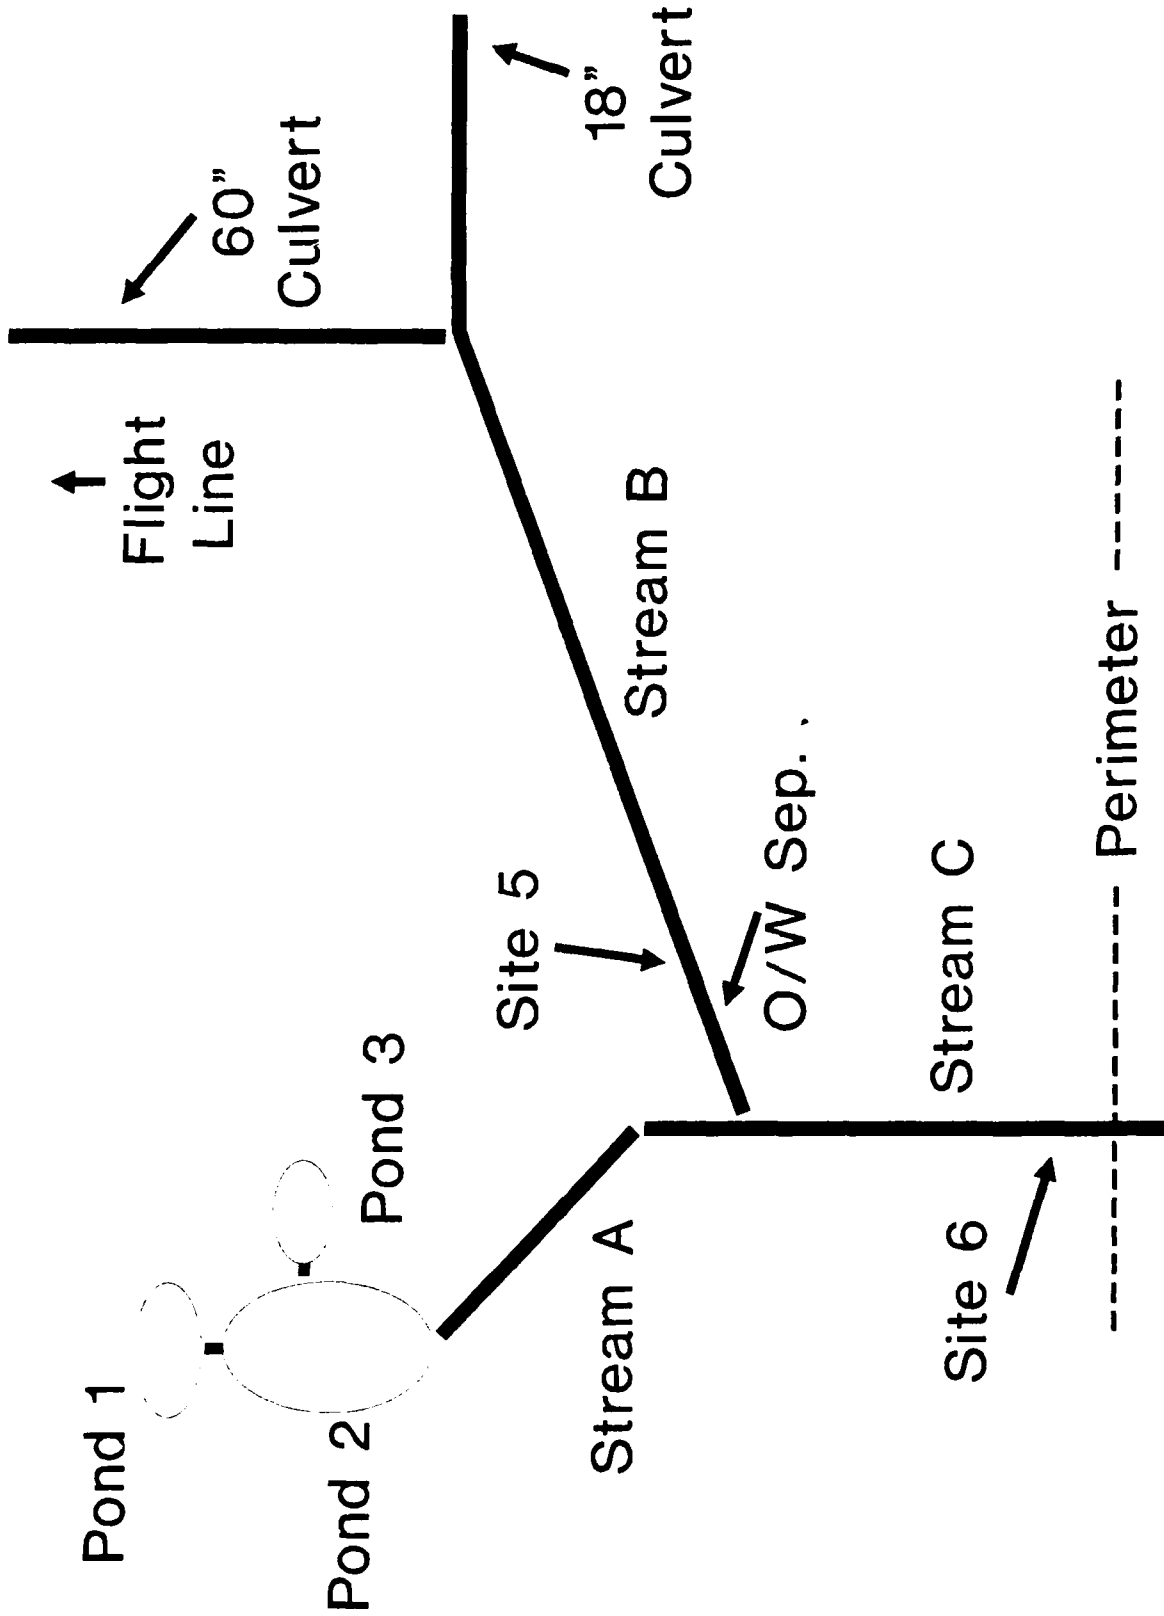
Figure 1. Schematic Diagram of Ponds and Streams  
Not to Scale

Upon arrival we observed three interconnecting ponds about 122 meters downhill from the flight line. Figures 1 & 2 show a schematic diagram of the flight line in comparison to the pond and streams. Stream A was fed by pond 2. Stream B was fed by two culverts, one a 60 inch pipe running under the length of the flight line; the other an 18 inch culvert perpendicular to the flight line. The two streams united downstream of an oil-water separator on stream B to form stream C. Stream C flows off base.

3. We obtained an ammonia level of 0.95 mg/L from stream B and an ammonia level of 0.53 mg/L from stream C. Stream B, as seen in Figure 1, is fed by a 60 inch culvert that accepts drainage from industrial operation shops located upstream. Stream C receives drainage from both streams A and B. The decrease in ammonia level seen in stream C was probably caused by a dilution effect caused by stream A mixing with stream B.

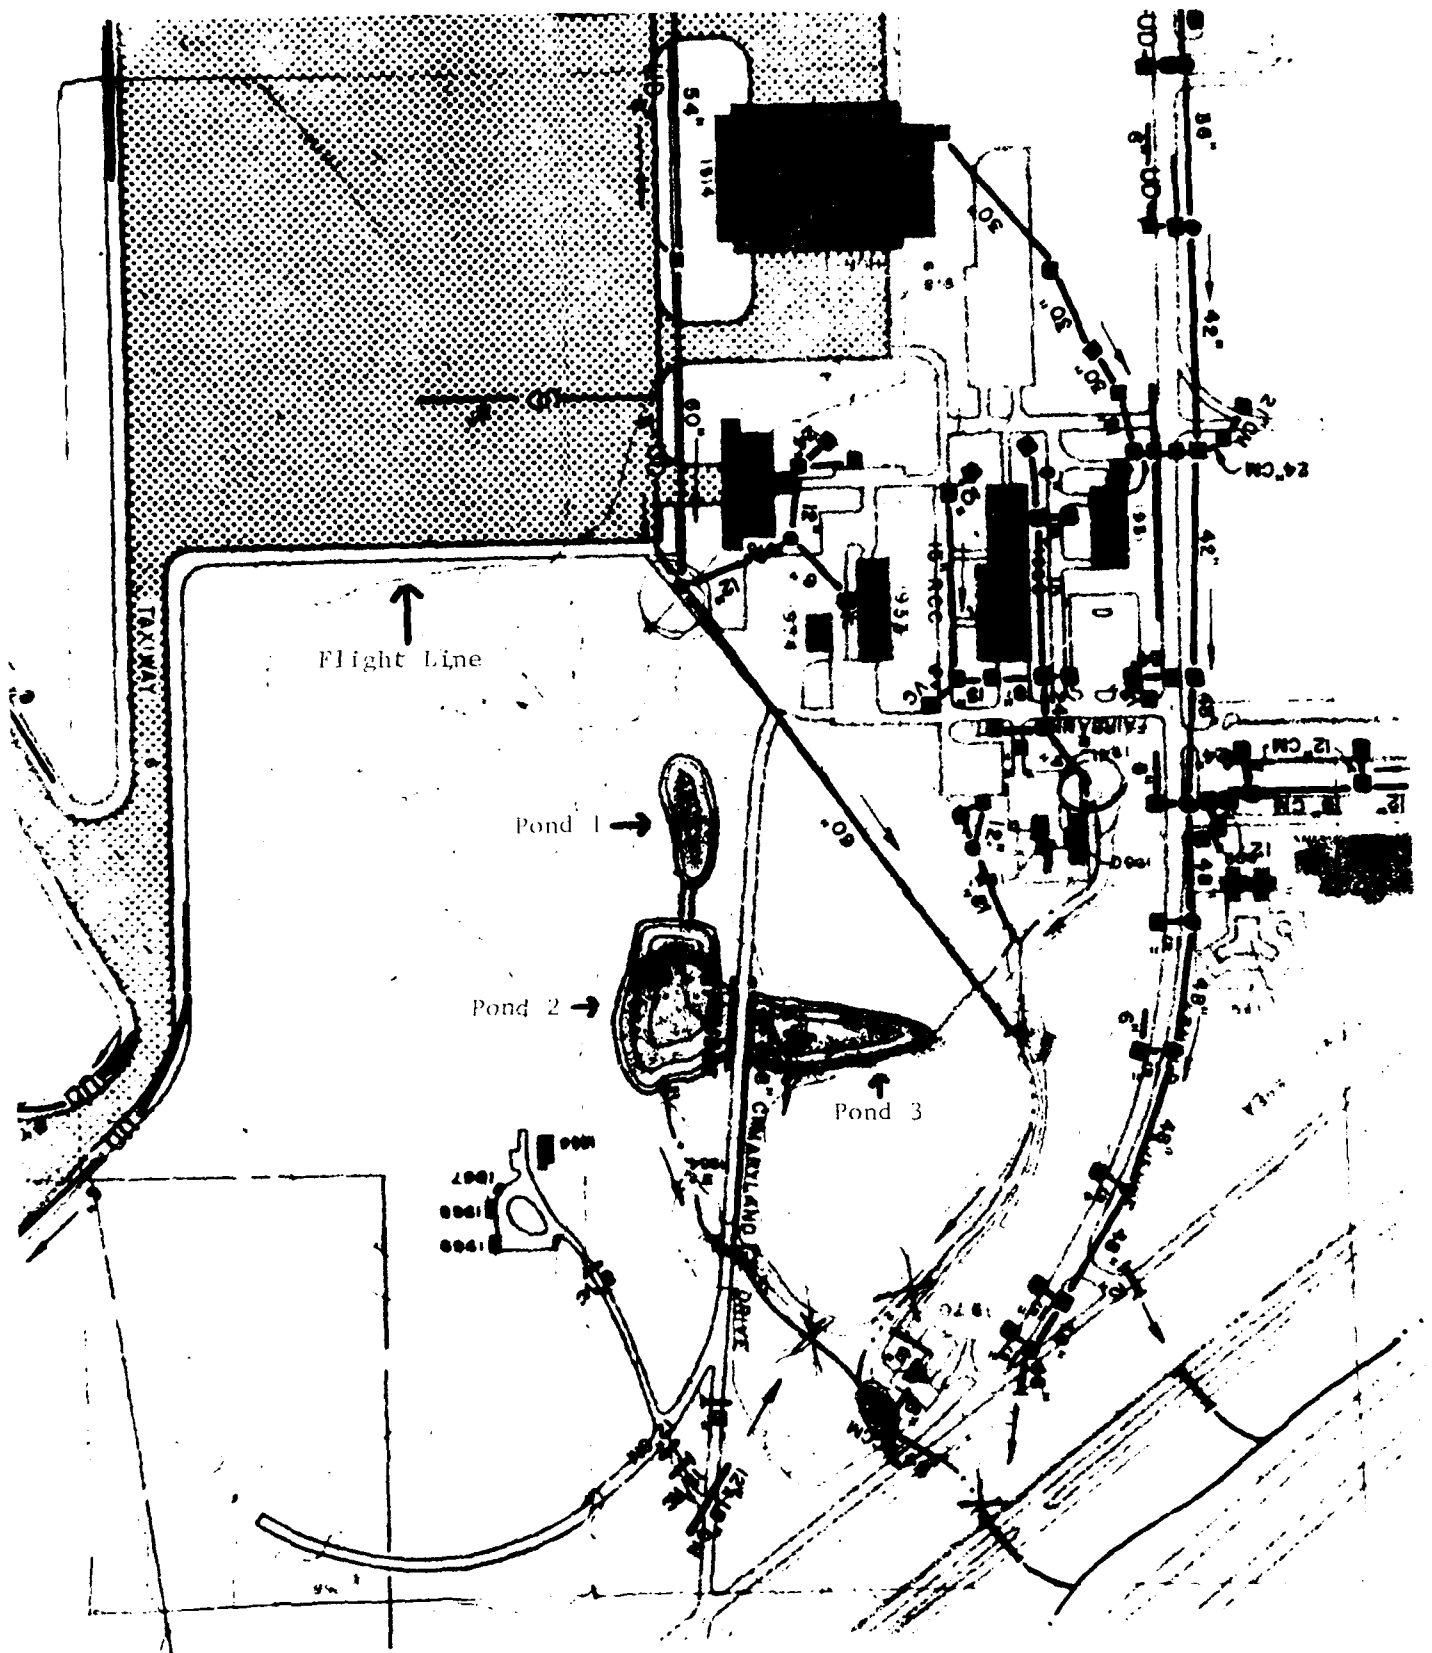
Figure 2. Location of Ponds

All three ponds were located approximately 122 meters down hill from the flight line. Figures 3 to 5 provide photographs of these ponds. The circumference of each pond was measured with a tape and the pH, temperature and dissolved oxygen levels were measured at various locations and depths. The depth was measured by using a weighted rope and the photic zone (depth of light penetration) measured by using a white, water sampling bottle. The results are summarized in Table 2.
