Infrared Study of a Piston Ring Temperatures in a Fired Engine

Final Technical Report

Dr H A Spikes

November 1990

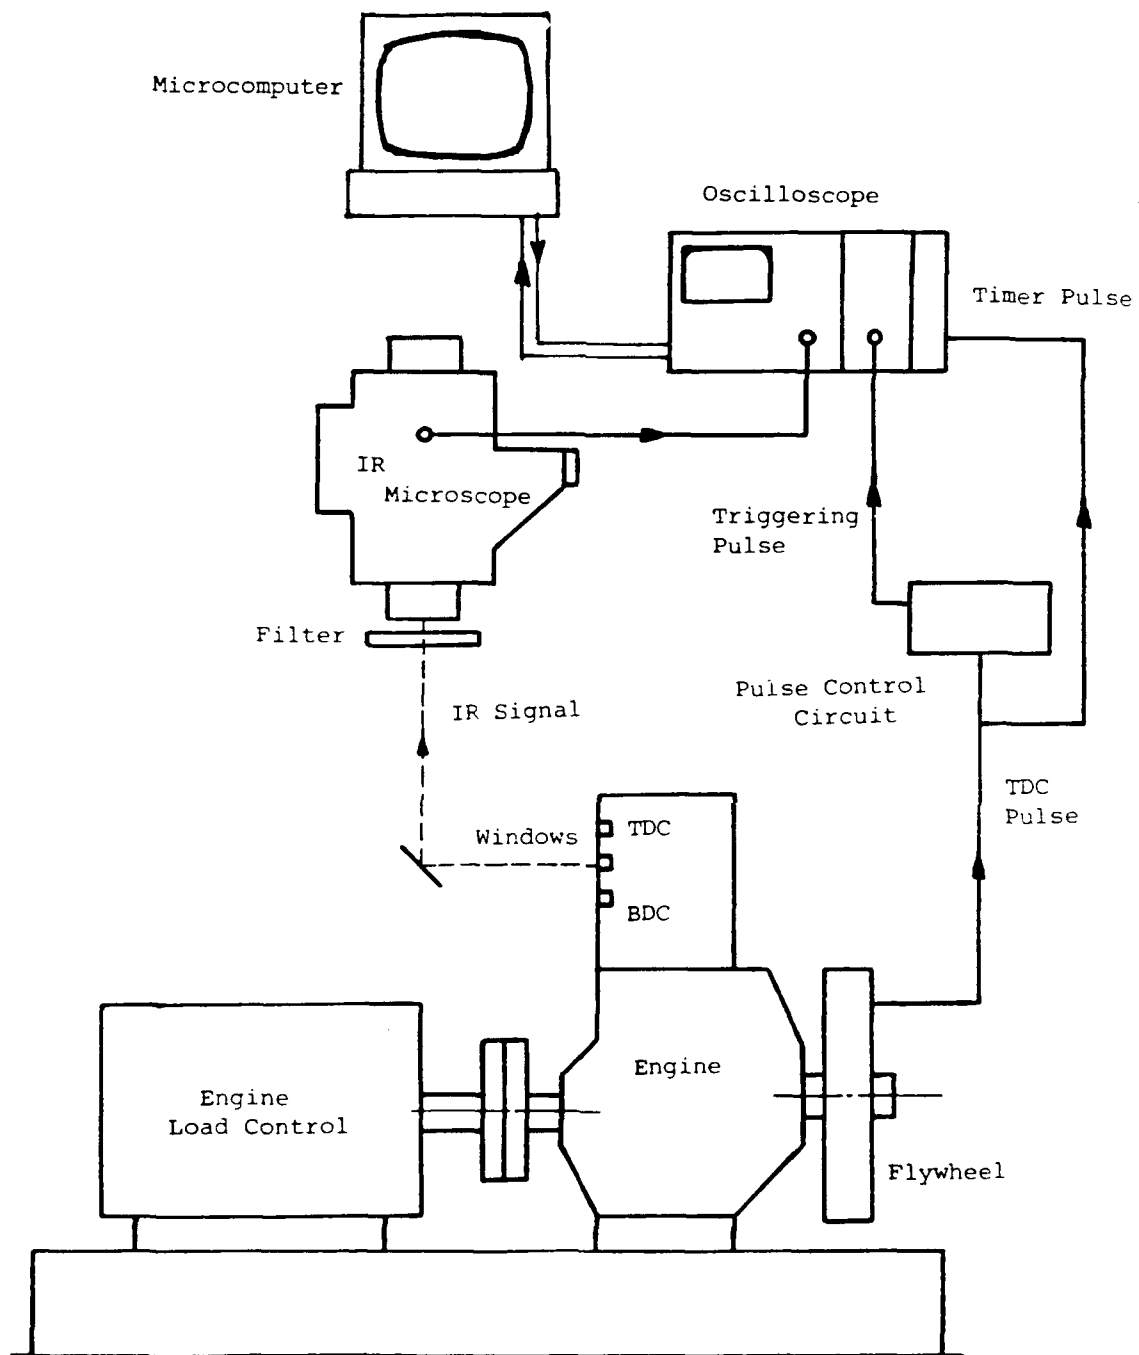
Figure 2. Schematic Diagram of Test Set Up

The overall experimental and optical setup is shown schematically in figure 2. The engine is operated under a fixed load at a set jacket coolant temperature. Infrared emission is monitored by the IR microscope operating in either transient or chopped mode and the IR signal is fed into a high speed storage oscilloscope. A magnetic plug and detector inserted in the flywheel produces an electrical pulse at each top dead centre position (TDC) of the piston. This pulse is used in two ways. Firstly it is fed into one channel of the oscilloscope to provide a piston position reference. It is also passed through a simple electrical circuit which suppresses every second pulse and allows the remaining pulses to be delayed by a fixed time interval.

Halving the number of pulses means that there is just one for every full cycle of the four stroke engine. Consequently this pulse train may be used to trigger and accumulate, in the oscilloscope, IR emission readings starting at any chosen portion of the firing cycle over a sequence of engine cycles. This averaging process greatly improved the signal to noise ratio of the system.

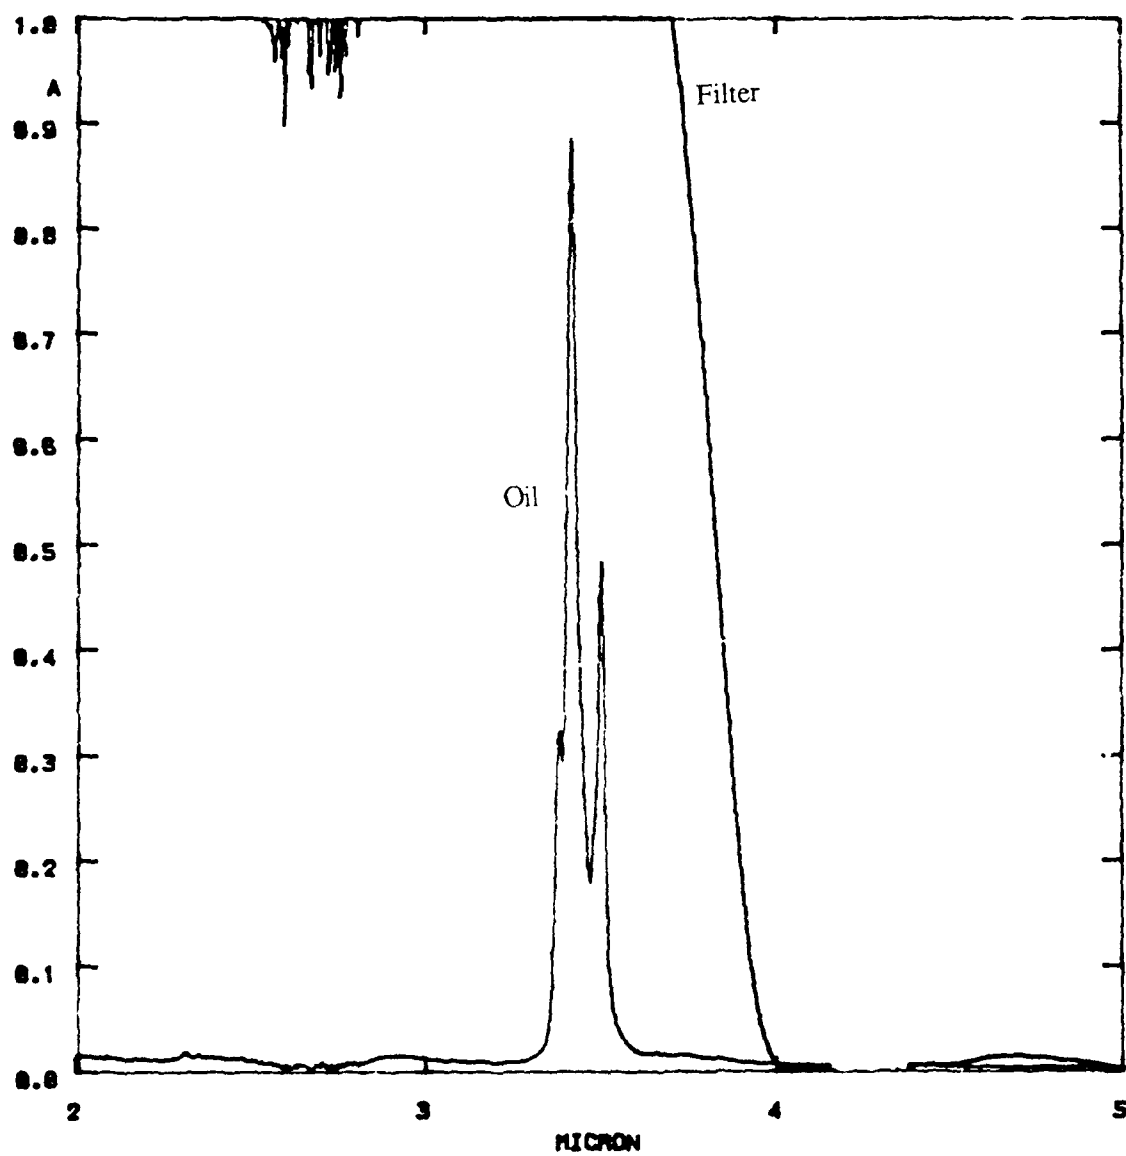
Figure 3. IR Absorbance Characteristics of Filter

With the window set back from the liner surface there is a likelihood of oil being trapped between ring and window. There may also be a significant quantity of oil between piston lands and liner. This could have two effects on the measured infrared emission. Firstly there might be emission, not just from the piston ring metal surface but also from this trapped oil. Secondly there is a possibility that the oil film will absorb radiation emitted from the ring surface. In an attempt to limit the effect of emission from the oil, an infrared filter was introduced between engine and IR microscope. This filter was chosen to selectively remove the infrared radiation in the frequency range emitted by hydrocarbon-based oils whilst still transmitting most of the lower frequency radiation emitted by hot metal surfaces. The filter absorption characteristics are shown in figure 3.

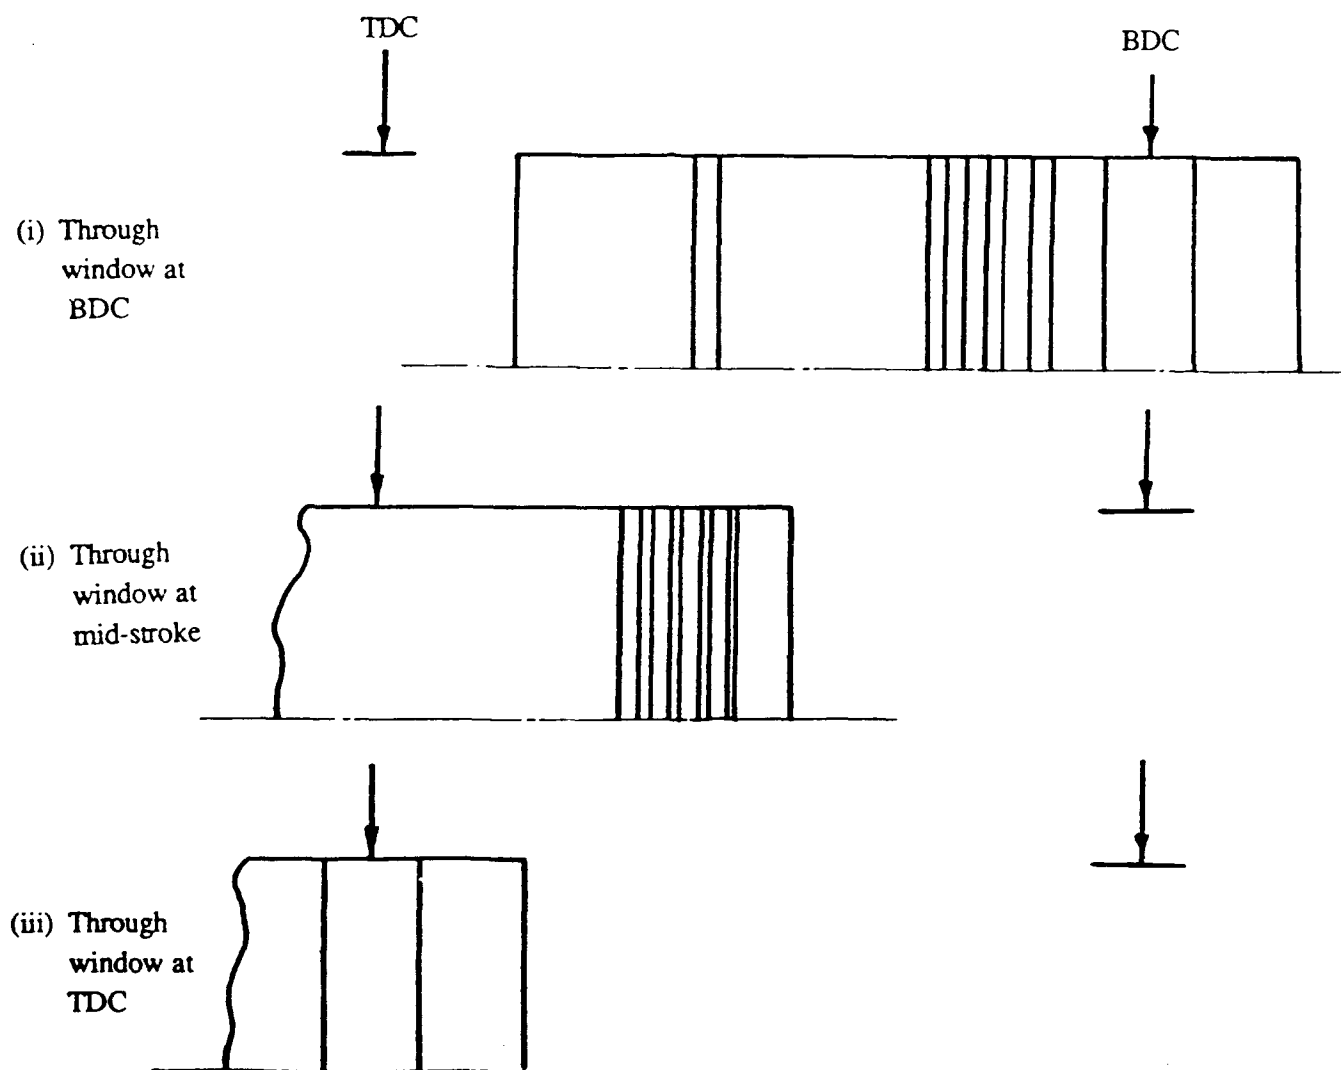
Figure 4. Influence of Motion on Apparent Piston Shape

To facilitate interpretation of results, sketches of the view of the piston as it passes each window have been prepared and are shown in figure 4. These, in effect, transform the piston from being linear with respect to actual size to being linear with respect to time of passage past the window and can thus be superimposed on the linear time scale oscilloscope voltage trace. As can be seen from the figure, for a window at mid-stroke, the areas of the piston that pass the window at around the middle of the stroke are effectively squashed, whereas parts that pass the window whilst the piston is reversing are elongated. By contrast, for a window at top dead centre the upper half of the top piston appears stretched.

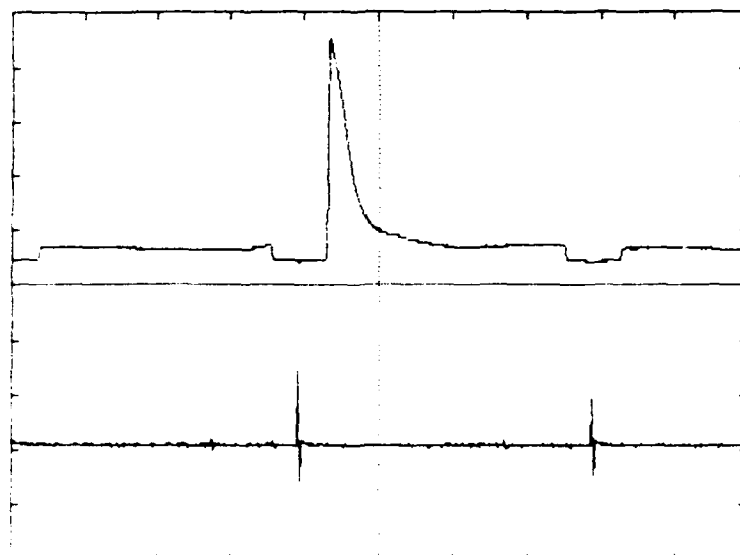
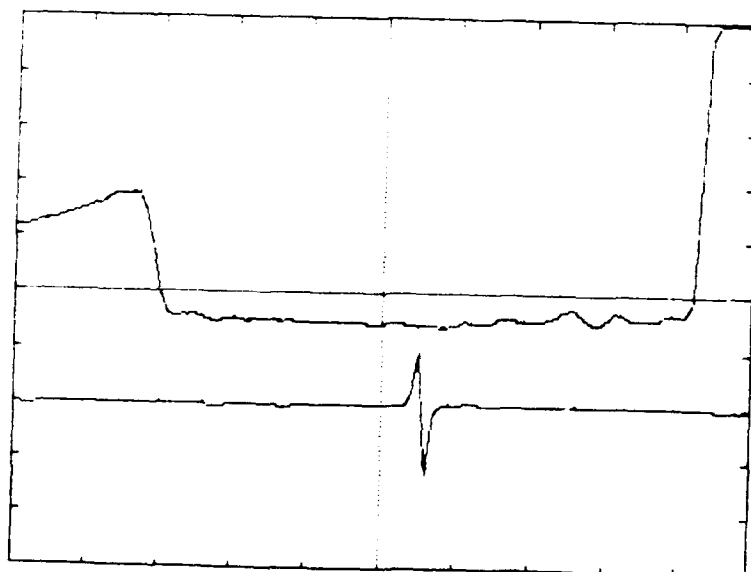
Figure 10. Radiance Trace Under  $\frac{1}{3}$  Load

Oscilloscope traces averaged over 80 successive engine cycles are shown in figures 9 to 11. These show less noise than earlier work, indicating the effectiveness of averaging.

From figure 9 to 11 it was possible to estimate the temperature of the

combustion chamber, assuming an emissivity value of unity. At zero engine load this was 250 to 300°C during the firing stroke, rising to 450 to 500°C for full load. Clearly these values are less than the peak temperatures produced during combustion in a diesel engine (approximately 1000 to 2500°C). However it should be noted that the microscope does not see the combustion chamber until approximately 38° of crank angle rotation after TDC, ie after 3.5 ms. Over this time, considerable cooling will have taken place. Very approximate back-extrapolation of the decaying temperature curve observed in figure 11 suggests that the maximum temperature may well have been considerably in excess of 1000°C just after ignition.

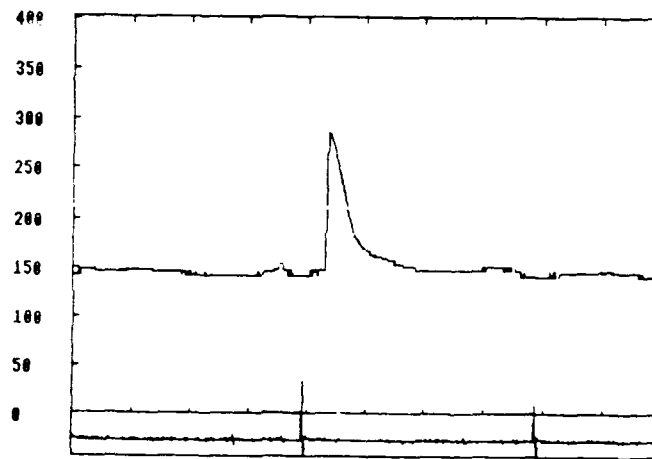
Figure 12. Temperature Curves From Radiance Traces

Figure 12 shows temperature traces calculated from the oscilloscope voltage traces in figures 9a, 10a and 11a. The program to calculate these allowed the user to input emissivities for each part of the trace and in figure 12 an emissivity of 1 was used for those parts of the trace where the combustion chamber was in view and the measured value of 0.7 was employed for the piston ring and land regions.

The resolution of the digital storage oscilloscope was only 8 bits or 1 in 256. This meant that the calculated temperature traces in figure 12 have very coarse resolution in the lower temperature range. This is only a limitation when a small oscilloscope voltage scale is chosen so as to accommodate the whole IR signal trace, including the very large combustion peak on the screen. Much more accurate temperature profiles can be obtained for small parts of the stroke by using a larger voltage scale, as shown in figure 13.
