**FLEXURAL FATIGUE BEHAVIOR OF ARALL<sup>®</sup>  
LAMINATES**

Jeffrey Cook and Mary Donnellan  
Air Vehicle and Crew Systems Technology Department (Code 6063)  
NAVAL AIR DEVELOPMENT CENTER  
Warminster, PA 18974-5000

**1 AUGUST 1990**

**FINAL REPORT**  
Period Covering 1 June 1989 to 1 August 1990  
Task No. R34500000  
Work Unit No. ZP100  
Program Element No. 62234N  
Project No. NA2A

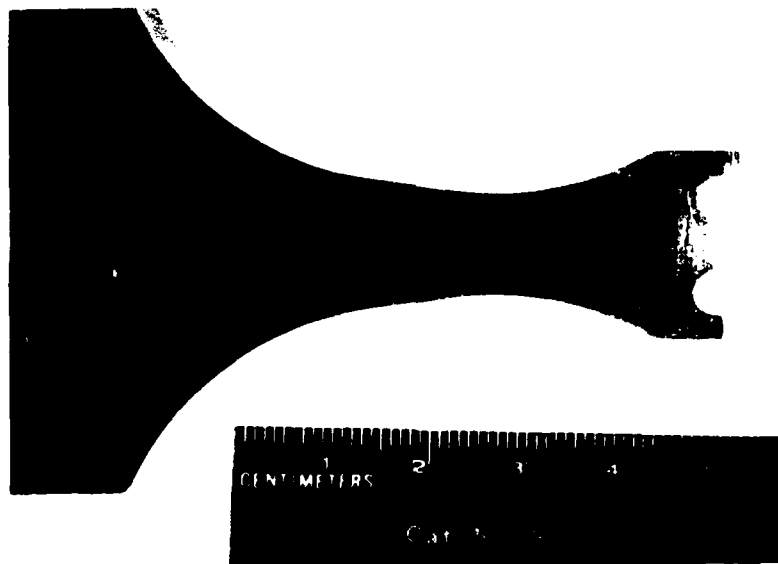
**Macrophotography:** Low-magnification photographs of the fatigued specimens showed a wide range of surface crack morphologies. Specimen 3203 (unexposed) showed two well-defined cracks, separated by about 6mm, on each side (Figure 6). Specimen 3202 was similar. Specimens 5401 and 5402 were tested in the same condition, but showed nearly a half dozen cracks on each side. These cracks were spaced 3 to 4mm apart. Transverse (unexposed) specimens typically had a single surface crack, and fractured all the way through at or near this crack (Figure 7).

Figure 7. Fracture of Specimen 3292 ( $8.6 \times 10^5$  cycles).
