NASA Contractor Report 185262  
Aerojet 2459-56-1

# Orbital Transfer Vehicle Oxygen Turbopump Technology

Final Report, Volume II—Nitrogen and  
Ambient Oxygen Testing

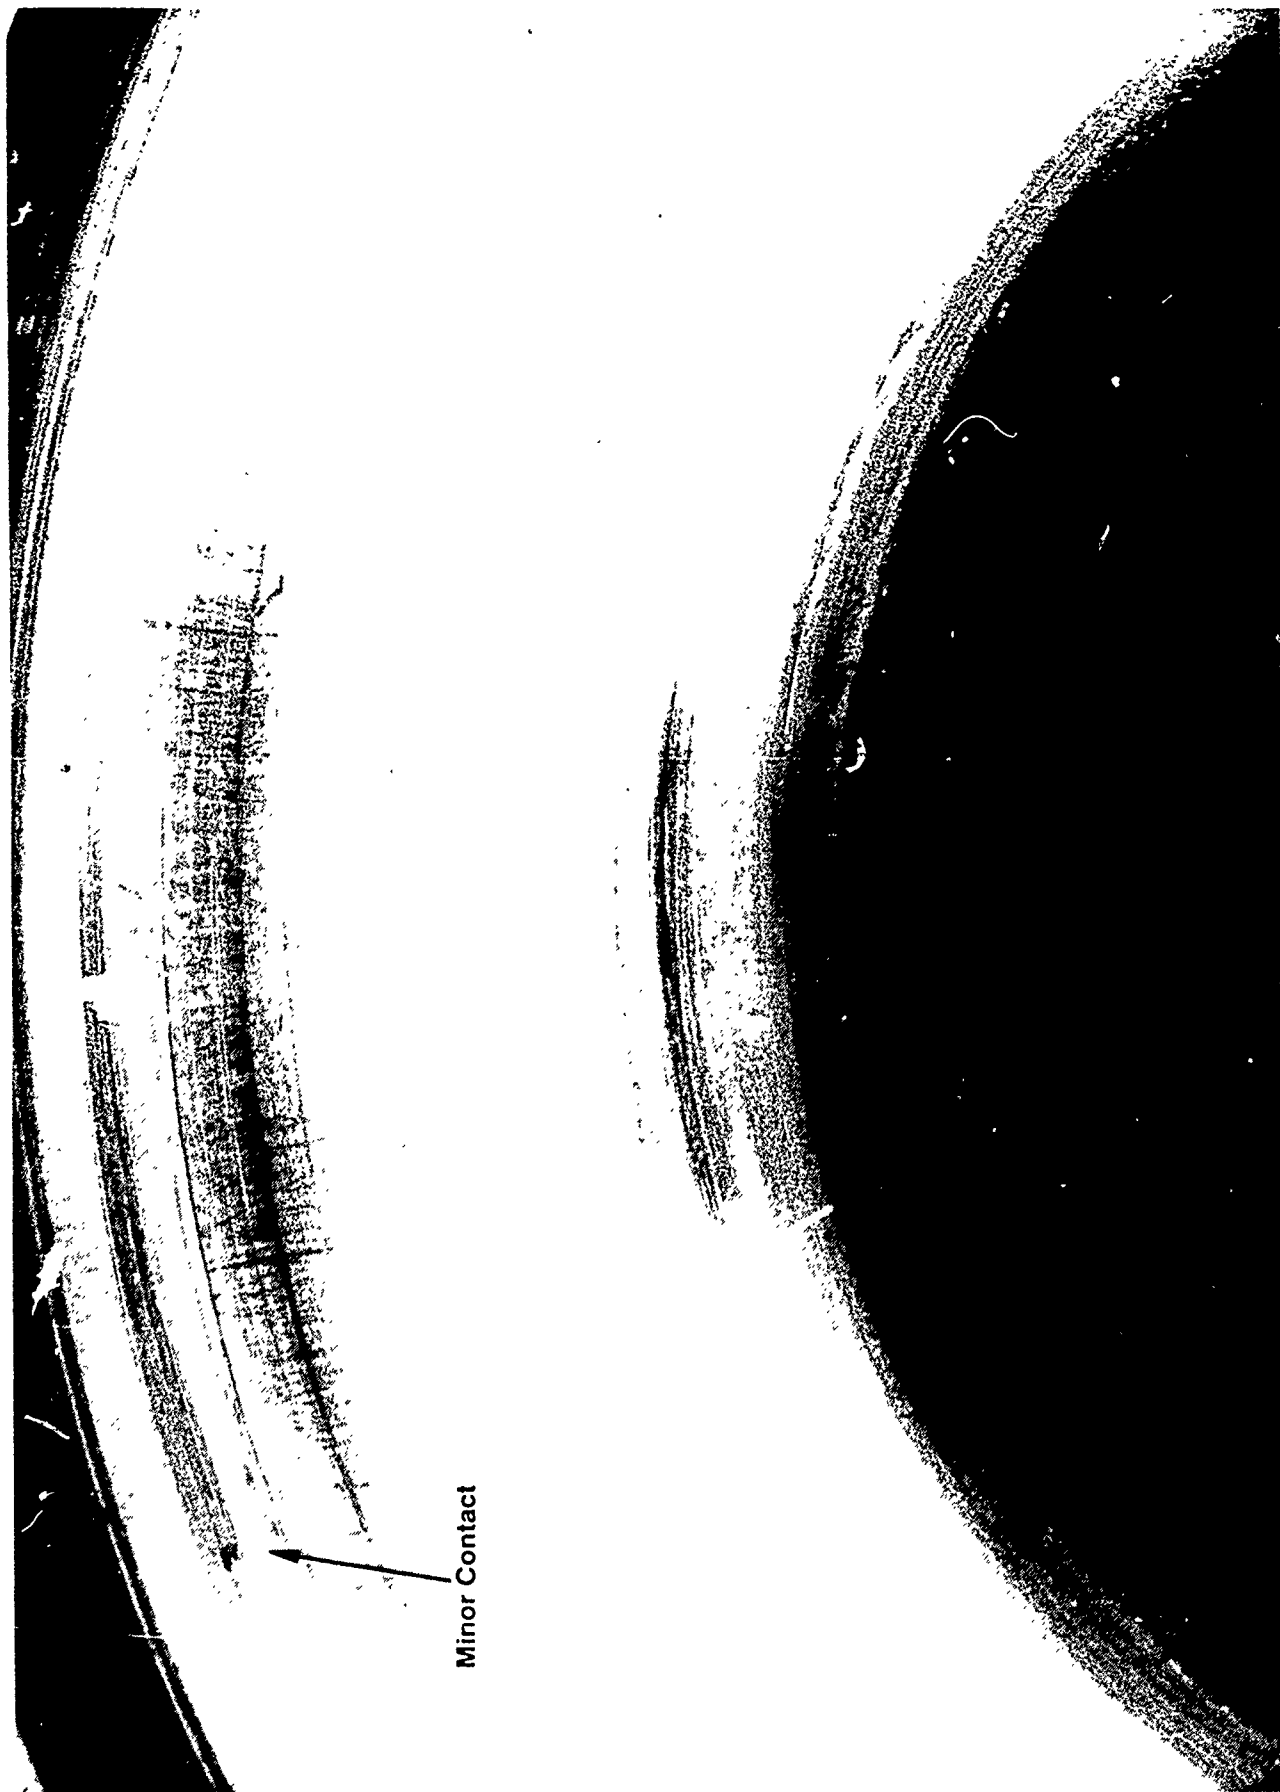
Figure 3.5-24. First Stage Impeller Shroud Contour

Minor Contact
