Aircraft Structures Technical Memorandum 578

A REVIEW OF AUSTRALIAN AND NEW ZEALAND
INVESTIGATIONS ON AERONAUTICAL FATIGUE DURING THE
PERIOD APRIL 1989 TO MARCH 1991

This document was prepared for presentation to the 22nd Conference of the International Committee on Aeronautical Fatigue scheduled to be held in Tokyo, Japan, on May 20 and 21, 1991.

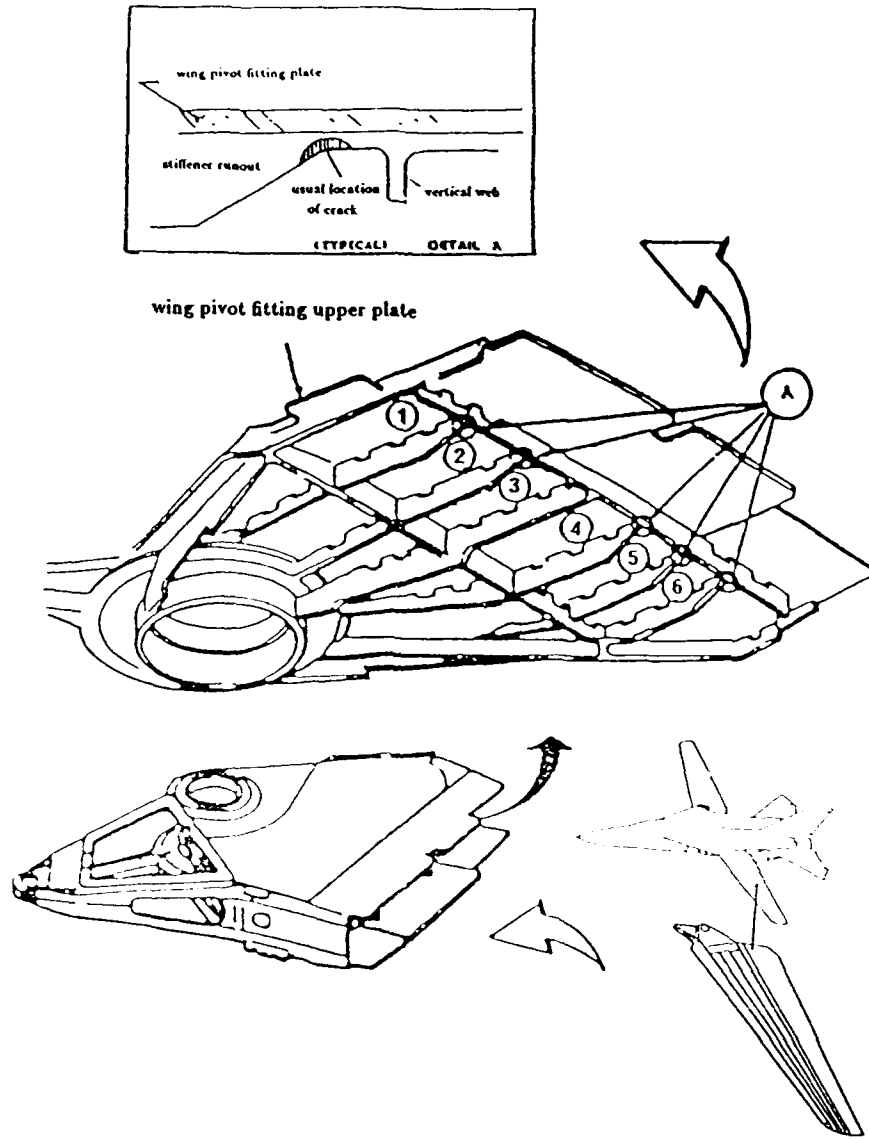
FIG. 1 F-111 WING PIVOT FITTING - LOCATION OF CRITICAL REGION ON STIFFENER RUNOUT

In conjunction with the development of the boron/epoxy doubler for the upper plate of the wing pivot fitting [1] the RAAF has requested that ARL estimate in-service inspection intervals for the No. 2 stiffener runout, Fig.1. ARL has obtained interim estimates of inspection intervals for the runout, both with and without doublers. The task is unusual in that the problem area is nominally in compression during positive manoeuvre loads. However the wings are regularly subjected to cold proof load testing, essentially to "inspect" for cracks in the lower load path in the wing and carry-through box, and during proof loading a local secondary bending influence in the upper plate of the wing pivot fitting causes local compressive yielding in the stiffener runouts. A residual tensile stress remains after removal of the proof load and hence all subsequent service loads below about 2g result in tensile cycling.

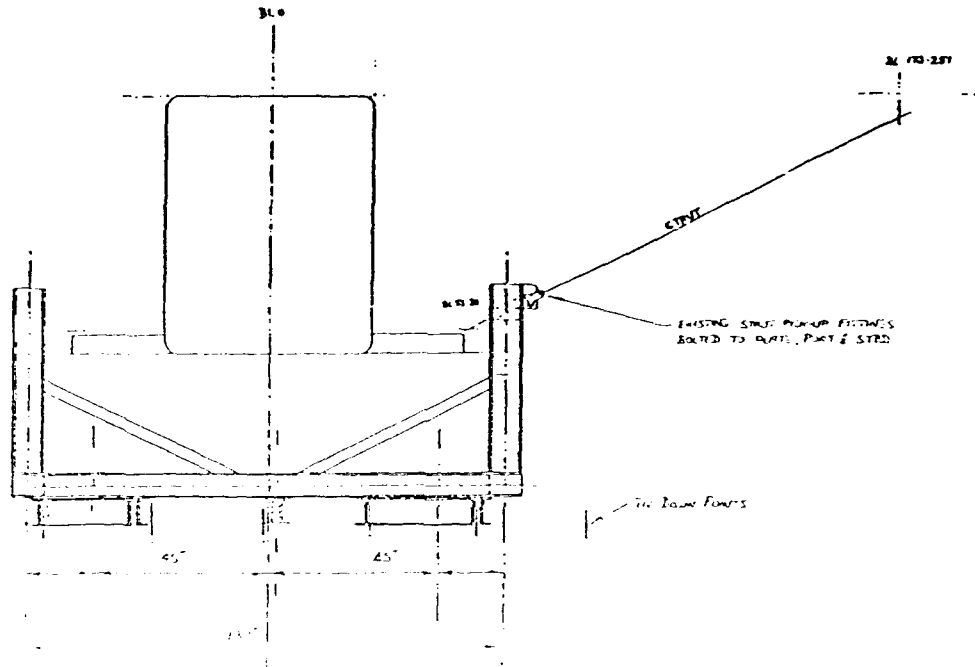
FIG. 2 NOMAD FULL SCALE FATIGUE TEST - SCHEMATIC OF STUBWING BY-PASS STRUCTURE

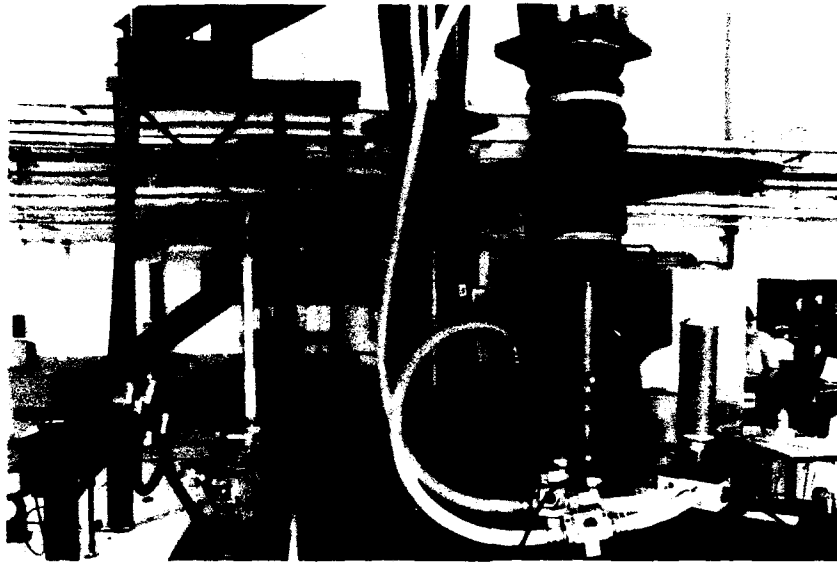
FIG. 3 DEMONSTRATOR F/A-18 AIRBAG MANOEUVRE LOADING SYSTEM

To ensure that the shaker attachment and air bag loading directions remain sensibly normal to the surfaces being loaded, the bulk displacement of the aft fuselage caused by manoeuvre loading will be minimized by employing an active reaction system using the hydraulic actuators suspending the test article in conjunction with a displacement controlled servo system.

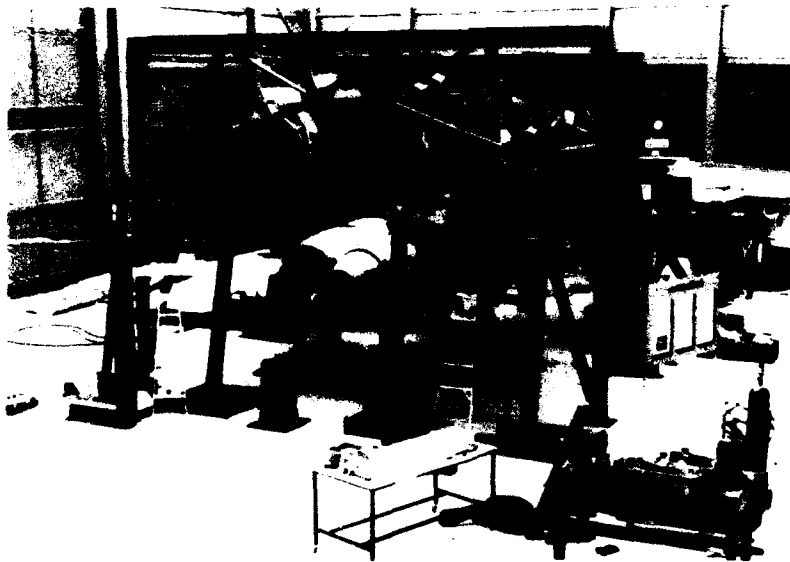
FIG. 4 F/A-18 TEST ARTICLE AND LOADING FRAMEWORK

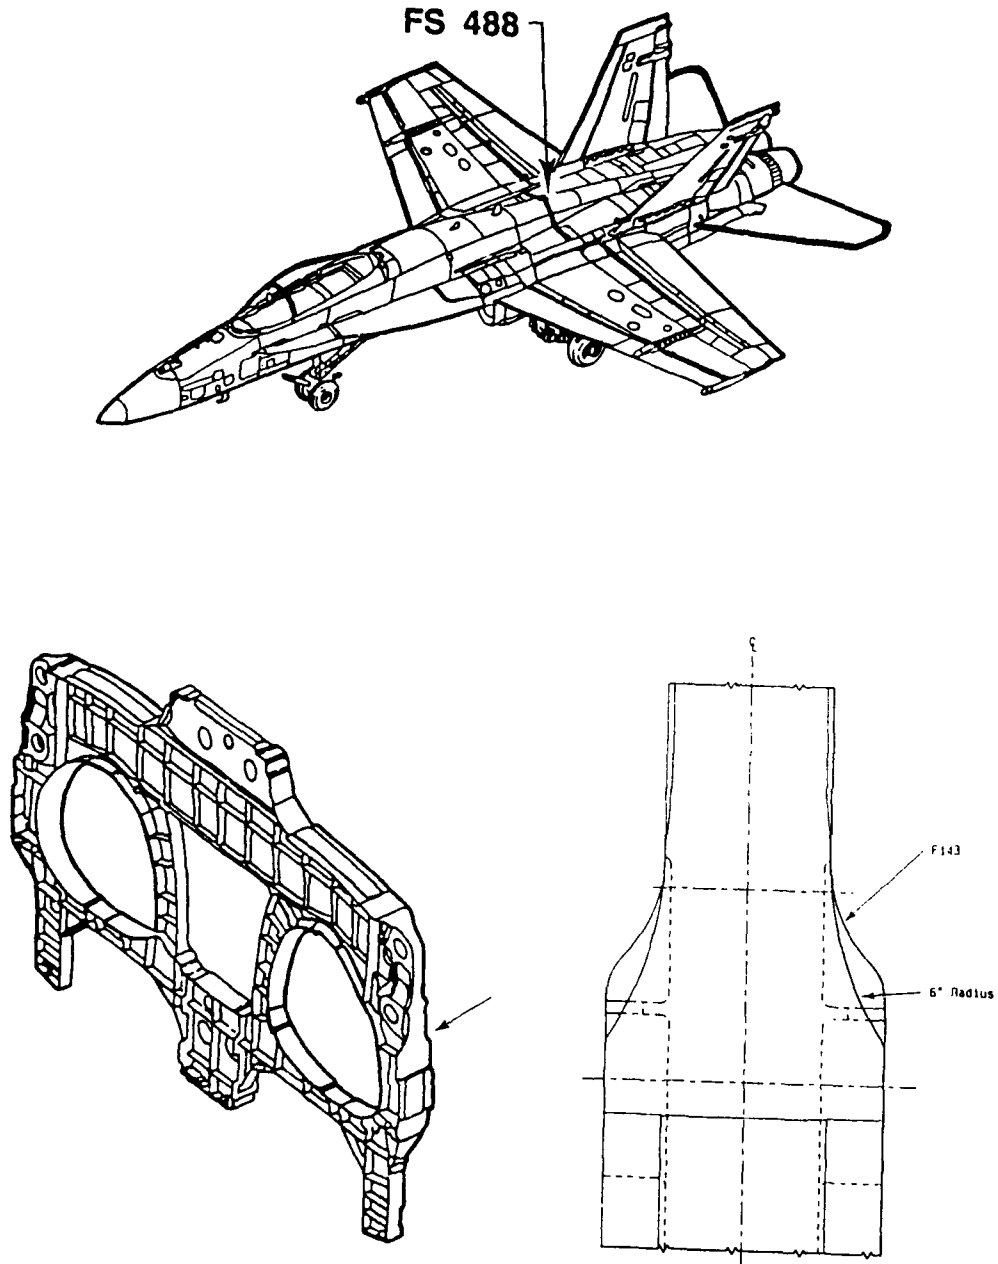
FIG. 5 FUSELAGE STATION 488 BULKHEAD SHOWING EARLIER (F143) AND LATER (6" RADIUS) FLANGE CONFIGURATIONS

The first 32 Australian F/A-18 aircraft were delivered with an early configuration fuselage station 488 bulkhead, which is one of the three wing support bulkheads. The mould-line flanges on these bulkheads (F143 configured) are such that their fatigue life may be inadequate. It is intended that these early configuration bulkheads be modified to increase their fatigue life. The modification involves re-shaping the mould-line flange from the F143 configuration to a 6" radius configuration, Fig.5. Tests of free standing bulkheads performed by McDonnell Douglas and Northrop have shown that the 6" radius configuration has an adequate fatigue life. Bulkheads with the F143 flange profile have not been freestand fatigue tested.

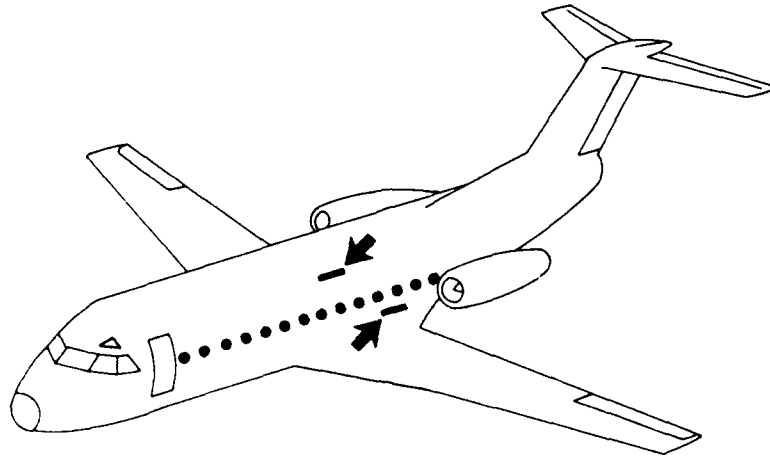
FIG. 6 FOKKER F28 SHOWING LOCATION OF FUSELAGE LAP JOINT CRACKING

The most recent of these problems to occur in Australia is cracking in the lap joints just above the fuselage floor line (at Stringers 17 and 58), behind the wing (between Frames 13345 and 14285) as shown in Fig.6, in several Fokker F28 aircraft. In this area the 0.040 inch thick skins are joined by two rows of dimpled countersunk rivets. An initial fortuitous discovery, followed up by a fleet-wide inspection, has revealed multiple cracks around the dimples in the outer skin at the upper row of rivets, and through the rivet holes in the inner skin at the lower row of rivets. The affected group of aircraft had between 50,000 and 55,000 pressurised flight cycles, and in several instances individual cracks had linked up over several rivets, the longest such crack being 8 inches. Initial fractography indicates that cracking has been present for up to 17,000 cycles; this is still to be confirmed.

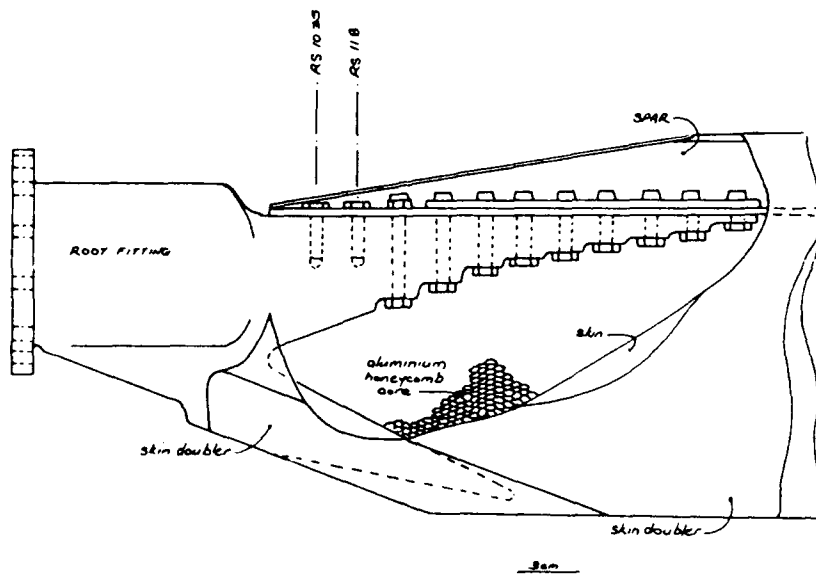
FIG. 7 ROBINSON R-22 MAIN ROTOR BLADE CONSTRUCTION DETAIL

Failure occurred in the 7075 aluminium alloy root fitting, Fig. 7, at the most inboard threaded bolt hole of 11 bolts which fasten the stainless steel leading edge D-spar to the fitting. The failure location is shown in Fig. 8. and the fracture surface in Fig. 9.

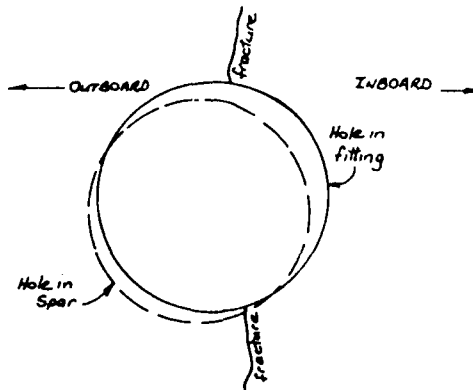
FIG. 10 ROBINSON R-22 MAIN ROTOR BLADE FAILURE
HOLE MISMATCH AT FAILURE LOCATION

the spar and the fitting. Contact marks on the bolt and in the holes confirms this. The contention is that the resultant frictional forces were sufficient to absorb much of the specified bolt tightening torque, resulting in inadequate clamping at this location. Further, the orientation of the mismatch was such that there was significant preload contact between the bolt and the inboard side of the hole in the spar, and the outboard side of the hole in the fitting, resulting in substantially increased load transfer at this first bolt location, Fig. 10.

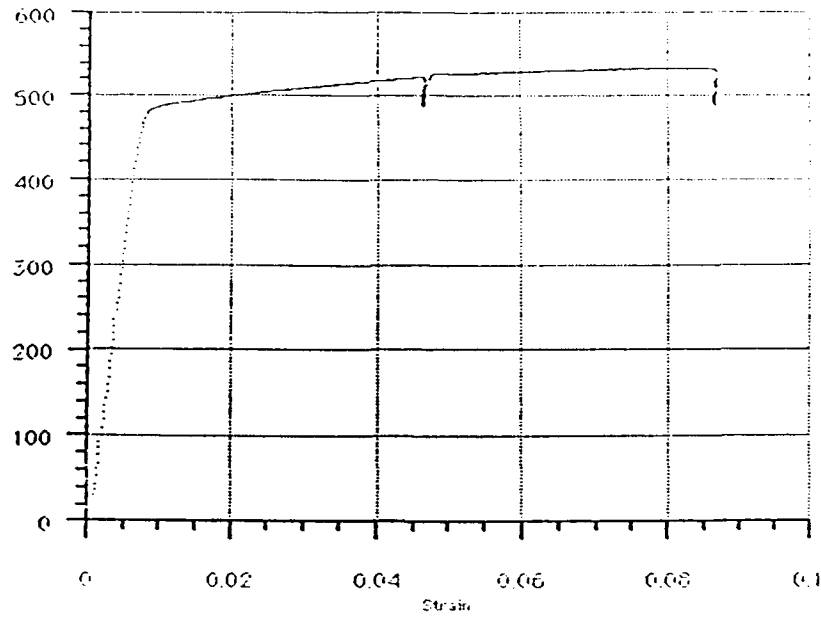
FIG. 11 EXPERIMENTAL STRESS-STRAIN CURVE WITH SHORT (10 MIN) STRAIN HOLDS AT STRAINS OF 0.045 AND 0.085

To date, some success has been achieved from investigations on 7050-T7451 aluminium alloy of which major components of the F/A-18 Hornet aircraft are made [22]. By way of example, it has been found that, under strain controlled loading, a strain hold in the plastic region results in significant stress relaxation which asymptotes to a constant stress level, Fig. 11. This phenomenon is predicted by the Stouffer-Bodner theory, Fig. 12. Similar stress relaxation behaviour occurs at strain holds during fatigue cycling.

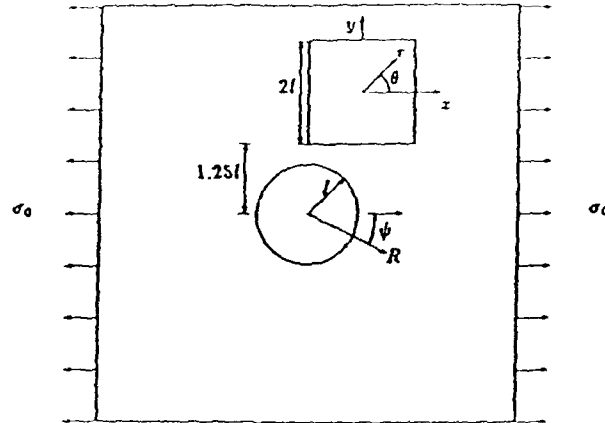
FIG. 13 GEOMETRY OF CIRCULAR HOLE IN UNIAXIALLY LOADED SQUARE PLATE SHOWING SQUARE SCAN REGION $\sigma_0 = 50$

Most recent work [31] deals with the problem of determining stress components from both the first and second harmonic response without using boundary conditions. Since the second harmonic response is small compared to the level of noise, the question of experimental design both spatially and temporally is examined. Simulations have shown that, in the presence of realistic noise, the stress invariants and the principal stresses can be recovered extremely accurately. Stress components can also be determined to a lesser, but nevertheless satisfactory, degree of accuracy, Figs. 13, 14 and 15.

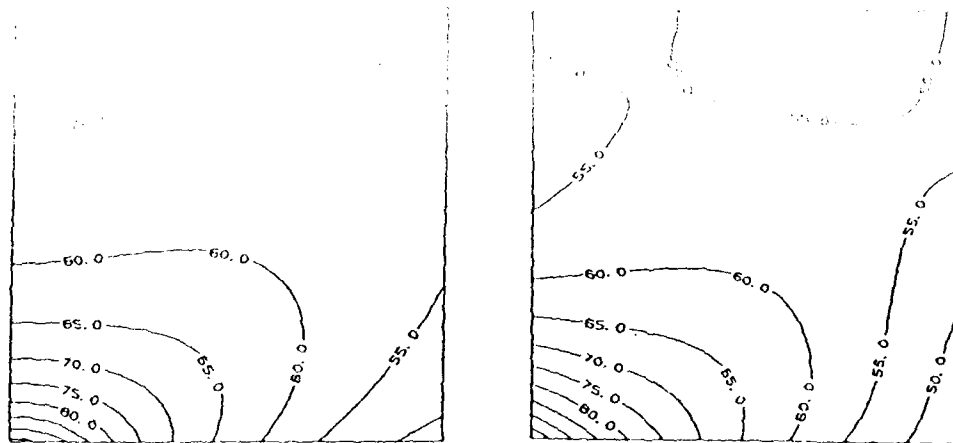
FIG. 14 COMPARISON OF DIRECT (LEFT) AND INVERSE (RIGHT) σ_{xx} STRESSES FOR GEOMETRY OF FIG. 13.

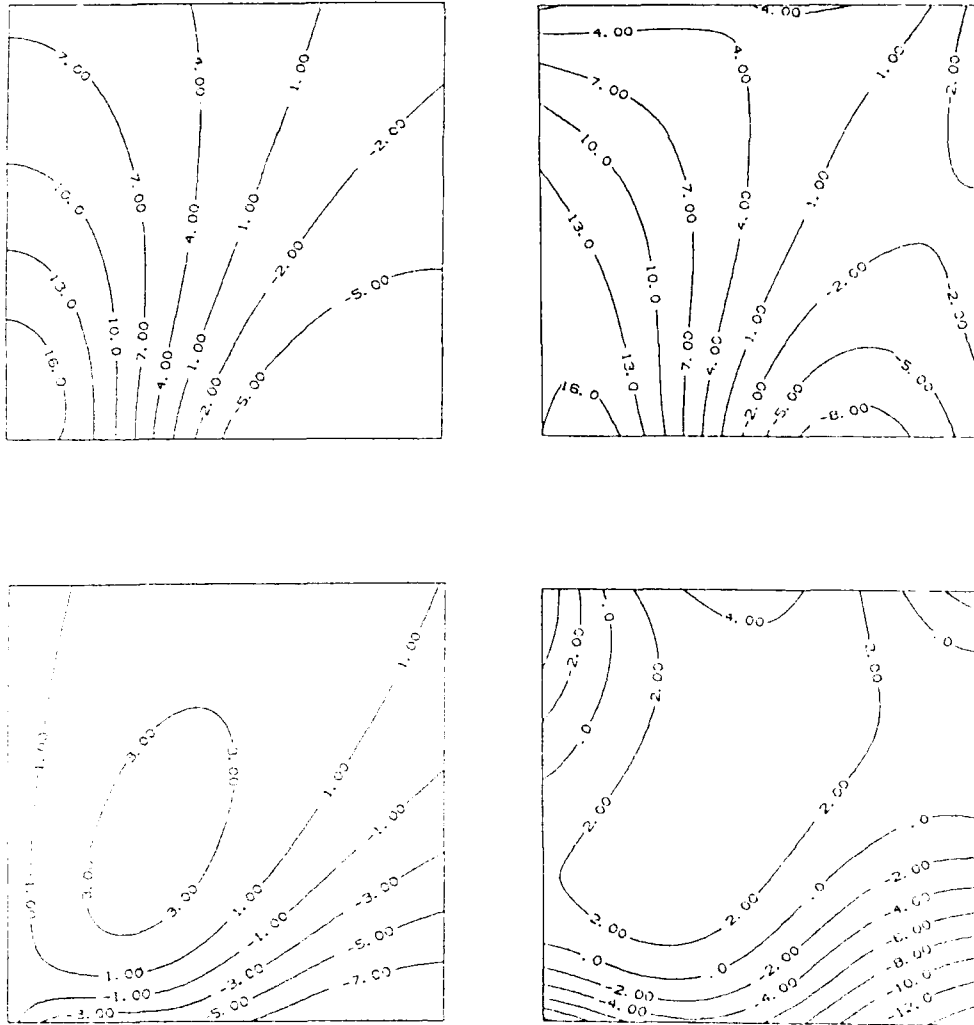
FIG. 15 COMPARISON OF DIRECT (LEFT) AND INVERSE (RIGHT) STRESSES FOR GEOMETRY OF FIG. 13. UPPER: σ_{yy} , LOWER: τ_{xy}

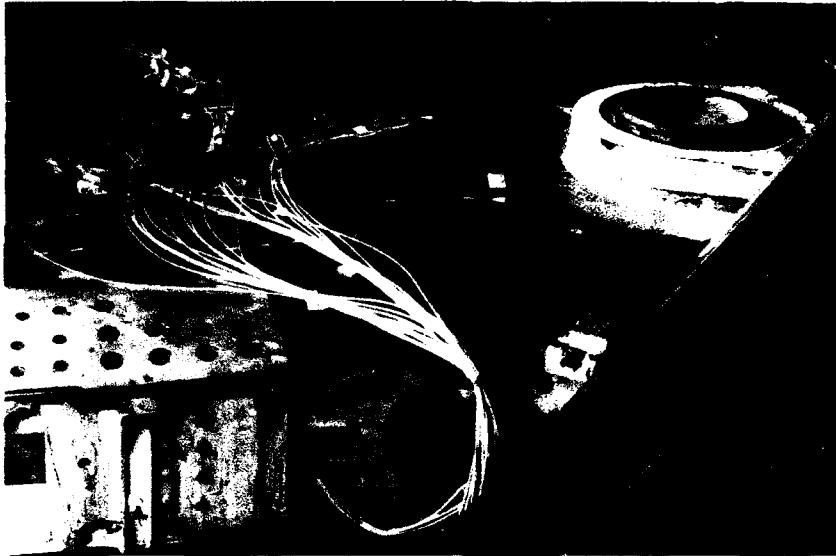
FIG. 19 F-111 WING PIVOT FITTING DOUBLERS

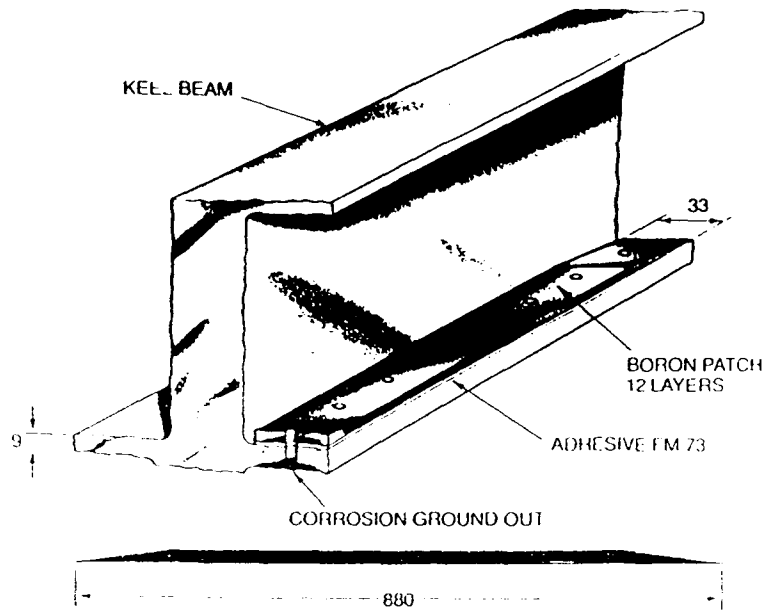
FIG. 21 767 KEEL BEAM DOUBLER
