# **FRACTURE MICROMECHANICS OF INTERMETALLIC AND CERAMIC MATRIX CONTINUOUS FIBER COMPOSITES**

Interim Technical Report

**The micromechanics of fatigue crack growth in Ti-6Al-4V reinforced with SiC continuous fiber SCS-6 at 25°C**

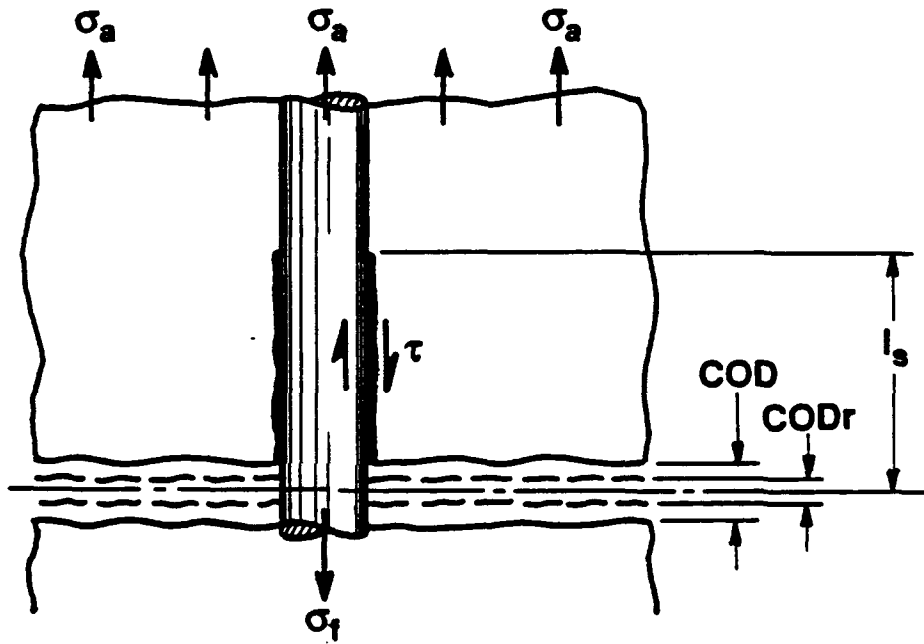
Fig. B1 Stresses on loaded crack and their relation to COD.

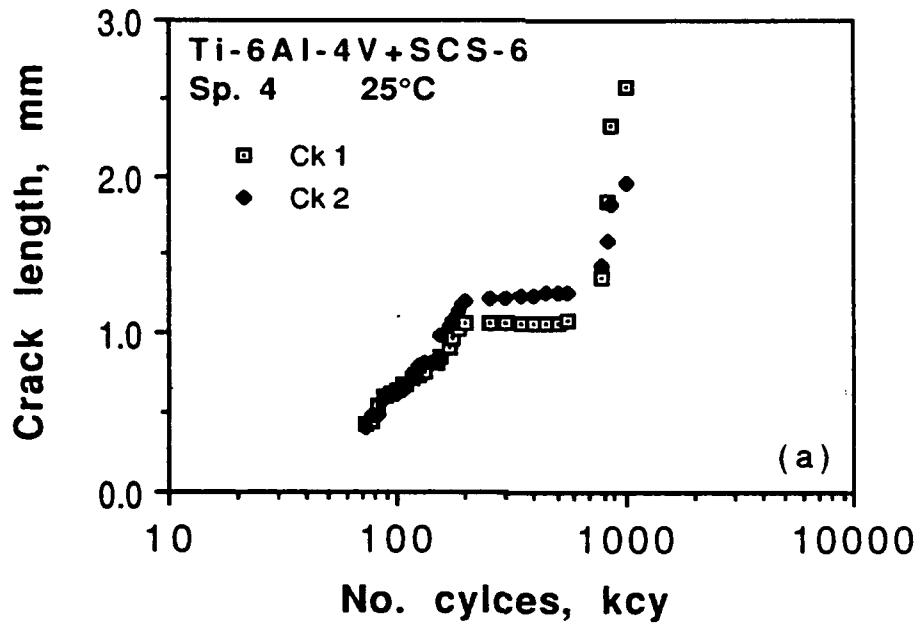
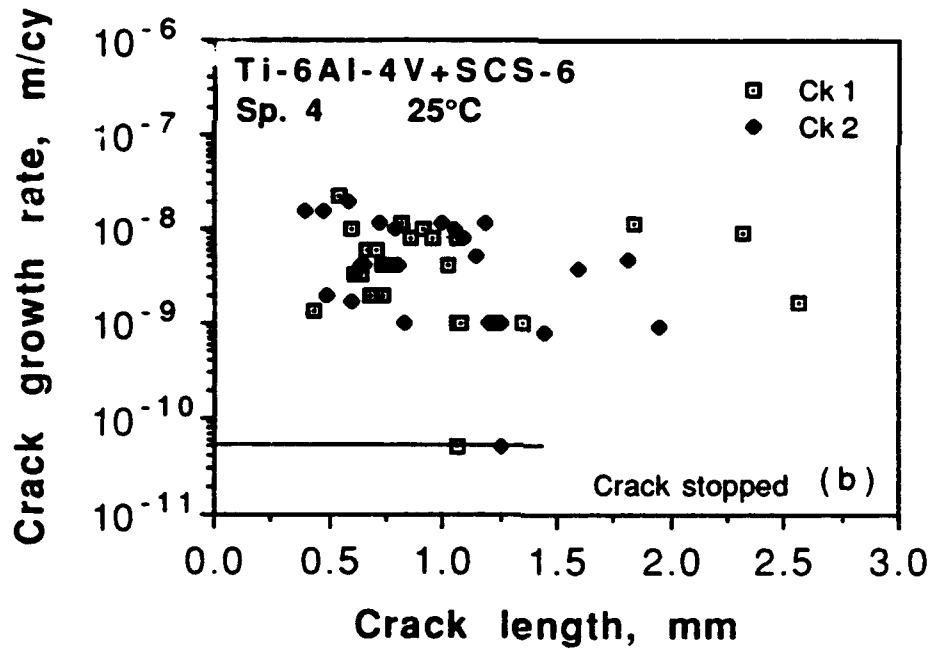
Fig. 6 (a) Specimen 4, crack length vs cycles showing the effect of stress level.  
 (b) Fatigue crack growth rates corresponding to the data in (a).

included in the data for specimens 1 and 2. For several specimens, applied stress levels were increased during the experiments because the cracks arrest. Crack arrest may be seen in Fig. 6(a), together with the effect of increasing stress, but not nearly so well in Fig. 6(b). Applied stresses and crack lengths are given in Table 1.

Using this relationship with the  $\Delta K_{\text{eff}}$  values derived gives crack growth rates of  $2.5 \times 10^{-9} \text{ m/cy}$ , which is within the band of crack growth rates measured, as shown in Fig. 6.

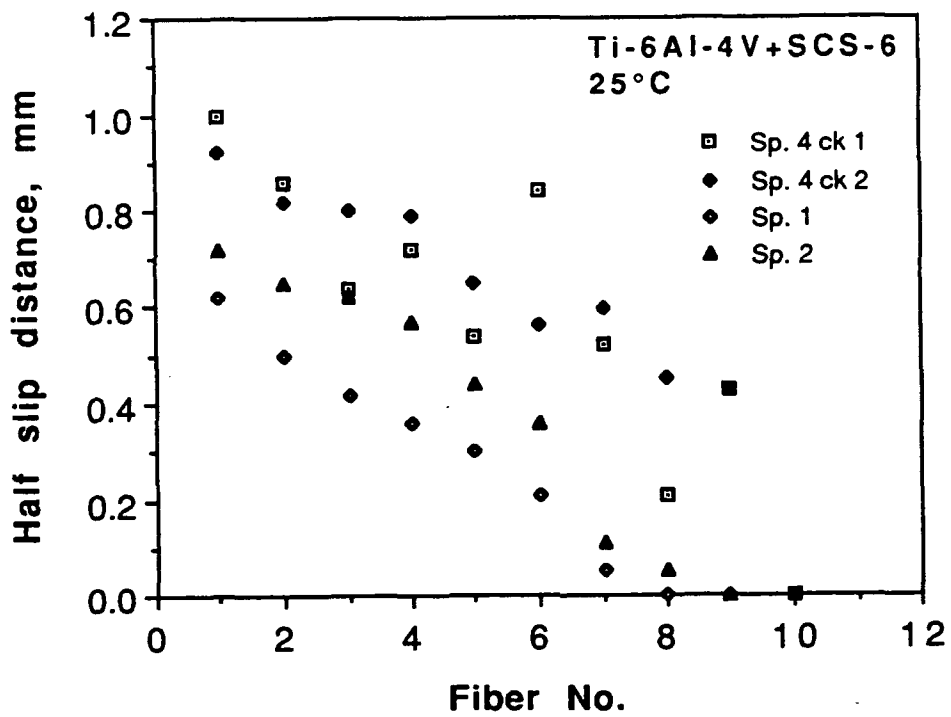
Fig. 9 Slip distance, as determined by fiber damage, as a function of distance along the crack plane, for specimens 1, 2 and 4.

fiber over which slippage occurs relative to the matrix. Slippage lowers the strain on the fibers and allows the fatigue crack to pass without breaking fibers. The extent of fiber slippage has been measured for specimens 1 and 4, and is compared in Fig. 9. Slip distance is a function of the level of applied stress, crack length, and the stress needed to debond the fiber from the matrix.

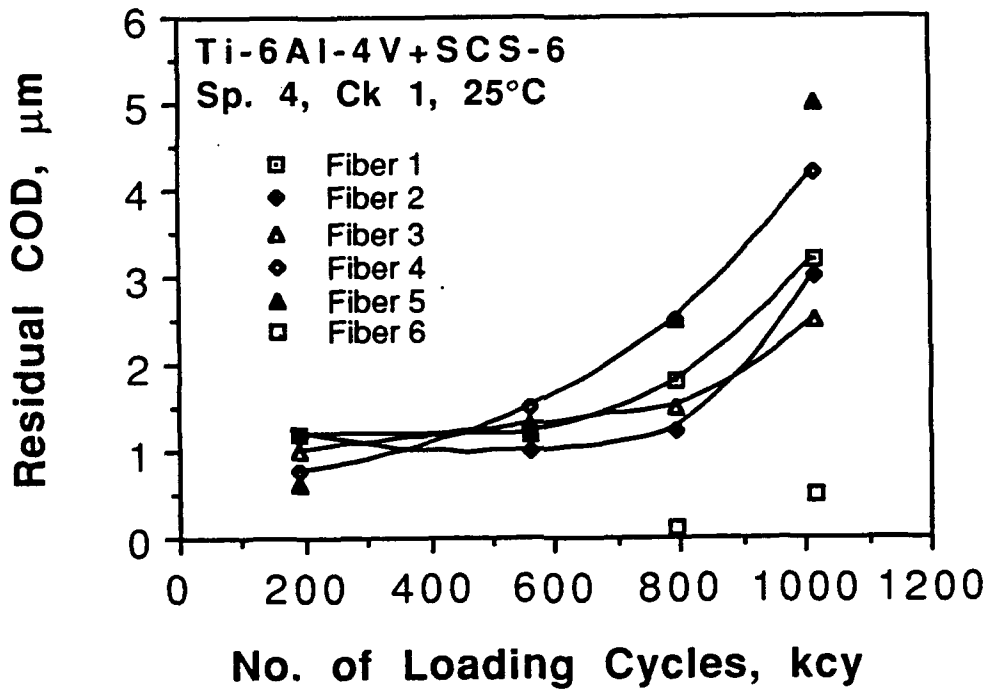
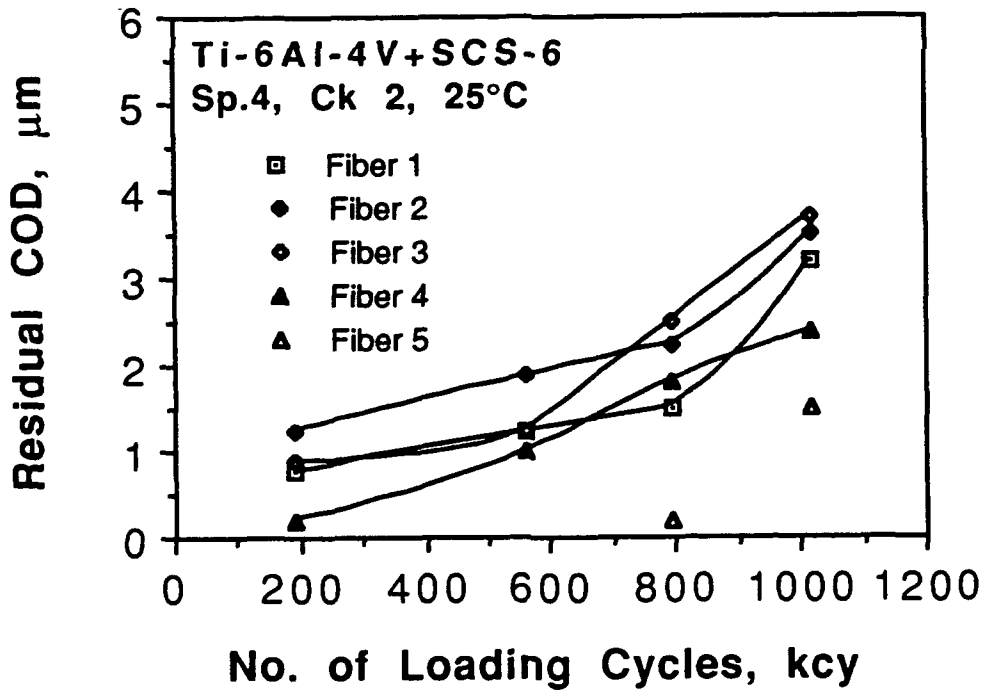
Fig. 10 Residual Crack Opening Displacement (CODr) as a function of the number of loading cycles for specimen 4, (a) crack 1, and (b) crack 2.

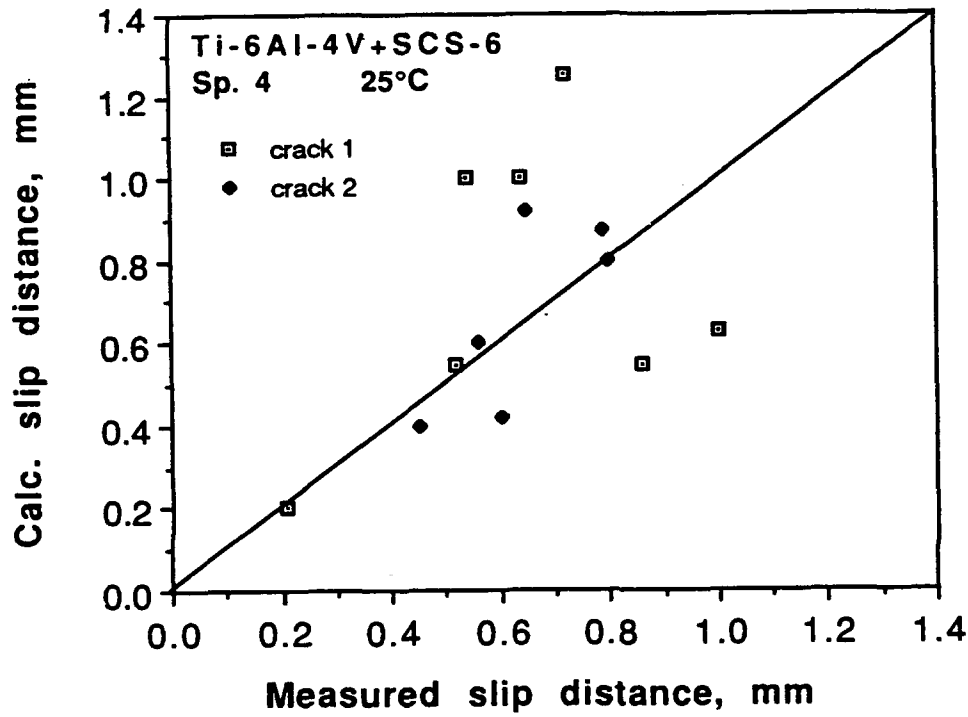
Fig. 11 Comparison of slip distances calculated from CODr and measured.

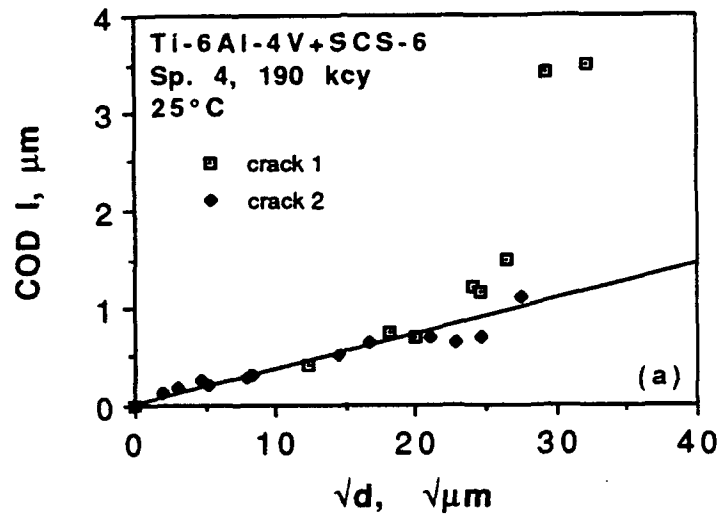
Fig. 13 Specimen 4, COD as a function of the distance from the crack tip for several crack lengths. (a) 190 kcy, (b) 561 kcy, and (c) 1016 kcy.

stereoimaging. Crack opening displacement is easily determined from these displacements, and the results are shown in Figs. 12 and 13. COD is shown as a function of the square root of distance behind the tip because this functional form fits the data better than a linear relation; also, the same function fits COD for fatigue cracks in unreinforced matrix. The lines shown correlating Mode I COD have the form

Using this correlation gives for specimen 4 at 190 and 561 kcy,  $\Delta K_{\text{eff}} \approx 4.0 \text{ MPa}\sqrt{\text{m}}$ , and for 1016 kcy,  $\Delta K_{\text{eff}} \approx 5 \text{ MPa}\sqrt{\text{m}}$ . The relationship between fatigue crack growth rate (m/cy) and  $\Delta K_{\text{eff}}$  (MPa $\sqrt{\text{m}}$ ) for Ti-6Al-4V (RA) is [17]
