USAARL Report No. 91-7

## Concept Evaluation of the UH-60 Externally Mounted Rescue Hoist

January 1991

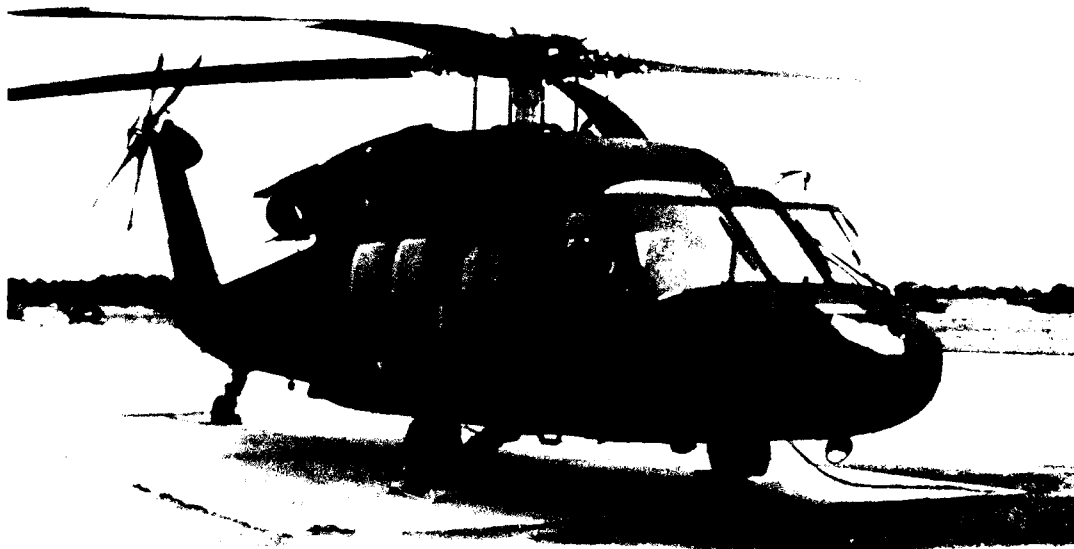
Figure 2. Three-quarter view UH-60 with EMRH installed.

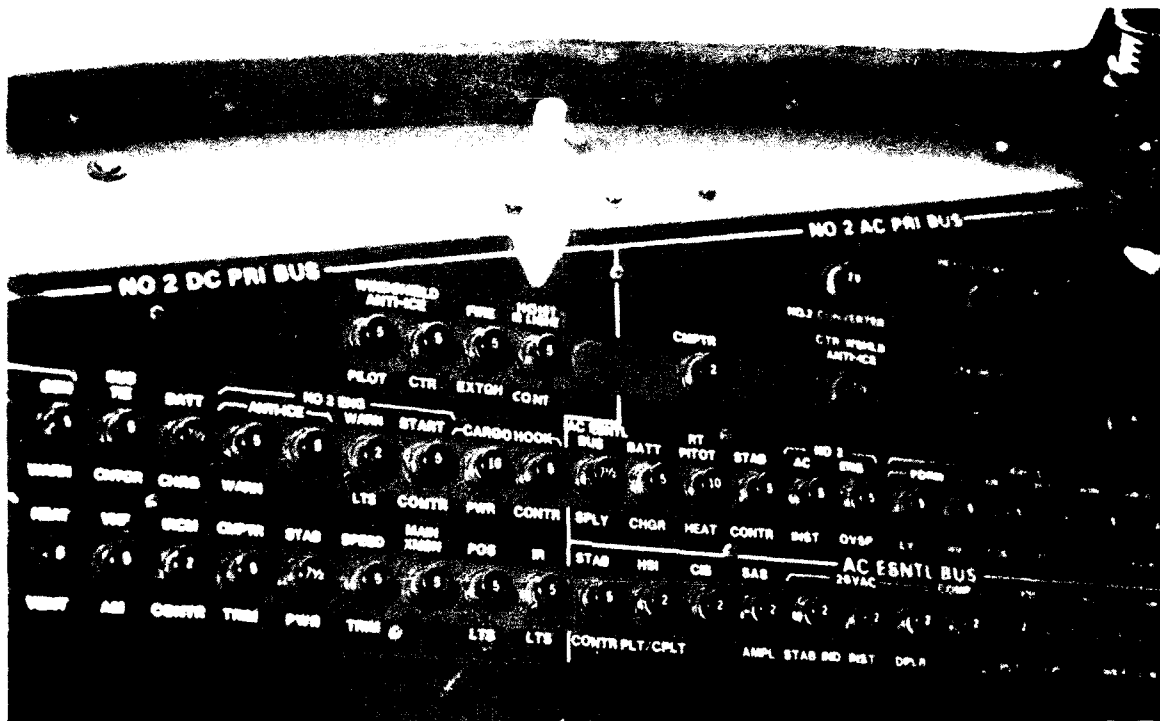
Figure 6. Circuit breaker panel located above and behind pilot's seat (hoist IR light 5-amp circuit breaker).

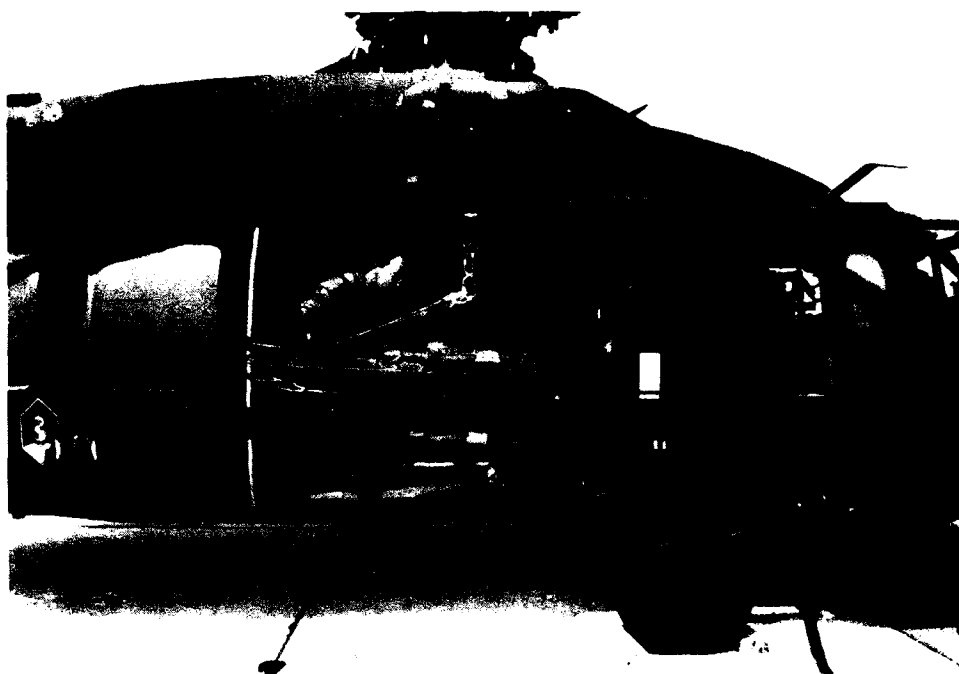
Figure 20. Litter carousel fly position, six-man configuration, Stokes litter in horizontal position, loading head first.
