**US Army Corps
of Engineers**
Construction Engineering
Research Laboratory

USACERL Technical Report M-91/18
July 1991

Guide for Visual Inspection of Structural Concrete Building Components

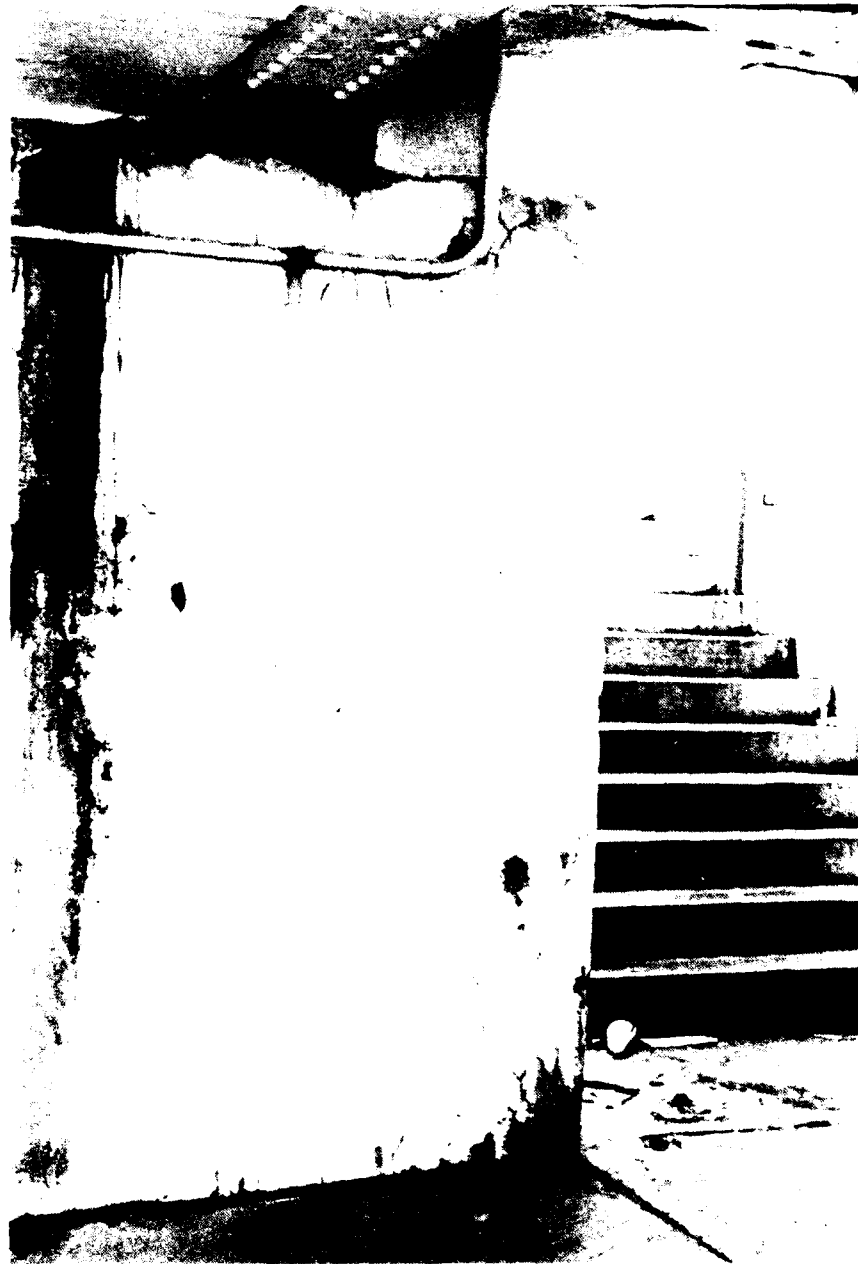
Figure 3. Random pattern cracking of a wall.

Map cracking, sometimes known as pattern cracking, is characterized by fine openings on the surface of the concrete. Map cracks generally result from a decrease in the volume of the material near the surface or an increase in subsurface material volume. Map cracking is structurally significant if the pattern follows the pattern of the underlying reinforcing steel or demonstrates separation of the concrete materials (Figure 3).

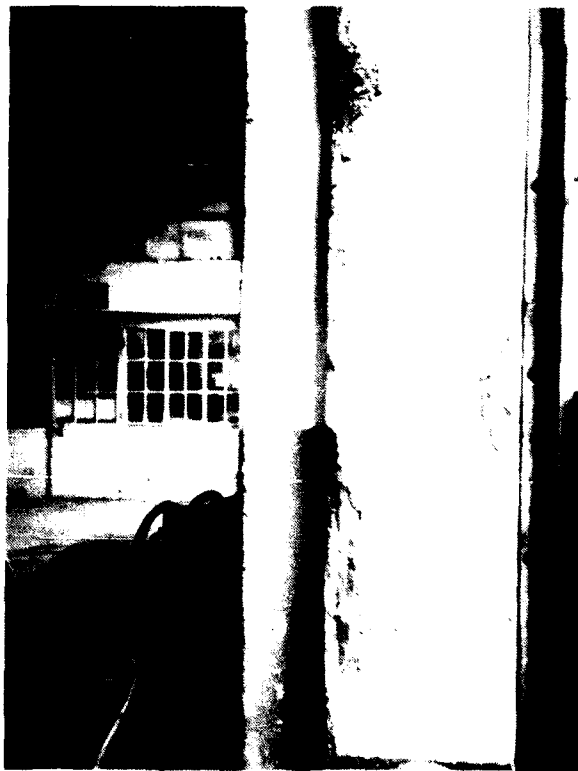
Figure 7. Abrasion/impact damage to a concrete column.

equipment crossing areas not designed for abrasive conditions. Impact damage from collision with a concrete member can result in severe material loss (Figure 7).

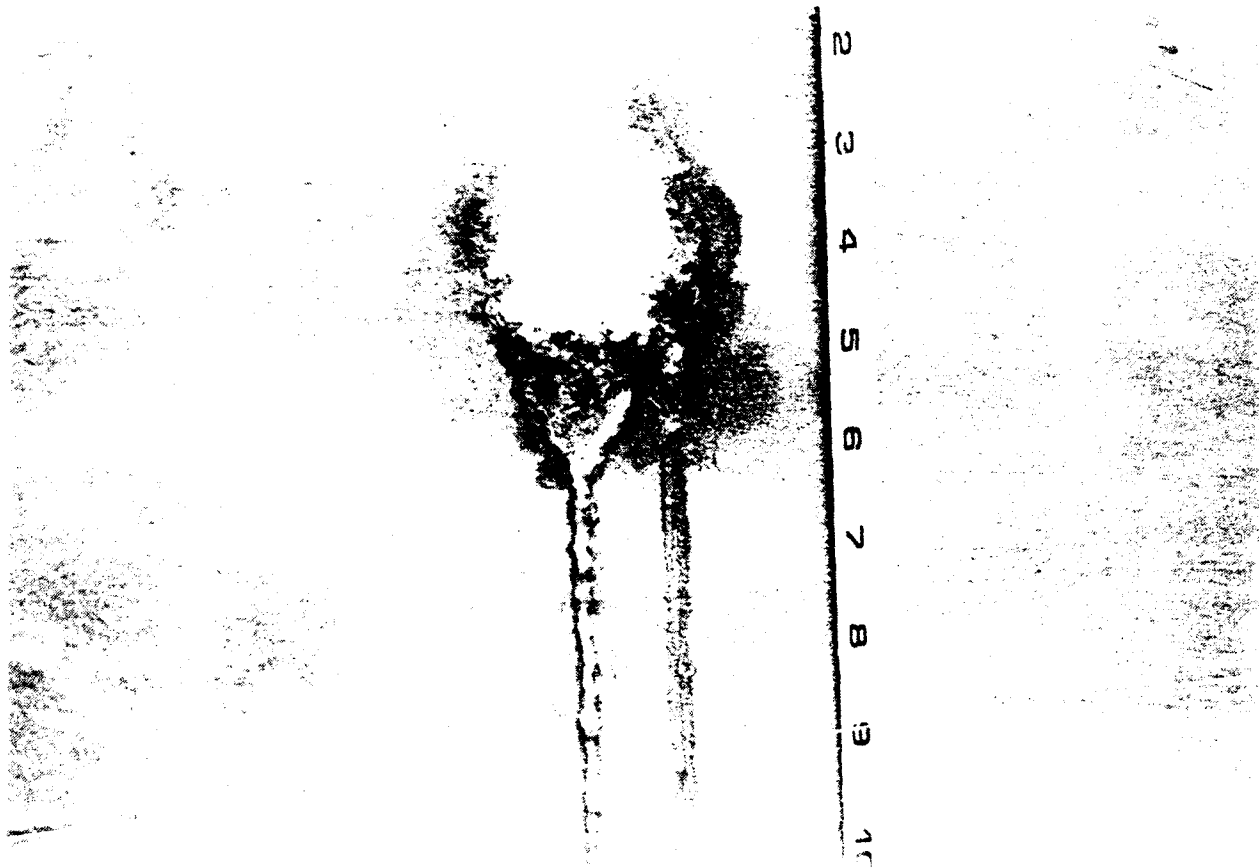
Figure 11. Efflorescence on a concrete wall.

Including aggregates in the mix that are reactive with the cement can cause a deposit of salts to form on the surface as bleed water rises to the surface and evaporates. Excessive amounts of water in the mix compounds the condition. Repeated wetting and drying of inservice concrete can leach salt deposits from the concrete mass and deposit them on the surface through cracks or other surface penetration (Figure 11).

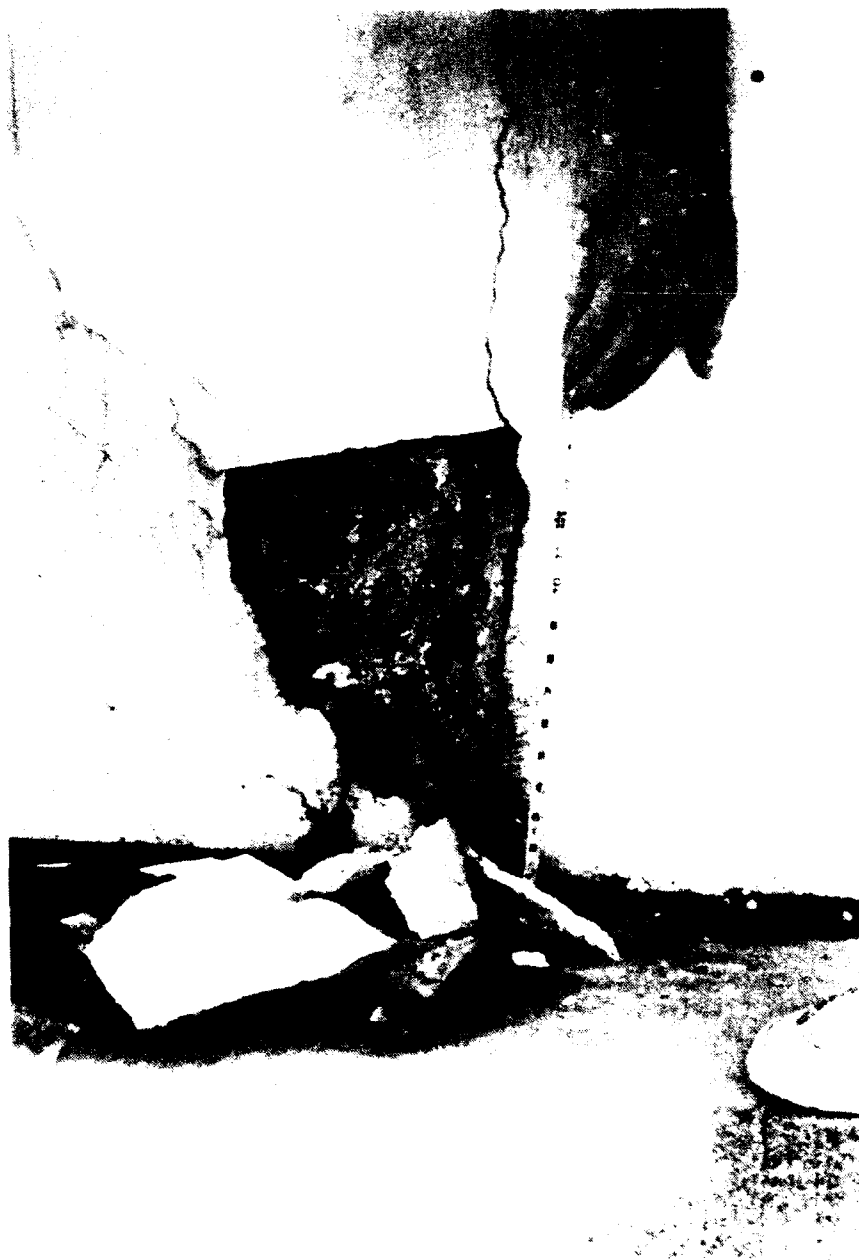
Figure 13. Flaking of a concrete wall.

Flaking is the delamination of the surface concrete from the subsurface mass. It occurs because of improper construction practices or freezing and thawing of permeable concrete (Figure 13). High water content of the concrete mix can cause a concentration of fine aggregates and water at the surface. If finishing techniques are carried out while excess bleed water is still on the surface, delamination of the surface layer can later occur.
